# Manhole Inspection Report

Date:	<b>04/08/2018</b>	Weather:		Coding:	<b>RZMACP</b>
MH#:	<b>M-503-084</b>	Owner:	<b>NA</b>	Len. Surveyed:	<b>6.3</b>
P.O.#:		Surveyor:	<b>John Kuglmaier</b>	Rim to Invert:	<b>7.4</b>
Customer:		Cert. #:	<b>U-1215-07002349</b>	Wall Material:	<b>Concrete (reinforced)</b>

Street:	<b>359' South of 37th Ave. Between Gu</b>	Project:	<b>Hobart, IN</b>
City:	<b>Hobart, IN</b>	GPS Northing:	<b>2899526.261</b>
Location:		GPS Easting:	<b>2899526.261</b>
Drain Area:	<b>Northwest</b>	GPS Accuracy:	<b>Sub-Meter</b>
Cover Shape:	<b>Circular</b>	Evidence of Surcharge:	<b>No</b>
Cover Size:	<b>23.0</b>	Potential for Runoff:	<b>None</b>
Comments:

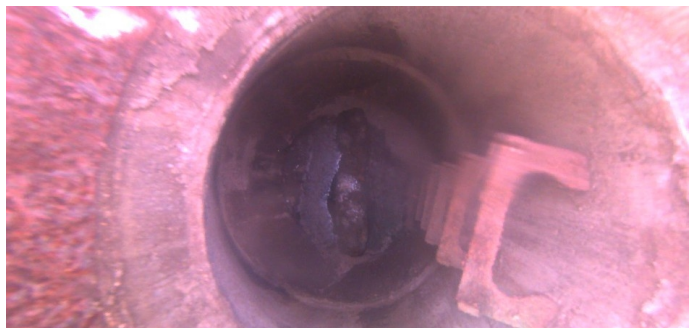
Code: **MGP**  
Description: **General Photo**

Distance (ft): **.0**  
Structural Grade: **0**  
O&M Grade: **0**  
Clock Start/From:  
Clock To:  
1st Value:  
2nd Value:  
Value Percent:  
Step: **NO**  
Remarks:

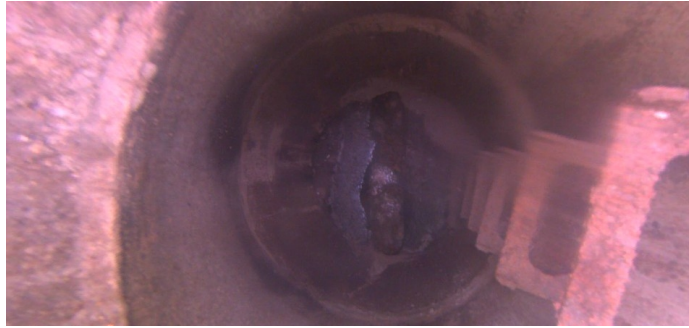
Code: **IS**  
Description: **Infil Stain**

Distance (ft): **.7**  
Structural Grade: **0**  
O&M Grade: **0**  
Clock Start/From: **12**  
Clock To: **12**  
1st Value:  
2nd Value:  
Value Percent:  
Step: **NO**  
Remarks:

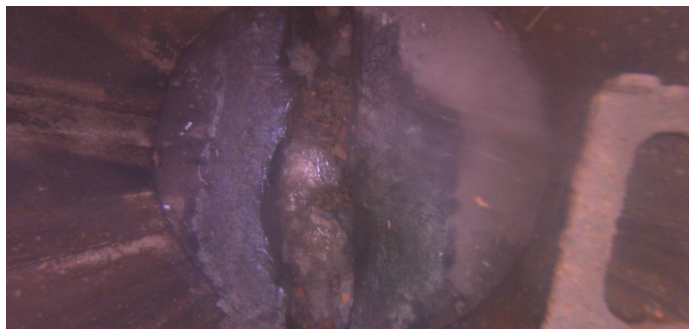
Code: **DAZ**  
Description: **Deposits Attached Other**

Distance (ft): **4.5**  
Structural Grade: **0**  
O&M Grade: **3**  
Clock Start/From: **12**  
Clock To: **12**  
1st Value:  
2nd Value:  
Value Percent: **15.000**  
Step: **NO**  
Remarks: **Mixed materials**

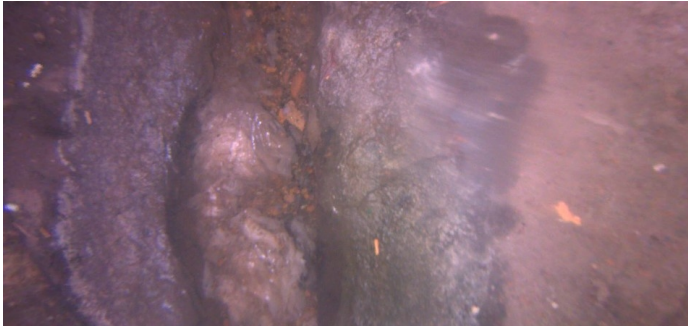
Code:	<b>MGO</b>
Description:	<b>General Observation</b>
Distance (ft):	<b>5.7</b>
Structural Grade:	<b>0</b>
O&M Grade:	<b>0</b>
Clock Start/From:	
Clock To:	
1st Value:	
2nd Value:	
Value Percent:	
Step:	<b>NO</b>
Remarks:	<b>Ins. Comp.</b>
