# Manhole Inspection Report

Date:	<b>03/30/2018</b>	Weather:		Coding:	<b>RZMACP</b>
MH#:	<b>M-503-085</b>	Owner:	<b>NA</b>	Len. Surveyed:	<b>4.4</b>
P.O.#:		Surveyor:	<b>John Kuglmaier</b>	Rim to Invert:	<b>6.0</b>
Customer:		Cert. #:	<b>U-1215-07002349</b>	Wall Material:	<b>Concrete (reinforced)</b>

Street:	<b>55' West of Guyer St. 165' South of</b>	Project:	<b>Hobart, IN</b>
City:	<b>Hobart, IN</b>	GPS Northing:	<b>0.0</b>
Location:		GPS Easting:	<b>0.0</b>
Drain Area:	<b>Northwest</b>	GPS Accuracy:	<b>Nearest Meter</b>
Cover Shape:	<b>Circular</b>	Evidence of Surcharge:	<b>No</b>
Cover Size:	<b>23.0</b>	Potential for Runoff:	<b>None</b>
Comments:

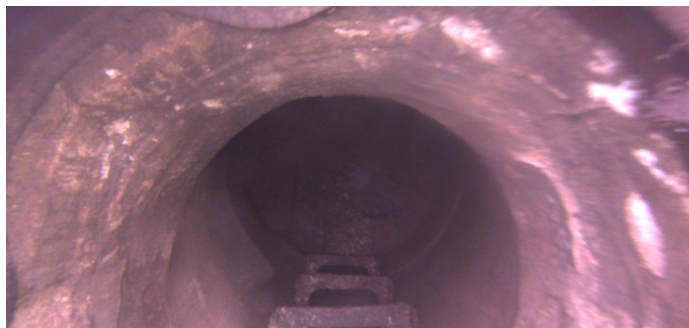
Code: **MGP**  
Description: **General Photo**

Distance (ft): **.0**  
Structural Grade: **0**  
O&M Grade: **0**  
Clock Start/From:  
Clock To:  
1st Value:  
2nd Value:  
Value Percent:  
Step: **NO**  
Remarks:

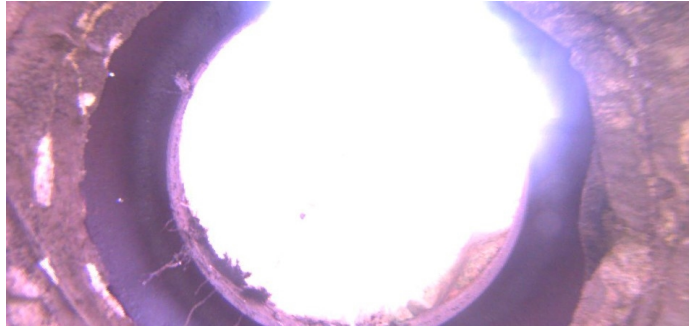
Code: **MGP**  
Description: **General Photo**

Distance (ft): **1.8**  
Structural Grade: **0**  
O&M Grade: **0**  
Clock Start/From:  
Clock To:  
1st Value:  
2nd Value:  
Value Percent:  
Step: **NO**  
Remarks:

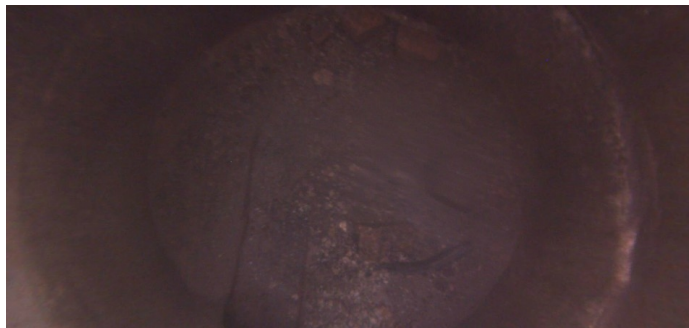
Code: **DSF**  
Description: **Deposits Settled Fine**

Distance (ft): **2.8**  
Structural Grade: **0**  
O&M Grade: **2**  
Clock Start/From: **12**  
Clock To: **12**  
1st Value:  
2nd Value:  
Value Percent: **10.000**  
Step: **NO**  
Remarks:

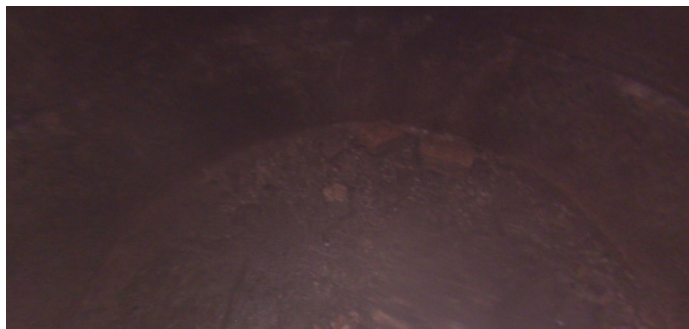
Code: **OBB**  
Description: **Obstacle Brick**

Distance (ft): **3.6**  
Structural Grade: **0**  
O&M Grade: **2**  
Clock Start/From: **1**  
Clock To:  
1st Value:  
2nd Value:  
Value Percent: **5.000**  
Step: **NO**  
Remarks:

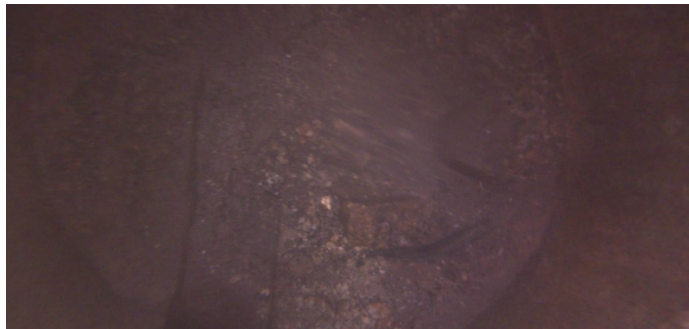
Code: **OBB**  
Description: **Obstacle Brick**

Distance (ft): **3.6**  
Structural Grade: **0**  
O&M Grade: **2**  
Clock Start/From: **3**  
Clock To: **4**  
1st Value:  
2nd Value:  
Value Percent: **5.000**  
Step: **NO**  
Remarks:

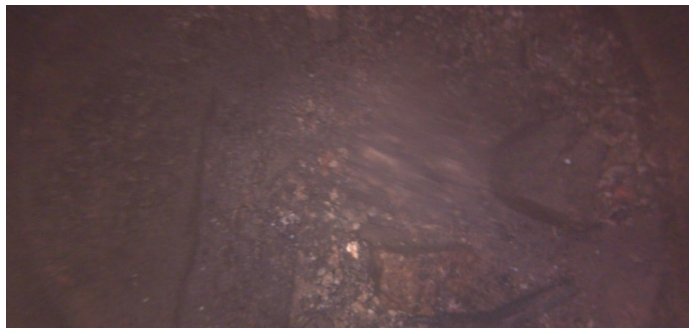
Code: **MGO**  
Description: **General Observation**

Distance (ft): **4.0**  
Structural Grade: **0**  
O&M Grade: **0**  
Clock Start/From:  
Clock To:  
1st Value:  
2nd Value:  
Value Percent:  
Step: **NO**  
Remarks: **Ins. Comp.**
