# Manhole Inspection Report

Date:	<b>03/30/2018</b>	Weather:		Coding:	<b>RZMACP</b>
MH#:	<b>M-503-086</b>	Owner:	<b>NA</b>	Len. Surveyed:	<b>8.2</b>
P.O.#:		Surveyor:	<b>John Kuglmaier</b>	Rim to Invert:	<b>9.9</b>
Customer:		Cert. #:	<b>U-1215-07002349</b>	Wall Material:	<b>Concrete (reinforced)</b>

Street:	<b>163' East of Wilson St. 165' South of</b>	Project:	<b>Hobart, IN</b>
City:	<b>Hobart, IN</b>	GPS Northing:	<b>0.0</b>
Location:		GPS Easting:	<b>0.0</b>
Drain Area:	<b>Northwest</b>	GPS Accuracy:	<b>Nearest Meter</b>
Cover Shape:	<b>Circular</b>	Evidence of Surcharge:	<b>No</b>
Cover Size:	<b>23.0</b>	Potential for Runoff:	<b>None</b>
Comments:

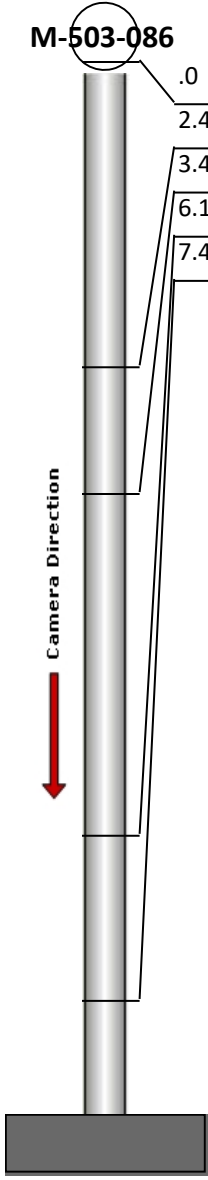
.0	MGP	General Photo	10	NA
	2.4	MGP	General Photo	29	NA
	3.4	IS	Infil Stain	44	NA
	6.1	DSF	Deposits Settled Fine	61	M 2
	7.4	MGO	General Observation	75	NA

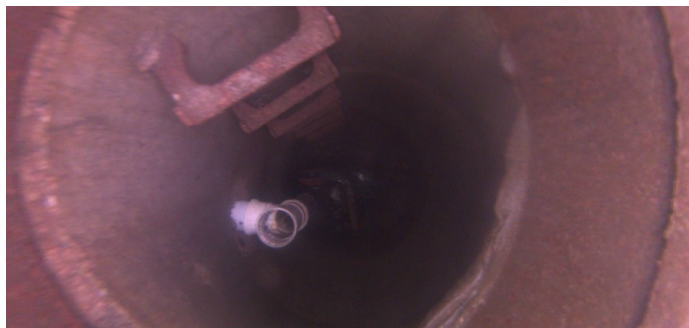
Code: **MGP**  
Description: **General Photo**

Distance (ft): **.0**  
Structural Grade: **0**  
O&M Grade: **0**  
Clock Start/From:  
Clock To:  
1st Value:  
2nd Value:  
Value Percent:  
Step: **NO**  
Remarks:

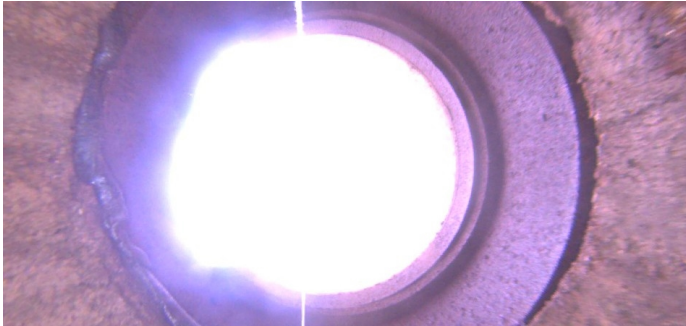
Code: **MGP**  
Description: **General Photo**

Distance (ft): **2.4**  
Structural Grade: **0**  
O&M Grade: **0**  
Clock Start/From:  
Clock To:  
1st Value:  
2nd Value:  
Value Percent:  
Step: **NO**  
Remarks:

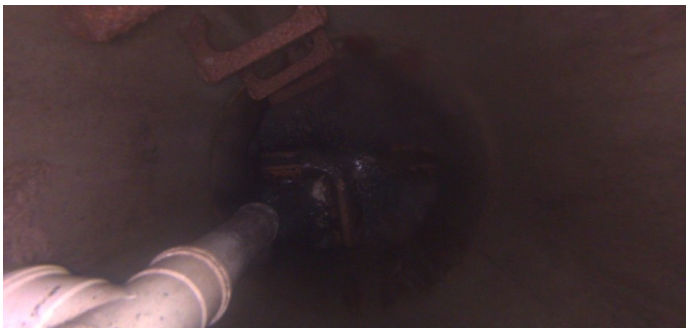
Code: **IS**  
Description: **Infil Stain**

Distance (ft): **3.4**  
Structural Grade: **0**  
O&M Grade: **0**  
Clock Start/From: **12**  
Clock To: **12**  
1st Value:  
2nd Value:  
Value Percent:  
Step: **NO**  
Remarks:

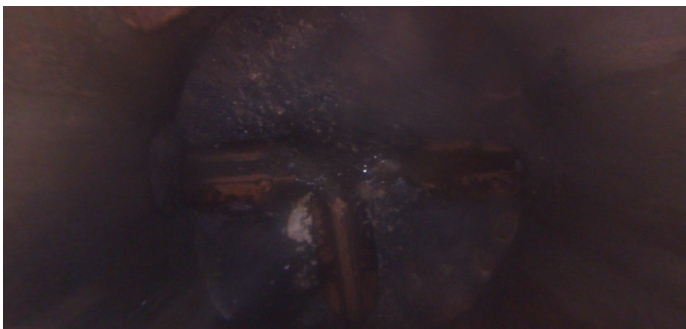
Code: **DSF**  
Description: **Deposits Settled Fine**

Distance (ft): **6.1**  
Structural Grade: **0**  
O&M Grade: **2**  
Clock Start/From: **12**  
Clock To: **12**  
1st Value:  
2nd Value:  
Value Percent: **10.000**  
Step: **NO**  
Remarks:

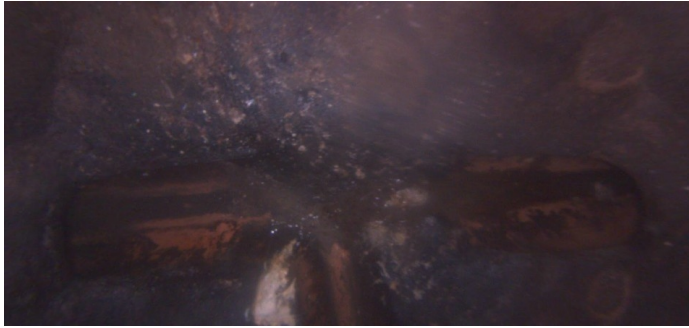
Code:	<b>MGO</b>
Description:	<b>General Observation</b>
Distance (ft):	<b>7.4</b>
Structural Grade:	<b>0</b>
O&M Grade:	<b>0</b>
Clock Start/From:	
Clock To:	
1st Value:	
2nd Value:	
Value Percent:	
Step:	<b>NO</b>
Remarks:	<b>Ins. Comp.</b>
