Manhole Inspection Report

Date:	04/10/2018	Weather:		Coding:	RZMACP
MH#:	M-503-088	Owner:	NA	Len. Surveyed:	7.3
P.O.#:		Surveyor:	John Kuglmaier	Rim to Invert:	8.8
Customer:		Cert. #:	U-1215-07002349	Wall Material:	Concrete (reinforced)

Street:	40th Ave. 161' West of Cavender St.	Project:	Hobart, IN
City:	Hobart, IN	GPS Northing:	0.0
Location:		GPS Easting:	0.0
Drain Area:	Northwest	GPS Accuracy:	Nearest Meter
Cover Shape:	Circular	Evidence of Surcharge:	Yes
Cover Size:	23.0	Potential for Runoff:	None
Comments:

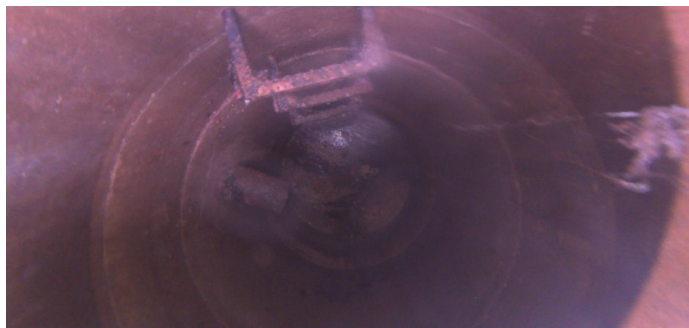
Code: **MGP**
Description: **General Photo**

Distance (ft): **.0**
Structural Grade: **0**
O&M Grade: **0**
Clock Start/From:
Clock To:
1st Value:
2nd Value:
Value Percent:
Step: **NO**
Remarks:

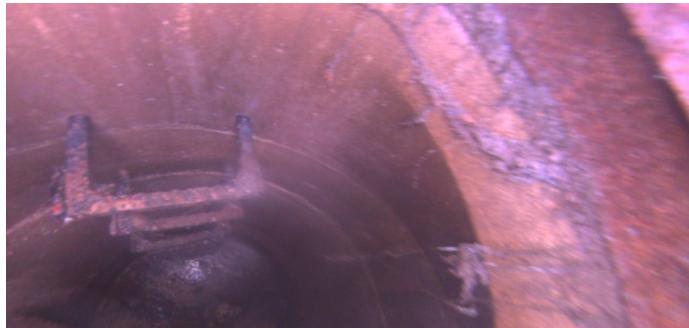
Code:	RFJ
Description:	Roots Fine Joint
Distance (ft):	.2
Structural Grade:	0
O&M Grade:	1
Clock Start/From:	2
Clock To:	3
1st Value:	
2nd Value:	
Value Percent:	
Step:	NO
Remarks:

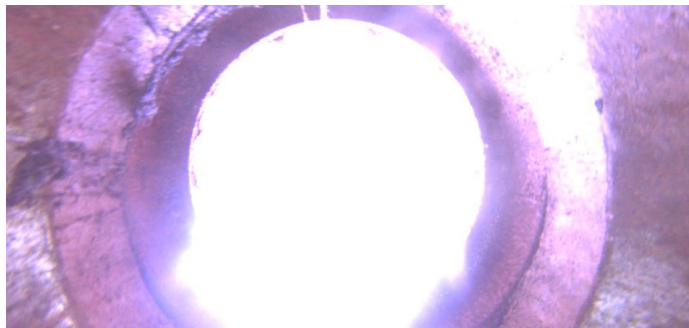
Code:	MGP
Description:	General Photo
Distance (ft):	1.8
Structural Grade:	0
O&M Grade:	0
Clock Start/From:	
Clock To:	
1st Value:	
2nd Value:	
Value Percent:	
Step:	NO
Remarks:

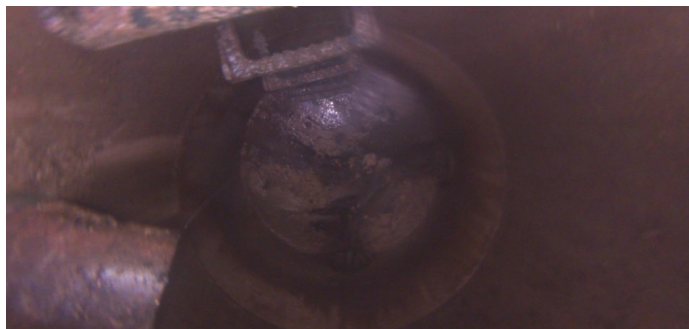
Code:	IS
Description:	Infil Stain
Distance (ft):	3.0
Structural Grade:	0
O&M Grade:	0
Clock Start/From:	12
Clock To:	12
1st Value:	
2nd Value:	
Value Percent:	
Step:	NO
Remarks:

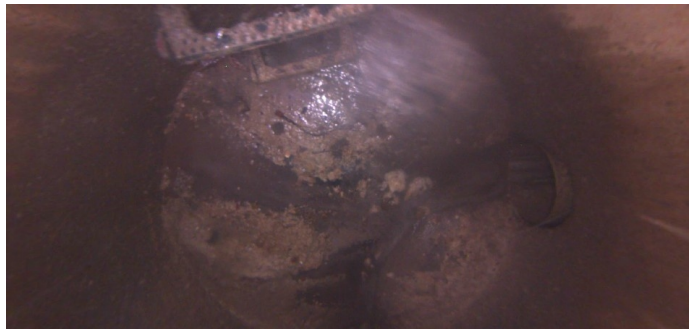
Code:	DAZ
Description:	Deposits Attached Other
Distance (ft):	5.5
Structural Grade:	0
O&M Grade:	2
Clock Start/From:	12
Clock To:	12
1st Value:	
2nd Value:	
Value Percent:	5.000
Step:	NO
Remarks:	Mixed materials

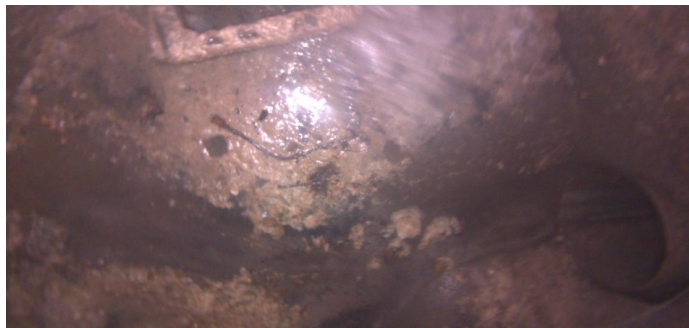
Code:	MGO
Description:	General Observation
Distance (ft):	6.5
Structural Grade:	0
O&M Grade:	0
Clock Start/From:	
Clock To:	
1st Value:	
2nd Value:	
Value Percent:	
Step:	NO
Remarks:	Ins. Comp.
