Manhole Inspection Report

Date:	04/10/2018	Weather:		Coding:	RZMACP
MH#:	M-503-089	Owner:	NA	Len. Surveyed:	4.1
P.O.#:		Surveyor:	John Kuglmaier	Rim to Invert:	4.5
Customer:		Cert. #:	U-1215-07002349	Wall Material:	Concrete (reinforced)

Street:	40th Ave. 163' East of Wilson St.	Project:	Hobart, IN
City:	Hobart, IN	GPS Northing:	2899548.143
Location:		GPS Easting:	2899548.143
Drain Area:	Northwest	GPS Accuracy:	Sub-Meter
Cover Shape:	Circular	Evidence of Surcharge:	No
Cover Size:	23.0	Potential for Runoff:	None
Comments:

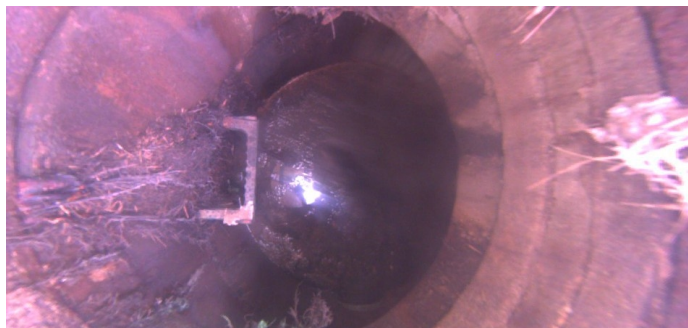
Code: **MGP**
Description: **General Photo**

Distance (ft): **.0**
Structural Grade: **0**
O&M Grade: **0**
Clock Start/From:
Clock To:
1st Value:
2nd Value:
Value Percent:
Step: **NO**
Remarks:

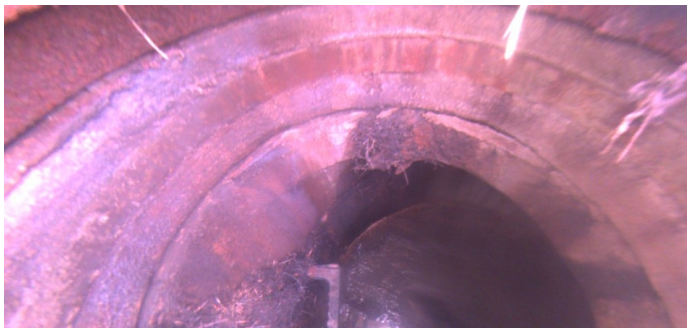
Code: **RFJ**
Description: **Roots Fine Joint**

Distance (ft): **.0**
Structural Grade: **0**
O&M Grade: **1**
Clock Start/From: **12**
Clock To:
1st Value:
2nd Value:
Value Percent:
Step: **NO**
Remarks:

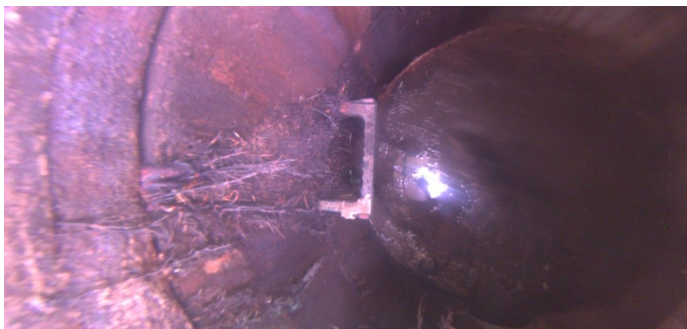
Code: **RFB**
Description: **Roots Fine Barrel**

Distance (ft): **.4**
Structural Grade: **0**
O&M Grade: **2**
Clock Start/From: **8**
Clock To:
1st Value:
2nd Value:
Value Percent:
Step: **NO**
Remarks:

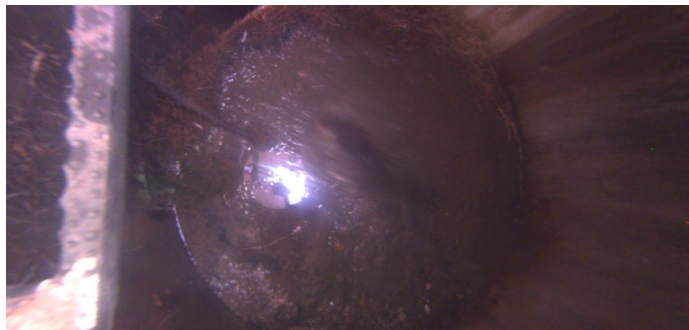
Code: **DSF**
Description: **Deposits Settled Fine**

Distance (ft): **1.9**
Structural Grade: **0**
O&M Grade: **2**
Clock Start/From: **12**
Clock To: **12**
1st Value:
2nd Value:
Value Percent: **5.000**
Step: **NO**
Remarks:

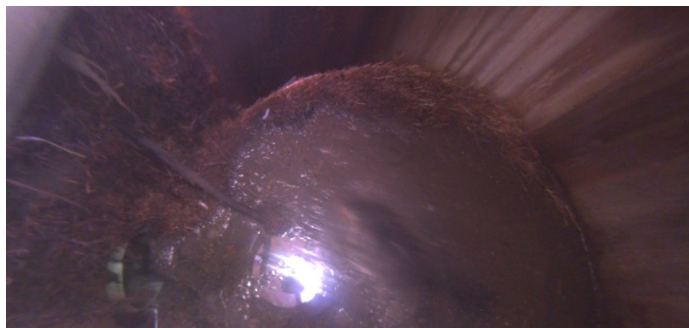
Code: **RFJ**
Description: **Roots Fine Joint**

Distance (ft): **2.2**
Structural Grade: **0**
O&M Grade: **1**
Clock Start/From: **9**
Clock To: **2**
1st Value:
2nd Value:
Value Percent:
Step: **NO**
Remarks:

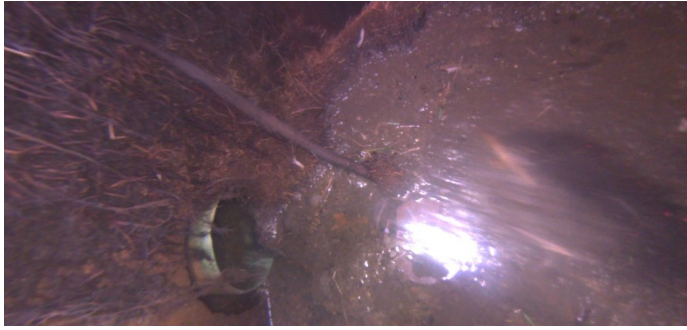
Code: **RFB**
Description: **Roots Fine Barrel**

Distance (ft): **3.0**
Structural Grade: **0**
O&M Grade: **2**
Clock Start/From: **8**
Clock To:
1st Value:
2nd Value:
Value Percent:
Step: **NO**
Remarks: **Clock positions vary**
