Manhole Inspection Report

Date:	10/06/2022	Weather:		Coding:	RZMACP
MH#:	M-503-092	Owner:	NA	Len. Surveyed:	5.5
P.O.#:		Surveyor:	Todd Machine	Rim to Invert:	6.0
Customer:		Cert. #:	P0038859-082022	Wall Material:	Concrete (reinforced)

Street:	70' East of Colorado St. and 220' Nor	Project:	Hobart, IN
City:	Hobart, IN	GPS Northing:	2295354.902
Location:	Other	GPS Easting:	2900509.045
Drain Area:	Northwest	GPS Accuracy:	Sub-Meter
Cover Shape:	Circular	Evidence of Surcharge:	
Cover Size:	24.0	Potential for Runoff:	
Comments:

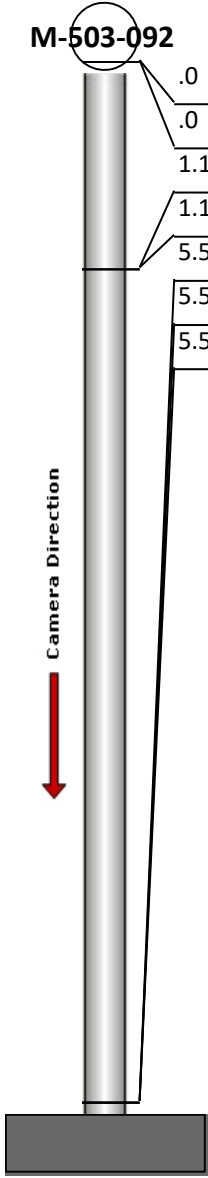
.0	MGO	General Observation	10	NA
	.0	SRI	Surface Roughness Increased	21	S 1
	1.1	RFJ	Roots Fine Joint	35	M 1
	1.1	MGO	General Observation	48	NA
	5.5	DSF	Deposits Settled Fine	69	M 2
	5.5	SRI	Surface Roughness Increased	80	S 1
	5.5	MGO	General Observation	90	NA

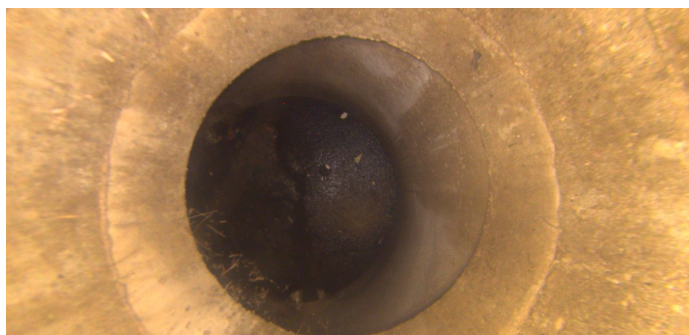
Code: **MGO**
Description: **General Observation**

Distance (ft): **.0**
Structural Grade: **0**
O&M Grade: **0**
Clock Start/From:
Clock To:
1st Value:
2nd Value:
Value Percent:
Step: **NO**
Remarks: **access mh**

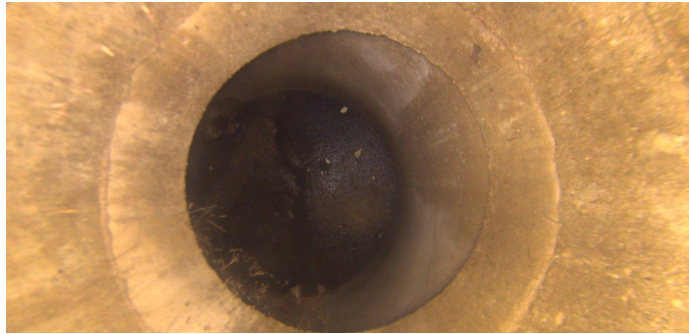
Code: **SRI**
Description: **Surface Roughness Increased**

Distance (ft): **.0**
Structural Grade: **1**
O&M Grade: **0**
Clock Start/From: **12**
Clock To: **12**
1st Value:
2nd Value:
Value Percent:
Step: **NO**
Remarks:

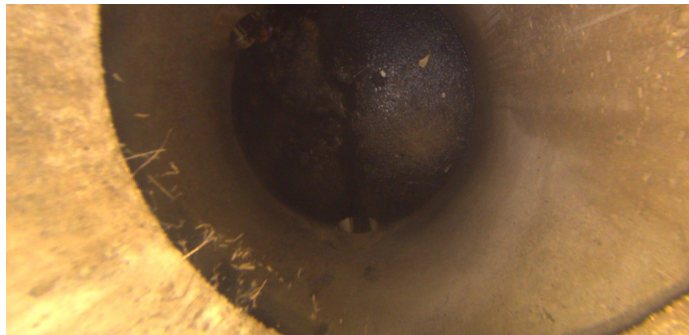
Code: **RFJ**
Description: **Roots Fine Joint**

Distance (ft): **1.1**
Structural Grade: **0**
O&M Grade: **1**
Clock Start/From: **3**
Clock To: **9**
1st Value:
2nd Value:
Value Percent:
Step: **NO**
Remarks:

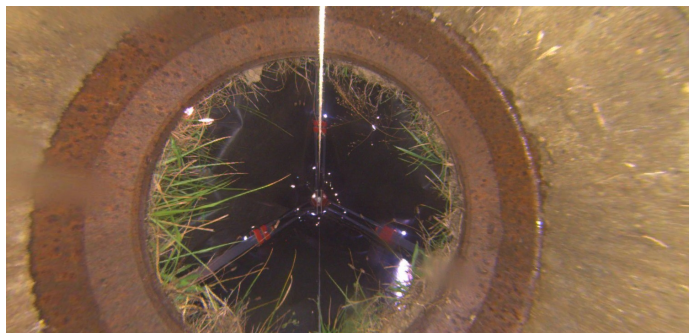
Code: **MGO**
Description: **General Observation**

Distance (ft): **1.1**
Structural Grade: **0**
O&M Grade: **0**
Clock Start/From:
Clock To:
1st Value:
2nd Value:
Value Percent:
Step: **NO**
Remarks: **underside of frame**

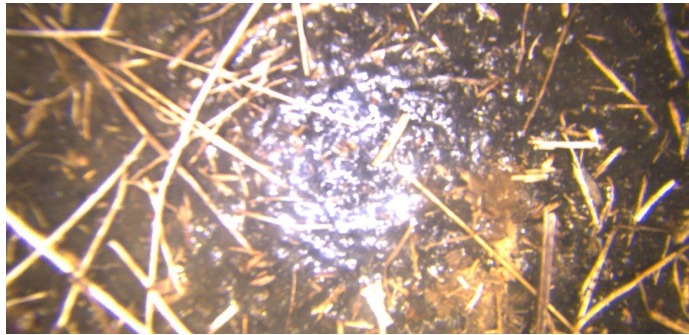
Code: **DSF**
Description: **Deposits Settled Fine**

Distance (ft): **5.5**
Structural Grade: **0**
O&M Grade: **2**
Clock Start/From: **12**
Clock To: **12**
1st Value:
2nd Value:
Value Percent: **5.000**
Step: **NO**
Remarks:

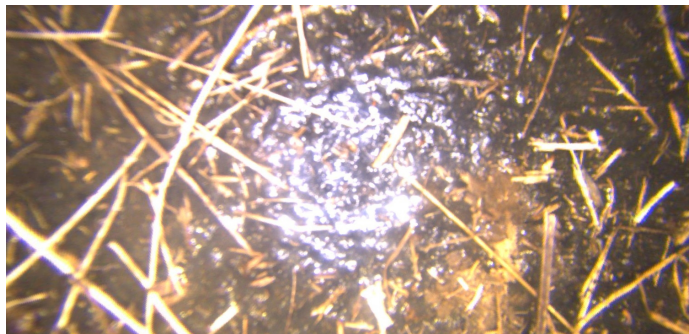
Code: **SRI**
Description: **Surface Roughness Increased**

Distance (ft): **5.5**
Structural Grade: **1**
O&M Grade: **0**
Clock Start/From: **12**
Clock To: **12**
1st Value:
2nd Value:
Value Percent:
Step: **NO**
Remarks:

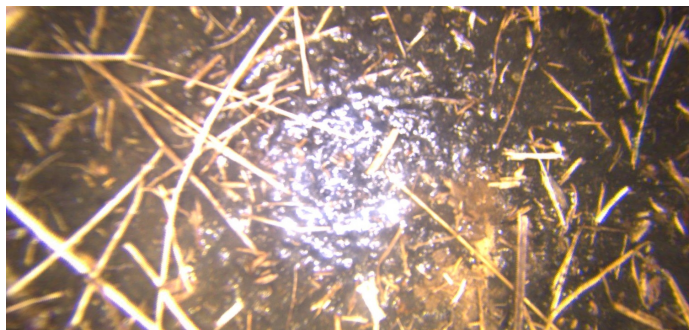
Code: **MGO**
Description: **General Observation**

Distance (ft): **5.5**
Structural Grade: **0**
O&M Grade: **0**
Clock Start/From:
Clock To:
1st Value:
2nd Value:
Value Percent:
Step: **NO**
Remarks: **End Of Survey**
