Manhole Inspection Report

Date:	05/14/2018	Weather:		Coding:	RZMACP
MH#:	M-504-008	Owner:	NA	Len. Surveyed:	8.9
P.O.#:		Surveyor:	Jen Costello	Rim to Invert:	9.0
Customer:		Cert. #:	U-907-5518	Wall Material:	Concrete (reinforced)

Street:	California St. 163' South of Old Ridg	Project:	Hobart, IN
City:	Hobart, IN	GPS Northing:	2901478.185
Location:		GPS Easting:	2901478.185
Drain Area:	West	GPS Accuracy:	Sub-Meter
Cover Shape:	Circular	Evidence of Surcharge:	No
Cover Size:	22.5	Potential for Runoff:	None
Comments:

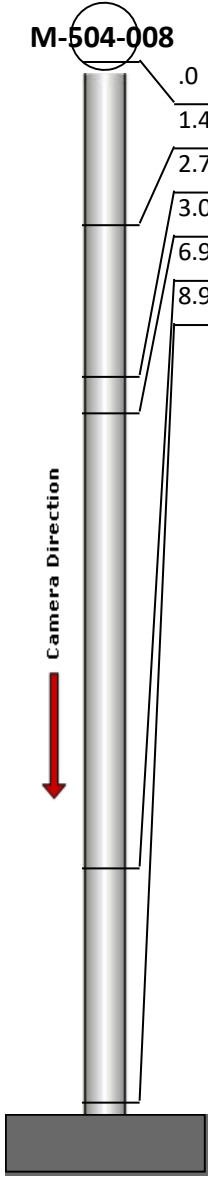
.0	MGP	General Photo	10	NA
	1.4	MGO	General Observation	26	NA
	2.7	DB	Displaced Brick	44	S 3
	3.0	IW	Infil Weeper	58	M 2
	6.9	IW	Infil Weeper	77	M 2
	8.9	MGO	General Observation	92	NA

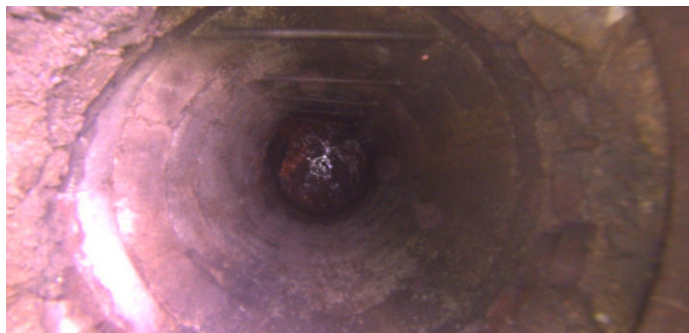
Code: **MGP**
Description: **General Photo**

Distance (ft): **.0**
Structural Grade: **0**
O&M Grade: **0**
Clock Start/From:
Clock To:
1st Value:
2nd Value:
Value Percent:
Step: **NO**
Remarks: **ACCESS MH**

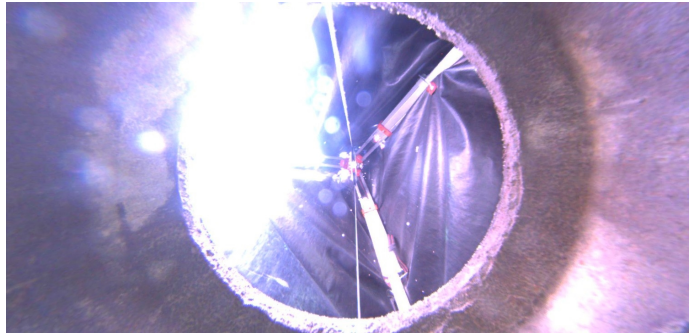
Code:	MGO
Description:	General Observation
Distance (ft):	1.4
Structural Grade:	0
O&M Grade:	0
Clock Start/From:	
Clock To:	
1st Value:	
2nd Value:	
Value Percent:	
Step:	NO
Remarks:	UNDERSIDE OF FRAME

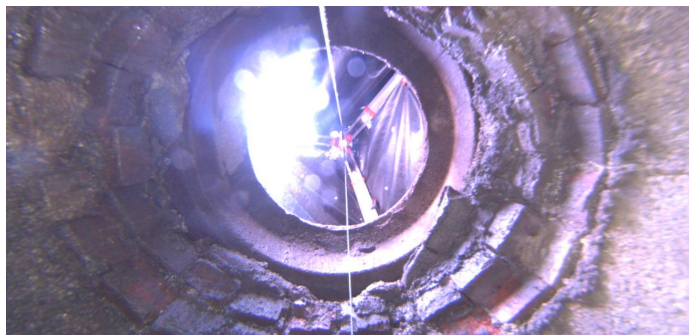
Code:	DB
Description:	Displaced Brick
Distance (ft):	2.7
Structural Grade:	3
O&M Grade:	0
Clock Start/From:	12
Clock To:	12
1st Value:	
2nd Value:	
Value Percent:	
Step:	NO
Remarks:

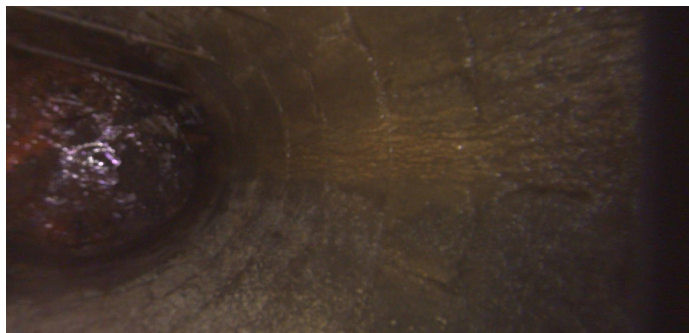
Code:	IW
Description:	Infil Weeper
Distance (ft):	3.0
Structural Grade:	0
O&M Grade:	2
Clock Start/From:	3
Clock To:	
1st Value:	
2nd Value:	
Value Percent:	
Step:	NO
Remarks:

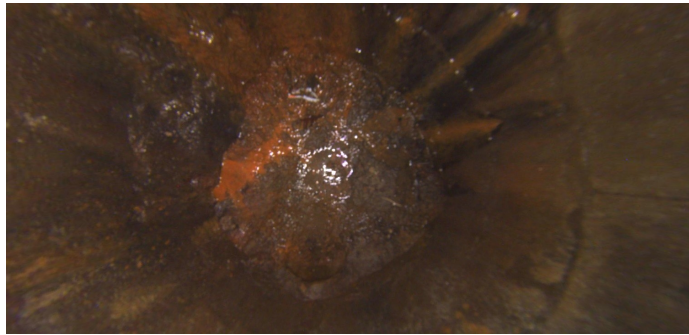
Code: **IW**
Description: **Infil Weeper**

Distance (ft): **6.9**
Structural Grade: **0**
O&M Grade: **2**
Clock Start/From: **12**
Clock To: **12**
1st Value:
2nd Value:
Value Percent:
Step: **NO**
Remarks:

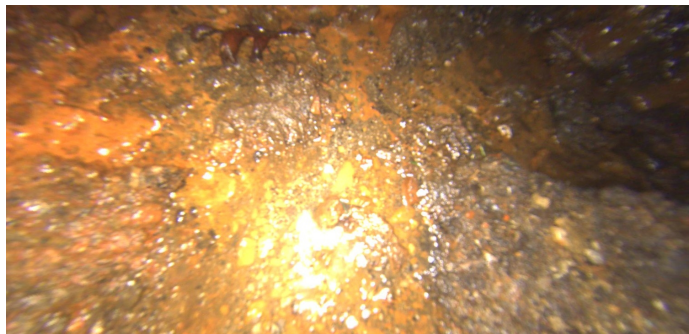
Code: **MGO**
Description: **General Observation**

Distance (ft): **8.9**
Structural Grade: **0**
O&M Grade: **0**
Clock Start/From:
Clock To:
1st Value:
2nd Value:
Value Percent:
Step: **NO**
Remarks: **END SURVEY**
