Manhole Inspection Report

Date:	05/14/2018	Weather:		Coding:	RZMACP
MH#:	M-504-013	Owner:	NA	Len. Surveyed:	9.1
P.O.#:		Surveyor:	Jen Costello	Rim to Invert:	9.6
Customer:		Cert. #:	U-907-5518	Wall Material:	Brick

Street:	North of 44th Ave. 164' East of Dela	Project:	Hobart, IN
City:	Hobart, IN	GPS Northing:	41.53865814
Location:		GPS Easting:	-87.2723465
Drain Area:	West	GPS Accuracy:	Nearest Meter
Cover Shape:	Circular	Evidence of Surcharge:	No
Cover Size:	22.5	Potential for Runoff:	None
Comments:

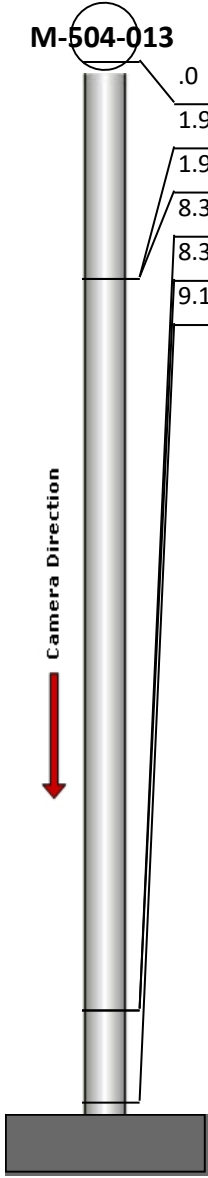
.0	MGO	General Observation	10	NA
	1.9	MGO	General Observation	27	NA
	1.9	SAV	Surface Aggregate Visible	41	S 3
	8.3	DSGV	Deposits Settled Gravel	65	M 2
	8.3	SAV	Surface Aggregate Visible	76	S 3
	9.1	MGO	General Observation	90	NA

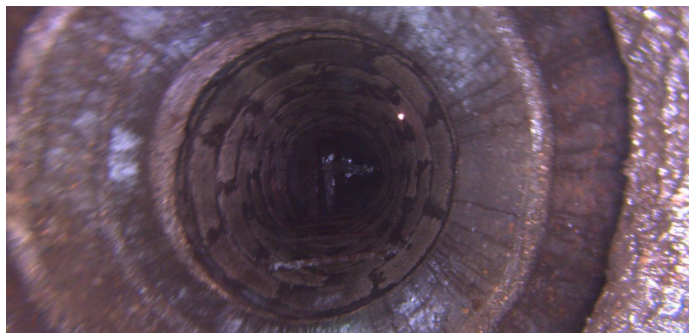
Code: **MGO**
Description: **General Observation**

Distance (ft): **.0**
Structural Grade: **0**
O&M Grade: **0**
Clock Start/From:
Clock To:
1st Value:
2nd Value:
Value Percent:
Step: **NO**
Remarks: **access mh**

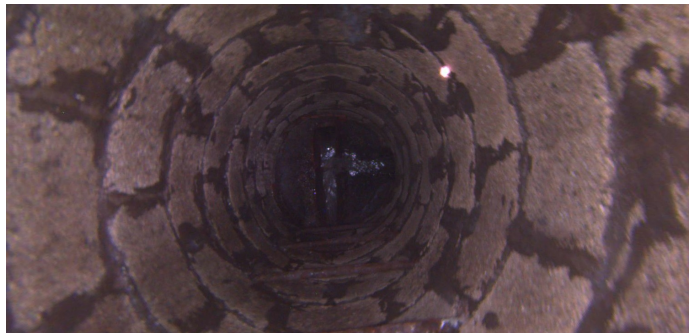
Code: **SAV**
Description: **Surface Aggregate Visible**

Distance (ft): **1.9**
Structural Grade: **3**
O&M Grade: **0**
Clock Start/From: **12**
Clock To: **12**
1st Value:
2nd Value:
Value Percent:
Step: **NO**
Remarks:

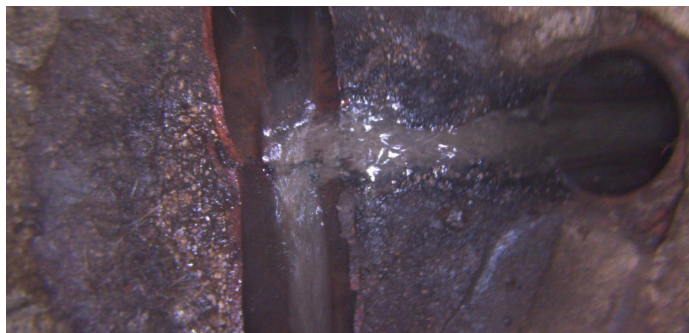
Code: **DSGV**
Description: **Deposits Settled Gravel**

Distance (ft): **8.3**
Structural Grade: **0**
O&M Grade: **2**
Clock Start/From: **12**
Clock To: **12**
1st Value:
2nd Value:
Value Percent: **5.000**
Step: **NO**
Remarks:

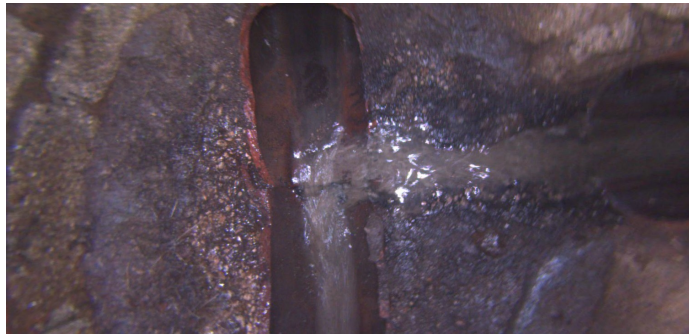
Code: **SAV**
Description: **Surface Aggregate Visible**

Distance (ft): **8.3**
Structural Grade: **3**
O&M Grade: **0**
Clock Start/From: **12**
Clock To: **12**
1st Value:
2nd Value:
Value Percent:
Step: **NO**
Remarks:

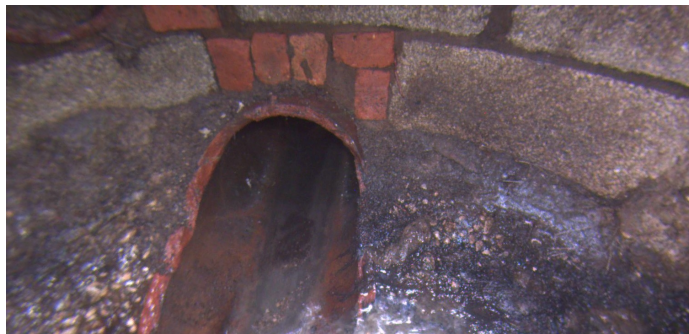
Code: **MGO**
Description: **General Observation**

Distance (ft): **9.1**
Structural Grade: **0**
O&M Grade: **0**
Clock Start/From:
Clock To:
1st Value:
2nd Value:
Value Percent:
Step: **NO**
Remarks: **end survey**
