Manhole Inspection Report

Date:	10/13/2022	Weather:		Coding:	RZMACP
MH#:	M-504-017	Owner:	NA	Len. Surveyed:	10.3
P.O.#:		Surveyor:	Jen Costello	Rim to Invert:	11.4
Customer:		Cert. #:	U-907-5518	Wall Material:	Concrete (cast in place)

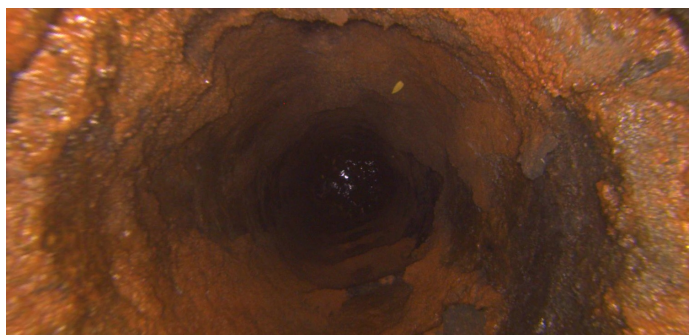
Code: **MGO**
Description: **General Observation**

Distance (ft): **.0**
Structural Grade: **0**
O&M Grade: **0**
Clock Start/From:
Clock To:
1st Value:
2nd Value:
Value Percent:
Step: **NO**
Remarks: **access mh**

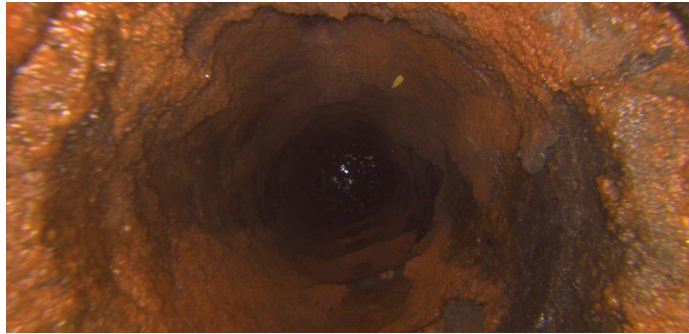
Code:	DAE
Description:	Deposits Attached Encrustation
Distance (ft):	.0
Structural Grade:	0
O&M Grade:	2
Clock Start/From:	12
Clock To:	12
1st Value:	
2nd Value:	
Value Percent:	10.000
Step:	NO
Remarks:

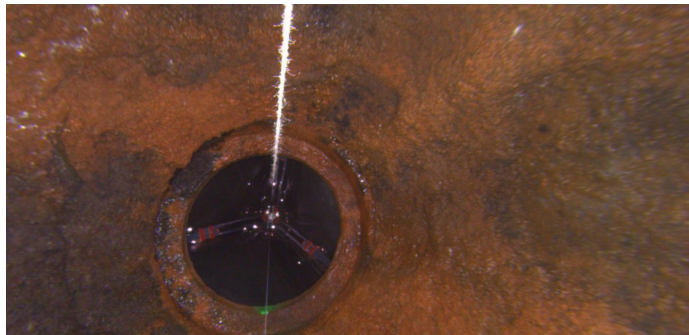
Code:	MGO
Description:	General Observation
Distance (ft):	3.8
Structural Grade:	0
O&M Grade:	0
Clock Start/From:	
Clock To:	
1st Value:	
2nd Value:	
Value Percent:	
Step:	NO
Remarks:	underside of frame

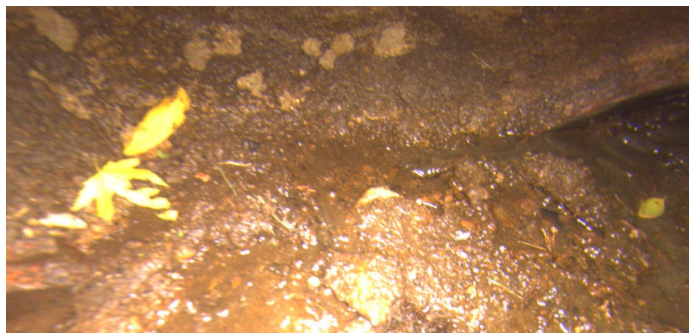
Code:	DSF
Description:	Deposits Settled Fine
Distance (ft):	10.3
Structural Grade:	0
O&M Grade:	2
Clock Start/From:	12
Clock To:	12
1st Value:	
2nd Value:	
Value Percent:	10.000
Step:	NO
Remarks:

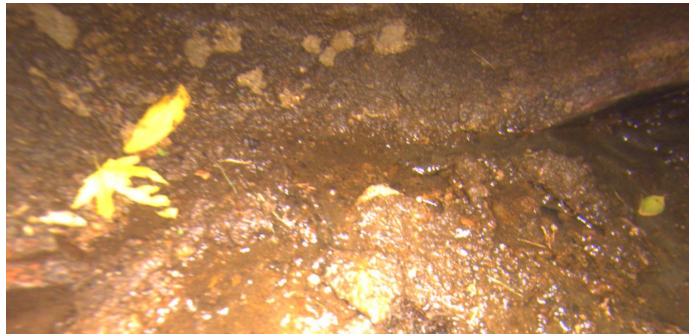
Code:	DAE
Description:	Deposits Attached Encrustation
Distance (ft):	10.3
Structural Grade:	0
O&M Grade:	2
Clock Start/From:	12
Clock To:	12
1st Value:	
2nd Value:	
Value Percent:	10.000
Step:	NO
Remarks:

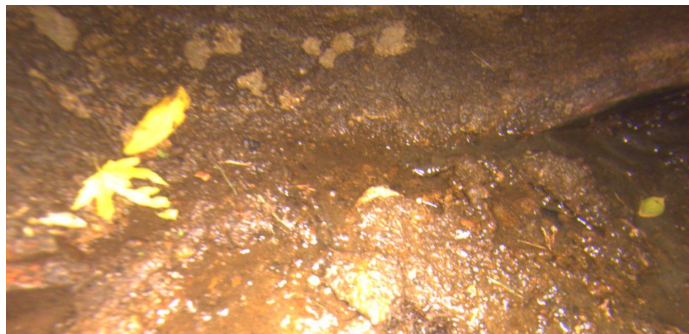
Code:	MGO
Description:	General Observation
Distance (ft):	10.3
Structural Grade:	0
O&M Grade:	0
Clock Start/From:	
Clock To:	
1st Value:	
2nd Value:	
Value Percent:	
Step:	NO
Remarks:	end of survey
