Manhole Inspection Report

Date:	05/14/2018	Weather:		Coding:	RZMACP
MH#:	M-504-018	Owner:	NA	Len. Surveyed:	11.3
P.O.#:		Surveyor:	Jen Costello	Rim to Invert:	11.0
Customer:		Cert. #:	U-907-5518	Wall Material:	Concrete (reinforced)

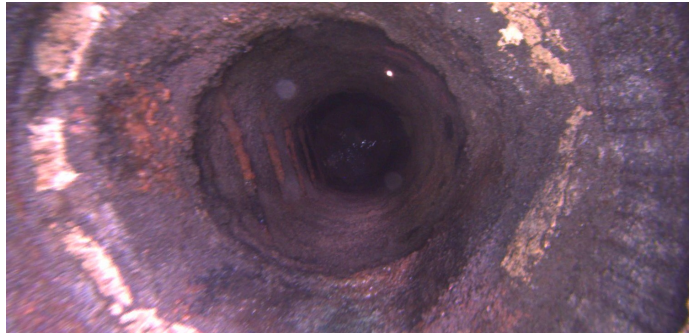
Code:	DAE
Description:	Deposits Attached Encrustation
Distance (ft):	.0
Structural Grade:	0
O&M Grade:	2
Clock Start/From:	12
Clock To:	12
1st Value:	
2nd Value:	
Value Percent:	5.000
Step:	NO
Remarks:

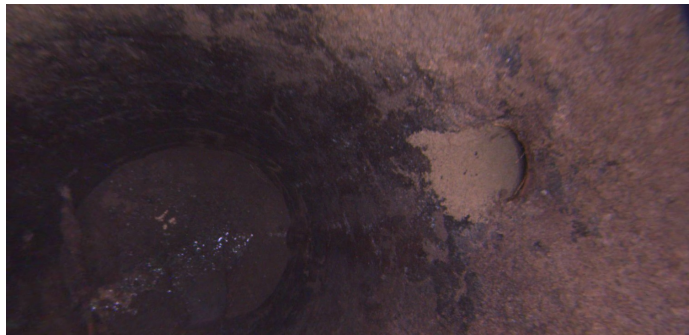
Code:	RFL
Description:	Roots Fine Lateral
Distance (ft):	6.4
Structural Grade:	0
O&M Grade:	1
Clock Start/From:	3
Clock To:	
1st Value:	
2nd Value:	
Value Percent:	
Step:	NO
Remarks:

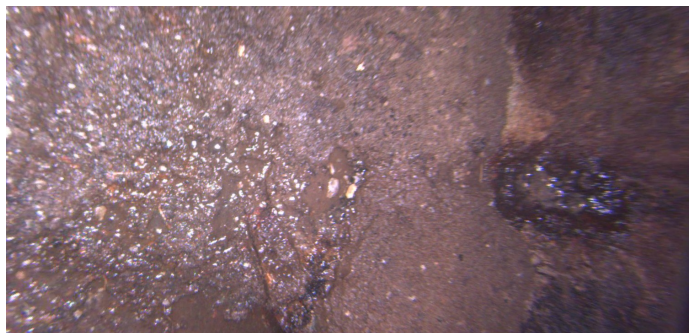
Code:	IW
Description:	Infil Weeper
Distance (ft):	11.0
Structural Grade:	0
O&M Grade:	2
Clock Start/From:	3
Clock To:	
1st Value:	
2nd Value:	
Value Percent:	
Step:	NO
Remarks:

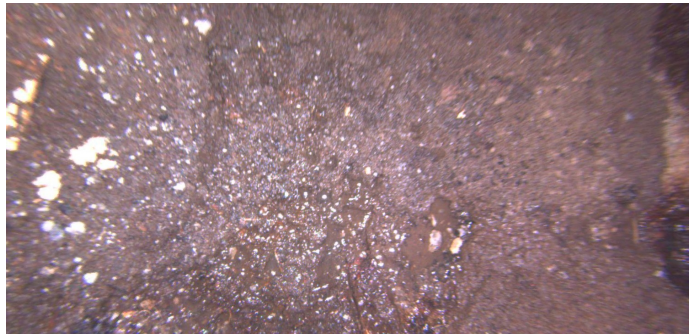
Code: **DSF**
Description: **Deposits Settled Fine**

Distance (ft): **11.0**
Structural Grade: **0**
O&M Grade: **2**
Clock Start/From: **12**
Clock To: **12**
1st Value:
2nd Value:
Value Percent: **10.000**
Step: **NO**
Remarks:

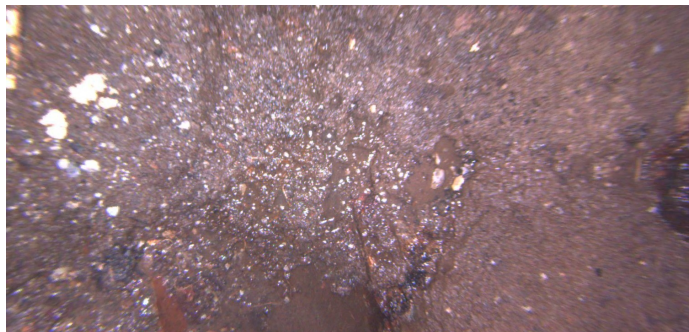
Code: **MGO**
Description: **General Observation**

Distance (ft): **11.0**
Structural Grade: **0**
O&M Grade: **0**
Clock Start/From:
Clock To:
1st Value:
2nd Value:
Value Percent:
Step: **NO**
Remarks: **END SURVEY**

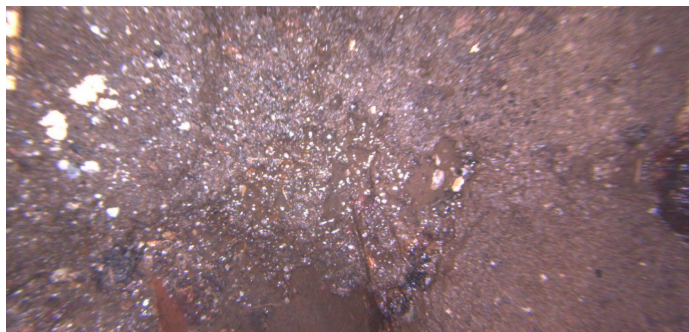
Code: **DAE**
Description: **Deposits Attached Encrustation**

Distance (ft): **11.0**
Structural Grade: **0**
O&M Grade: **2**
Clock Start/From: **12**
Clock To: **12**
1st Value:
2nd Value:
Value Percent: **5.000**
Step: **NO**
Remarks:
