Manhole Inspection Report

Date:	05/13/2018	Weather:		Coding:	RZMACP
MH#:	M-504-023	Owner:	NA	Len. Surveyed:	12.3
P.O.#:		Surveyor:	Jen Costello	Rim to Invert:	12.9
Customer:		Cert. #:	U-907-5518	Wall Material:	Concrete (reinforced)

Street:	Cleveland Ave. 167' East of Colorado	Project:	Hobart, IN
City:	Hobart, IN	GPS Northing:	41.5363884
Location:		GPS Easting:	-87.27363586
Drain Area:	West	GPS Accuracy:	Nearest Meter
Cover Shape:	Circular	Evidence of Surcharge:	No
Cover Size:	22.5	Potential for Runoff:	None
Comments:

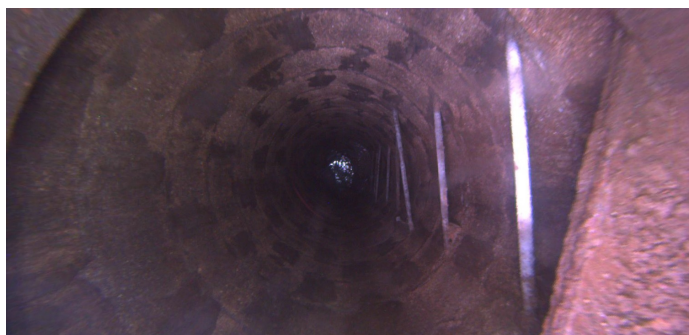
Code: **MGO**
Description: **General Observation**

Distance (ft): **.0**
Structural Grade: **0**
O&M Grade: **0**
Clock Start/From:
Clock To:
1st Value:
2nd Value:
Value Percent:
Step: **NO**
Remarks: **ACCESS MH**

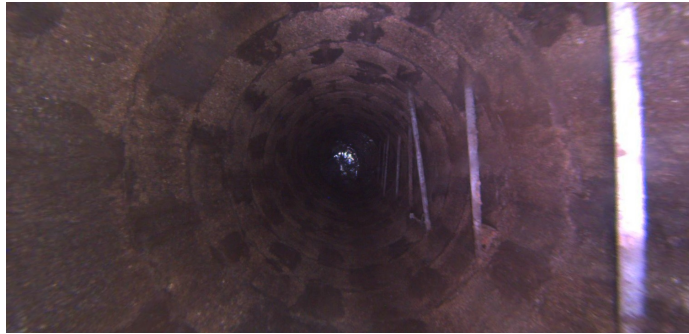
Code: **SAV**
Description: **Surface Aggregate Visible**

Distance (ft): **.6**
Structural Grade: **3**
O&M Grade: **0**
Clock Start/From: **12**
Clock To: **12**
1st Value:
2nd Value:
Value Percent:
Step: **NO**
Remarks:

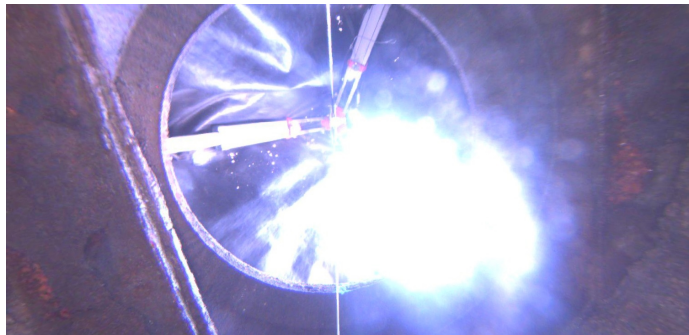
Code: **MGO**
Description: **General Observation**

Distance (ft): **2.0**
Structural Grade: **0**
O&M Grade: **0**
Clock Start/From:
Clock To:
1st Value:
2nd Value:
Value Percent:
Step: **NO**
Remarks: **UNDERSIDE OF FRAME**

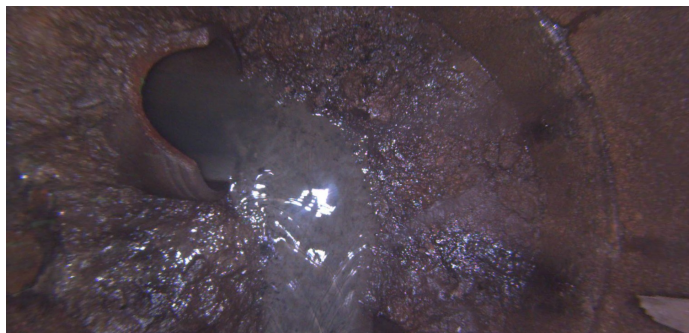
Code: **DSF**
Description: **Deposits Settled Fine**

Distance (ft): **11.4**
Structural Grade: **0**
O&M Grade: **2**
Clock Start/From: **12**
Clock To: **12**
1st Value:
2nd Value:
Value Percent: **10.000**
Step: **NO**
Remarks:

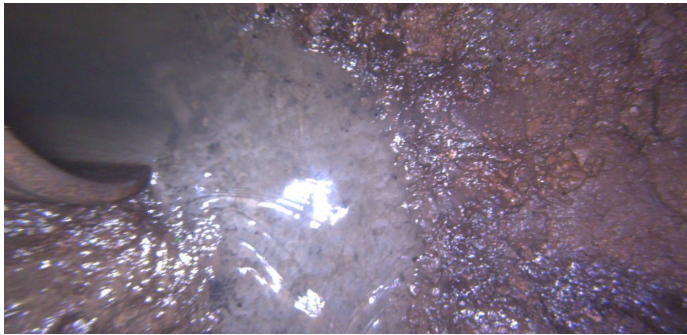
Code:	SAV
Description:	Surface Aggregate Visible
Distance (ft):	12.3
Structural Grade:	3
O&M Grade:	0
Clock Start/From:	12
Clock To:	12
1st Value:	
2nd Value:	
Value Percent:	
Step:	NO
Remarks:

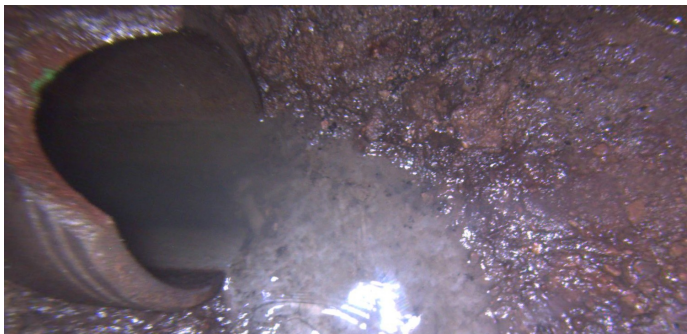
Code:	MGO
Description:	General Observation
Distance (ft):	12.3
Structural Grade:	0
O&M Grade:	0
Clock Start/From:	
Clock To:	
1st Value:	
2nd Value:	
Value Percent:	
Step:	NO
Remarks:	END SURVEY
