Manhole Inspection Report

Date:	05/13/2018	Weather:		Coding:	RZMACP
MH#:	M-504-024	Owner:	NA	Len. Surveyed:	14.8
P.O.#:		Surveyor:	Jen Costello	Rim to Invert:	15.7
Customer:		Cert. #:	U-907-5518	Wall Material:	Concrete (reinforced)

Street:	Intersection of Colorado St. and 45t	Project:	Hobart, IN
City:	Hobart, IN	GPS Northing:	41.53660965
Location:		GPS Easting:	-87.27415466
Drain Area:	West	GPS Accuracy:	Nearest Meter
Cover Shape:	Circular	Evidence of Surcharge:	No
Cover Size:	22.5	Potential for Runoff:	None
Comments:

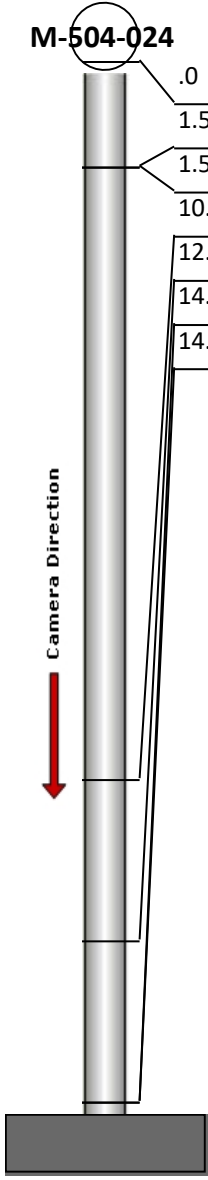
.0	MGO	General Observation	10	NA
	1.5	MGO	General Observation	26	NA
	1.5	SAV	Surface Aggregate Visible	39	S 3
	10.2	RFB	Roots Fine Barrel	68	M 2
	12.5	RFB	Roots Fine Barrel	84	M 2
	14.8	MGO	General Observation	100	NA
	14.8	SAV	Surface Aggregate Visible	111	S 3

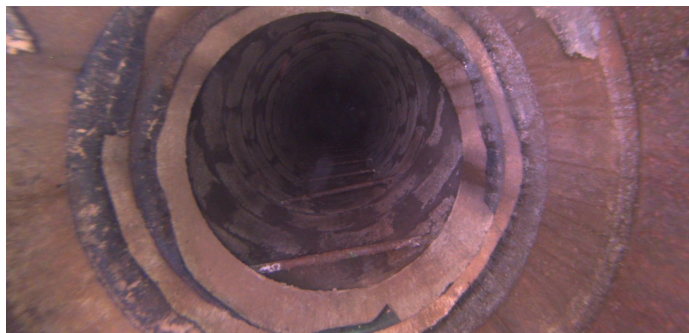
Code: **MGO**
Description: **General Observation**

Distance (ft): **.0**
Structural Grade: **0**
O&M Grade: **0**
Clock Start/From:
Clock To:
1st Value:
2nd Value:
Value Percent:
Step: **NO**
Remarks: **ACCESS MH**

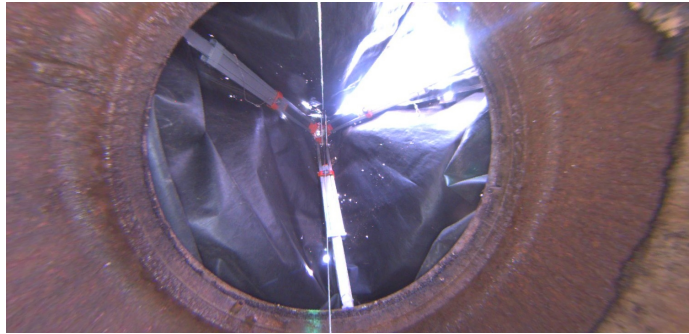
Code:	MGO
Description:	General Observation
Distance (ft):	1.5
Structural Grade:	0
O&M Grade:	0
Clock Start/From:	
Clock To:	
1st Value:	
2nd Value:	
Value Percent:	
Step:	NO
Remarks:	UNDERSIDE OF FRAME

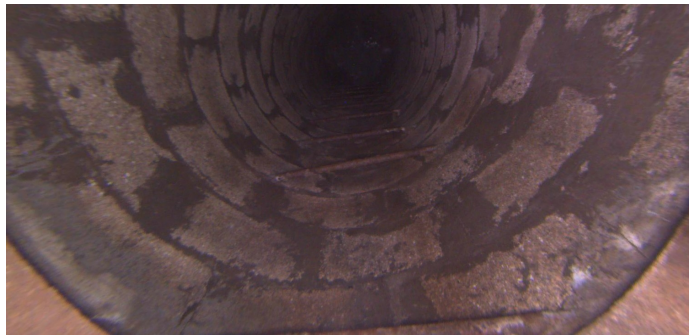
Code:	SAV
Description:	Surface Aggregate Visible
Distance (ft):	1.5
Structural Grade:	3
O&M Grade:	0
Clock Start/From:	12
Clock To:	12
1st Value:	
2nd Value:	
Value Percent:	
Step:	NO
Remarks:

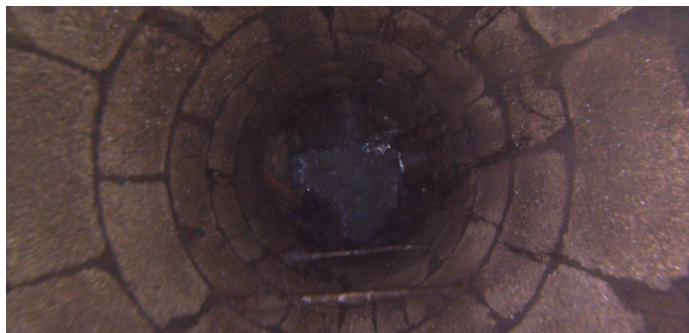
Code:	RFB
Description:	Roots Fine Barrel
Distance (ft):	10.2
Structural Grade:	0
O&M Grade:	2
Clock Start/From:	12
Clock To:	12
1st Value:	
2nd Value:	
Value Percent:	
Step:	NO
Remarks:

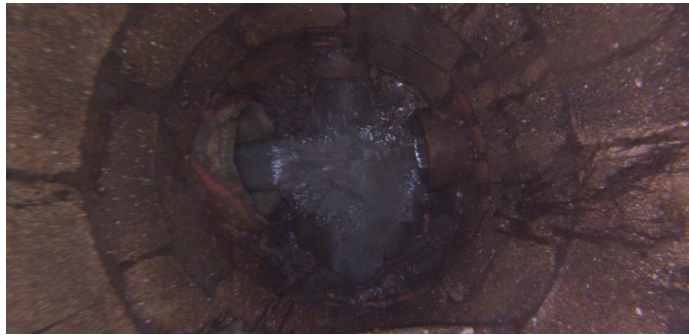
Code: **RFB**
Description: **Roots Fine Barrel**

Distance (ft): **12.5**
Structural Grade: **0**
O&M Grade: **2**
Clock Start/From: **12**
Clock To: **12**
1st Value:
2nd Value:
Value Percent:
Step: **NO**
Remarks:

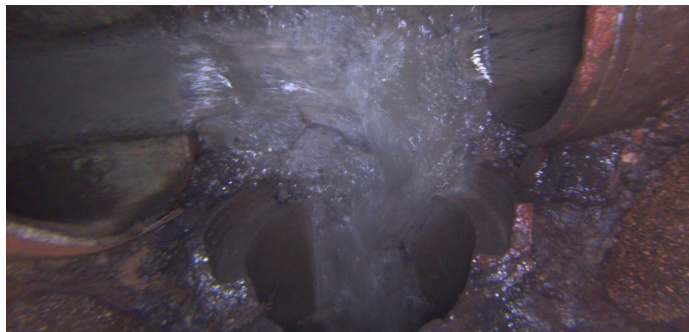
Code: **MGO**
Description: **General Observation**

Distance (ft): **14.8**
Structural Grade: **0**
O&M Grade: **0**
Clock Start/From:
Clock To:
1st Value:
2nd Value:
Value Percent:
Step: **NO**
Remarks: **END SURVEY**

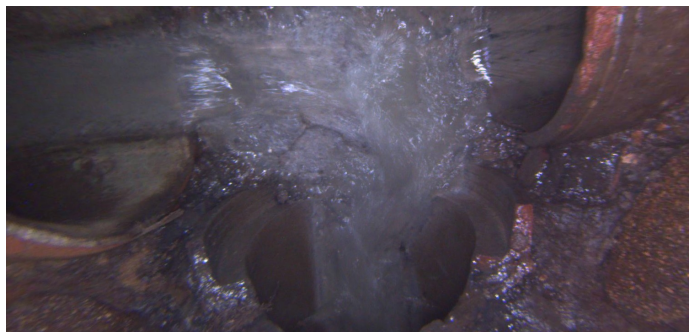
Code: **SAV**
Description: **Surface Aggregate Visible**

Distance (ft): **14.8**
Structural Grade: **3**
O&M Grade: **0**
Clock Start/From: **12**
Clock To: **12**
1st Value:
2nd Value:
Value Percent:
Step: **NO**
Remarks:
