# Manhole Inspection Report

Date:	05/13/2018	Weather:		Coding:	RZMACP
MH#:	M-504-026	Owner:	NA	Len. Surveyed:	14.0
P.O.#:		Surveyor:	Jen Costello	Rim to Invert:	13.5
Customer:		Cert. #:	U-907-5518	Wall Material:	Brick

Street:	Intersection of 45th Ave. and Caven	Project:	Hobart, IN
City:	Hobart, IN	GPS Northing:	41.53641129
Location:		GPS Easting:	-87.27588654
Drain Area:	West	GPS Accuracy:	Nearest Meter
Cover Shape:	Circular	Evidence of Surcharge:	No
Cover Size:	22.5	Potential for Runoff:	None
Comments:

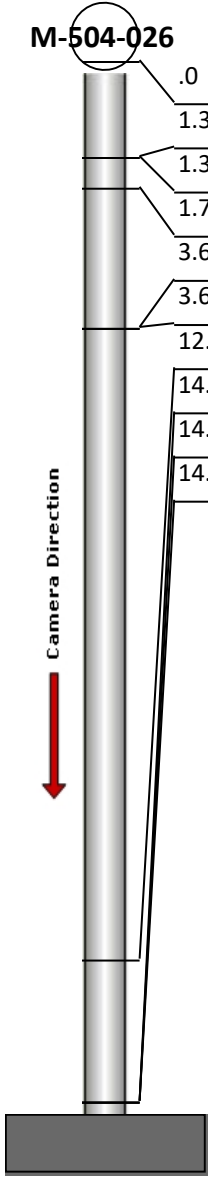
.0	MGO	General Observation	10	NA
	1.3	SAV	Surface Aggregate Visible	24	S 3
	1.3	IW	Infil Weeper	35	M 2
	1.7	SAV	Surface Aggregate Visible	46	S 3
	3.6	HSV	Hole Soil Visible	61	S 5
	3.6	IW	Infil Weeper	72	M 2
	12.1	DSF	Deposits Settled Fine	100	M 2
	14.0	SAV	Surface Aggregate Visible	115	S 3
	14.0	MGO	General Observation	126	NA
	14.0	MGO	General Observation	137	NA

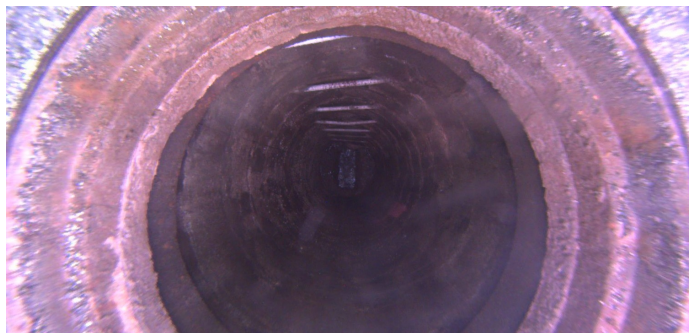
Code: **MGO**  
Description: **General Observation**

Distance (ft): **.0**  
Structural Grade: **0**  
O&M Grade: **0**  
Clock Start/From:  
Clock To:  
1st Value:  
2nd Value:  
Value Percent:  
Step: **NO**  
Remarks: **ACCESS MH**

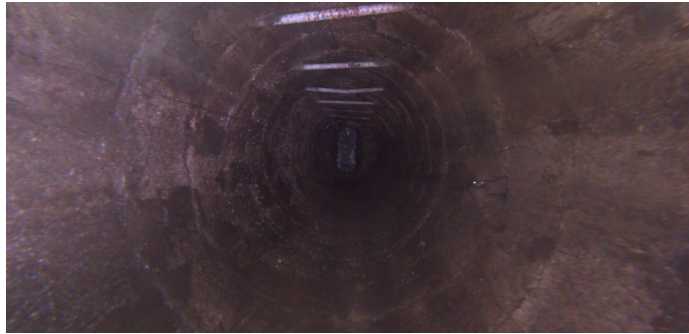
Code: **SAV**  
Description: **Surface Aggregate Visible**

Distance (ft): **1.3**  
Structural Grade: **3**  
O&M Grade: **0**  
Clock Start/From: **12**  
Clock To: **12**  
1st Value:  
2nd Value:  
Value Percent:  
Step: **NO**  
Remarks:

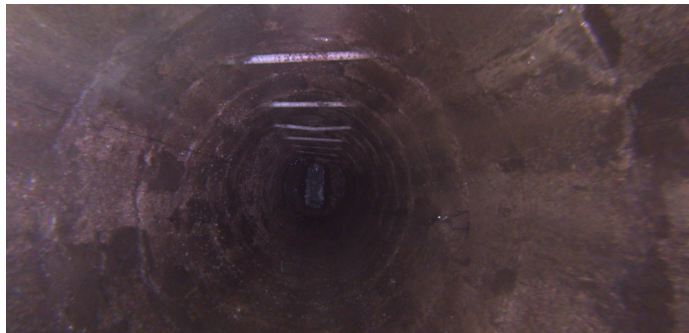
Code: **IW**  
Description: **Infil Weeper**

Distance (ft): **1.3**  
Structural Grade: **0**  
O&M Grade: **2**  
Clock Start/From: **2**  
Clock To:  
1st Value:  
2nd Value:  
Value Percent:  
Step: **NO**  
Remarks:

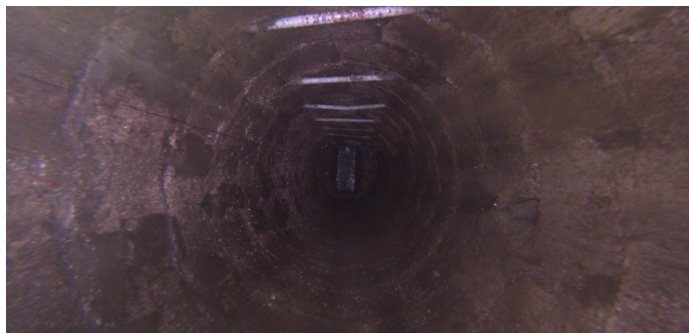
Code: **SAV**  
Description: **Surface Aggregate Visible**

Distance (ft): **1.7**  
Structural Grade: **3**  
O&M Grade: **0**  
Clock Start/From: **12**  
Clock To: **12**  
1st Value:  
2nd Value:  
Value Percent:  
Step: **NO**  
Remarks:

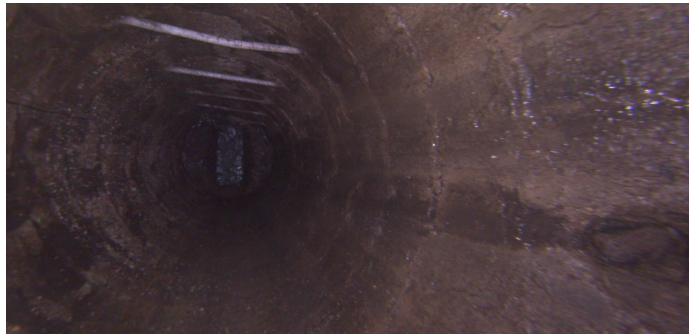
Code: **HSV**  
Description: **Hole Soil Visible**

Distance (ft): **3.6**  
Structural Grade: **5**  
O&M Grade: **0**  
Clock Start/From: **3**  
Clock To:  
1st Value:  
2nd Value:  
Value Percent:  
Step: **NO**  
Remarks:

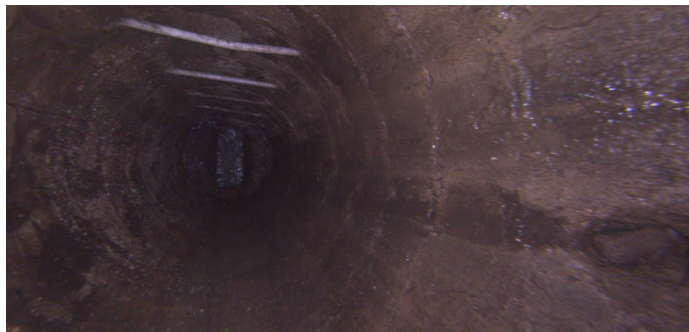
Code: **IW**  
Description: **Infil Weeper**

Distance (ft): **3.6**  
Structural Grade: **0**  
O&M Grade: **2**  
Clock Start/From: **3**  
Clock To:  
1st Value:  
2nd Value:  
Value Percent:  
Step: **NO**  
Remarks:

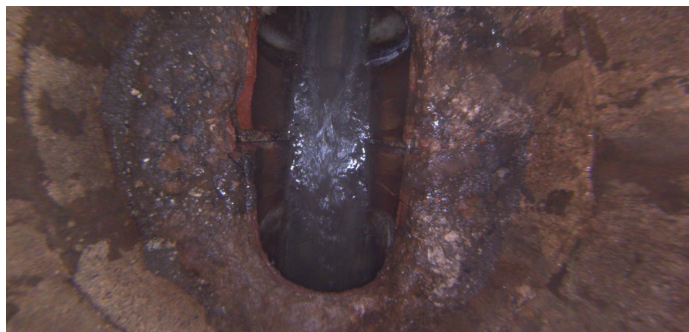
Code: **DSF**  
Description: **Deposits Settled Fine**

Distance (ft): **12.1**  
Structural Grade: **0**  
O&M Grade: **2**  
Clock Start/From: **12**  
Clock To: **12**  
1st Value:  
2nd Value:  
Value Percent: **5.000**  
Step: **NO**  
Remarks:

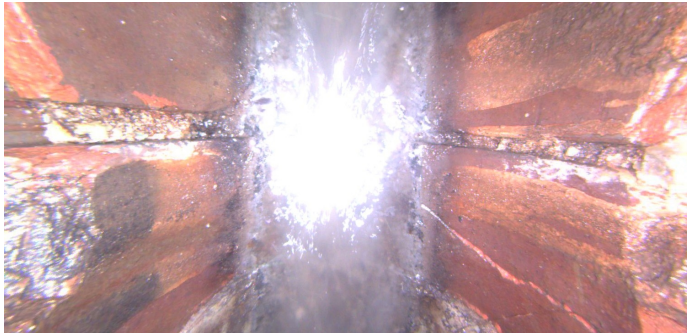
Code: **SAV**  
Description: **Surface Aggregate Visible**

Distance (ft): **14.0**  
Structural Grade: **3**  
O&M Grade: **0**  
Clock Start/From: **12**  
Clock To: **12**  
1st Value:  
2nd Value:  
Value Percent:  
Step: **NO**  
Remarks:

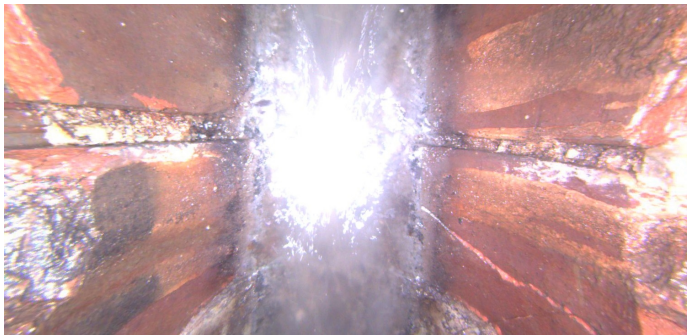
Code: **MGO**  
Description: **General Observation**

Distance (ft): **14.0**  
Structural Grade: **0**  
O&M Grade: **0**  
Clock Start/From:  
Clock To:  
1st Value:  
2nd Value:  
Value Percent:  
Step: **NO**  
Remarks: **END SURVEY**

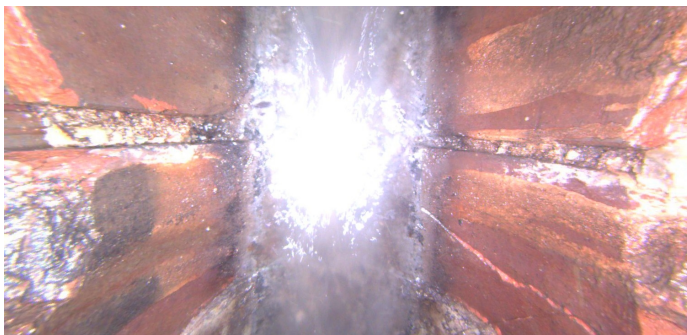
Code: **MGO**  
Description: **General Observation**

Distance (ft): **14.0**  
Structural Grade: **0**  
O&M Grade: **0**  
Clock Start/From:  
Clock To:  
1st Value:  
2nd Value:  
Value Percent:  
Step: **NO**  
Remarks: **END SURVEY**
