Manhole Inspection Report

Date:	05/13/2018	Weather:		Coding:	RZMACP
MH#:	M-504-030	Owner:	NA	Len. Surveyed:	12.8
P.O.#:		Surveyor:	Jen Costello	Rim to Invert:	13.5
Customer:		Cert. #:	U-907-5518	Wall Material:	Brick

Street:	178' North of Cleveland Ave. East of	Project:	Hobart, IN
City:	Hobart, IN	GPS Northing:	41.53692627
Location:		GPS Easting:	-87.27362823
Drain Area:	West	GPS Accuracy:	Nearest Meter
Cover Shape:	Circular	Evidence of Surcharge:	No
Cover Size:	22.5	Potential for Runoff:	None
Comments:

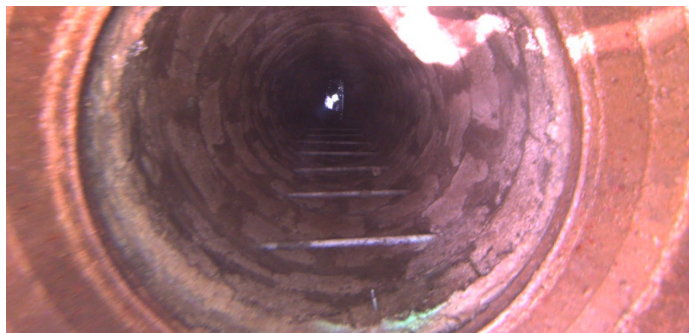
Code: **MGP**
Description: **General Photo**

Distance (ft): **.0**
Structural Grade: **0**
O&M Grade: **0**
Clock Start/From:
Clock To:
1st Value:
2nd Value:
Value Percent:
Step: **NO**
Remarks: **ACCESS MH**

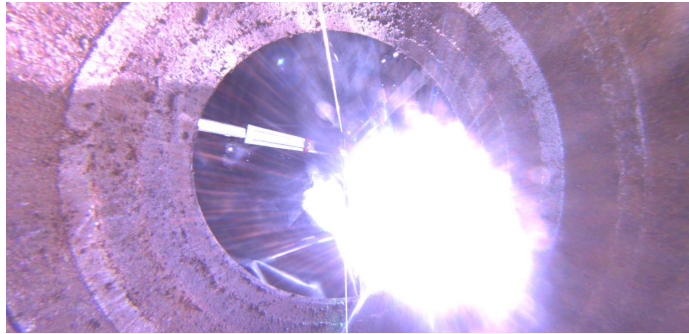
Code: **MGO**
Description: **General Observation**

Distance (ft): **1.6**
Structural Grade: **0**
O&M Grade: **0**
Clock Start/From:
Clock To:
1st Value:
2nd Value:
Value Percent:
Step: **NO**
Remarks: **UNDERSIDE OF FRAME**

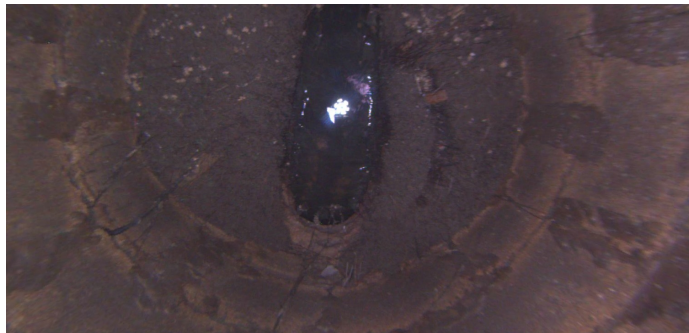
Code: **RFB**
Description: **Roots Fine Barrel**

Distance (ft): **10.5**
Structural Grade: **0**
O&M Grade: **2**
Clock Start/From: **3**
Clock To: **9**
1st Value:
2nd Value:
Value Percent:
Step: **NO**
Remarks:

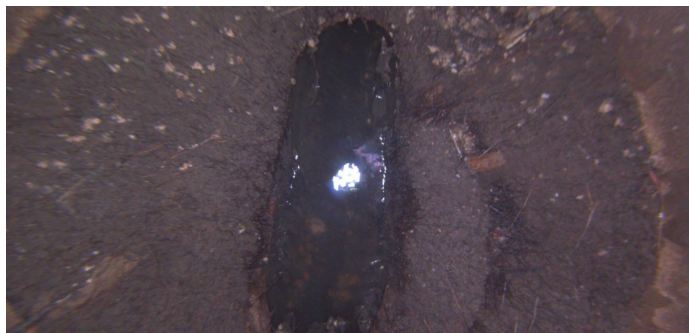
Code: **DSF**
Description: **Deposits Settled Fine**

Distance (ft): **11.5**
Structural Grade: **0**
O&M Grade: **2**
Clock Start/From: **12**
Clock To: **12**
1st Value:
2nd Value:
Value Percent: **10.000**
Step: **NO**
Remarks:

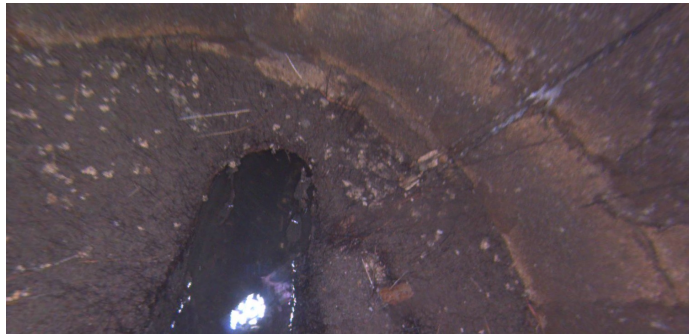
Code: **RFB**
Description: **Roots Fine Barrel**

Distance (ft): **11.5**
Structural Grade: **0**
O&M Grade: **2**
Clock Start/From: **1**
Clock To: **2**
1st Value:
2nd Value:
Value Percent:
Step: **NO**
Remarks:

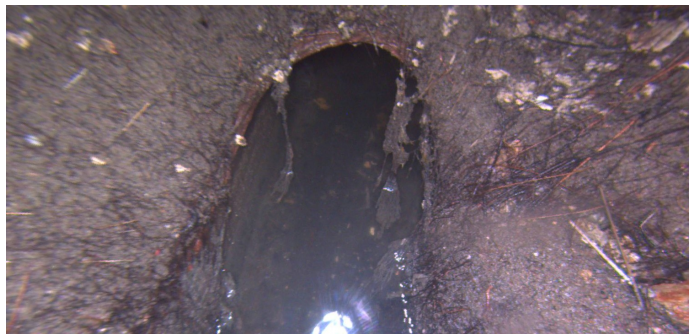
Code: **MGO**
Description: **General Observation**

Distance (ft): **12.8**
Structural Grade: **0**
O&M Grade: **0**
Clock Start/From:
Clock To:
1st Value:
2nd Value:
Value Percent:
Step: **NO**
Remarks: **END SURVEY**
