# Manhole Inspection Report

Date:	05/13/2018	Weather:		Coding:	RZMACP
MH#:	M-504-032	Owner:	NA	Len. Surveyed:	11.9
P.O.#:		Surveyor:	Jen Costello	Rim to Invert:	13.2
Customer:		Cert. #:	U-907-5518	Wall Material:	Brick

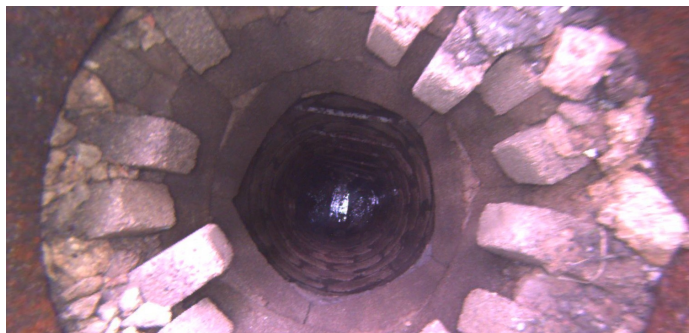
Code: **DB**  
Description: **Displaced Brick**

Distance (ft): **.0**  
Structural Grade: **3**  
O&M Grade: **0**  
Clock Start/From: **12**  
Clock To: **12**  
1st Value:  
2nd Value:  
Value Percent:  
Step: **NO**  
Remarks:

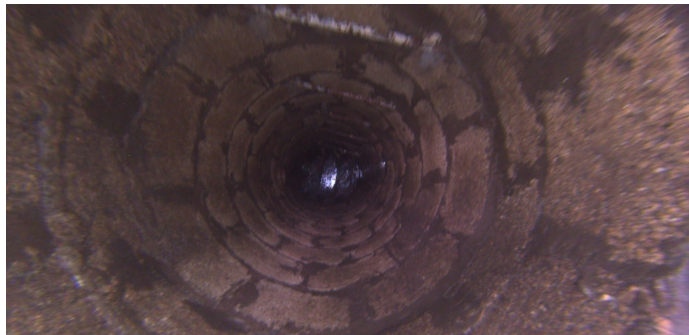
Code:	<b>SAV</b>
Description:	<b>Surface Aggregate Visible</b>
Distance (ft):	<b>2.5</b>
Structural Grade:	<b>3</b>
O&M Grade:	<b>0</b>
Clock Start/From:	<b>12</b>
Clock To:	<b>12</b>
1st Value:	
2nd Value:	
Value Percent:	
Step:	<b>NO</b>
Remarks:

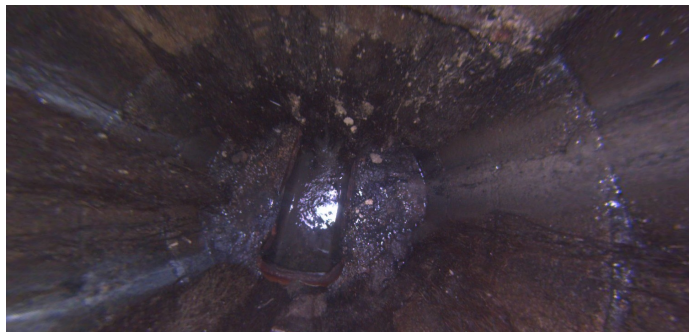
Code: **RFB**  
Description: **Roots Fine Barrel**

Distance (ft): **10.3**  
Structural Grade: **0**  
O&M Grade: **2**  
Clock Start/From: **12**  
Clock To: **12**  
1st Value:  
2nd Value:  
Value Percent:  
Step: **NO**  
Remarks:

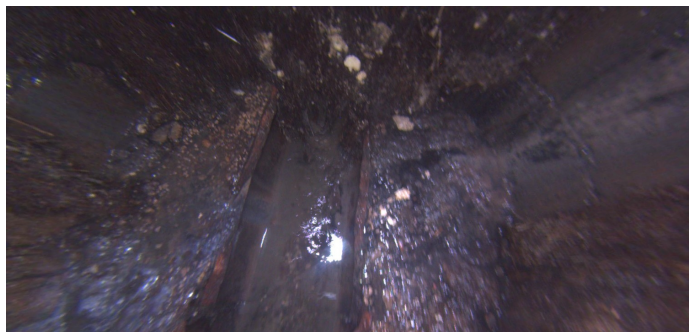
Code: **RMB**  
Description: **Roots Medium Barrel**

Distance (ft): **11.6**  
Structural Grade: **0**  
O&M Grade: **4**  
Clock Start/From: **12**  
Clock To: **12**  
1st Value:  
2nd Value:  
Value Percent: **10.000**  
Step: **NO**  
Remarks:

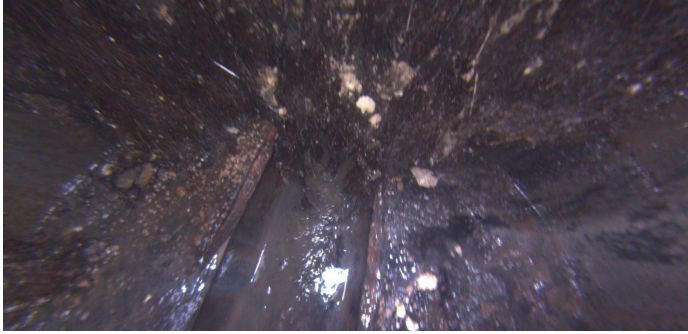
Code: **SAP**  
Description: **Surface Aggregate Projecting**

Distance (ft): **11.9**  
Structural Grade: **3**  
O&M Grade: **0**  
Clock Start/From: **12**  
Clock To: **12**  
1st Value:  
2nd Value:  
Value Percent:  
Step: **NO**  
Remarks:

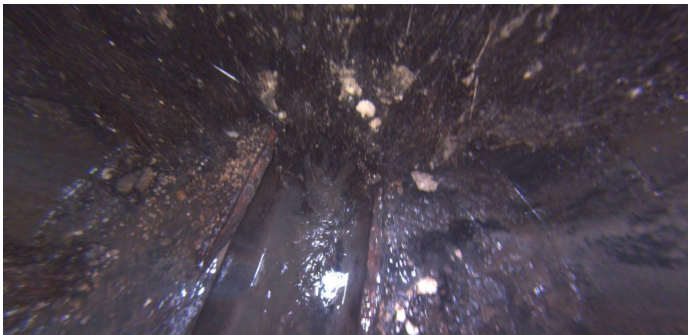
Code: **SAV**  
Description: **Surface Aggregate Visible**

Distance (ft): **11.9**  
Structural Grade: **3**  
O&M Grade: **0**  
Clock Start/From: **12**  
Clock To: **12**  
1st Value:  
2nd Value:  
Value Percent:  
Step: **NO**  
Remarks:
