# Manhole Inspection Report

Date:	<b>05/13/2018</b>	Weather:		Coding:	<b>RZMACP</b>
MH#:	<b>M-504-034</b>	Owner:	<b>NA</b>	Len. Surveyed:	<b>10.7</b>
P.O.#:		Surveyor:	<b>Jen Costello</b>	Rim to Invert:	<b>10.5</b>
Customer:		Cert. #:	<b>U-907-5518</b>	Wall Material:	<b>Brick</b>

Street:	<b>Intersection of Colorado St. and Ho</b>	Project:	<b>Hobart, IN</b>
City:	<b>Hobart, IN</b>	GPS Northing:	<b>41.5382576</b>
Location:		GPS Easting:	<b>-87.27420807</b>
Drain Area:	<b>West</b>	GPS Accuracy:	<b>Nearest Meter</b>
Cover Shape:	<b>Circular</b>	Evidence of Surcharge:	<b>No</b>
Cover Size:	<b>22.5</b>	Potential for Runoff:	<b>None</b>
Comments:

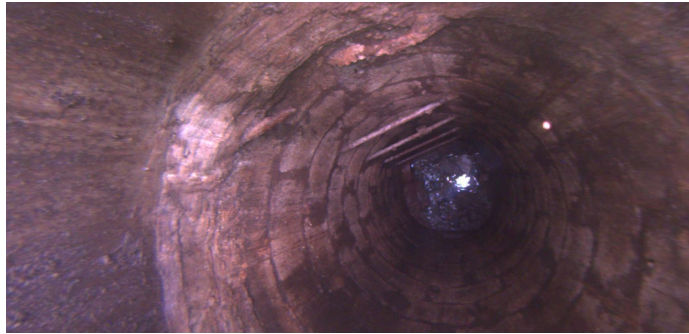
Code: **MGO**  
Description: **General Observation**

Distance (ft): **1.4**  
Structural Grade: **0**  
O&M Grade: **0**  
Clock Start/From:  
Clock To:  
1st Value:  
2nd Value:  
Value Percent:  
Step: **YES**  
Remarks: **BROKEN STEP**

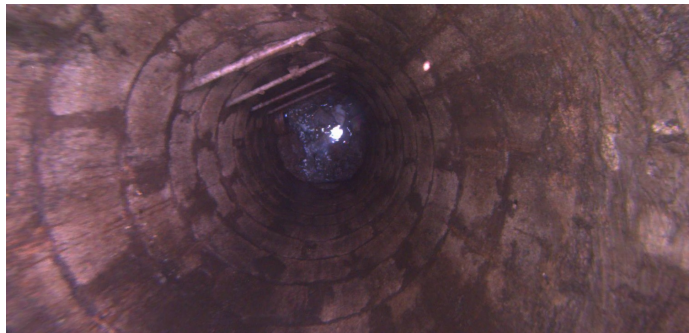
Code: **SAV**  
Description: **Surface Aggregate Visible**

Distance (ft): **2.0**  
Structural Grade: **3**  
O&M Grade: **0**  
Clock Start/From: **12**  
Clock To: **12**  
1st Value:  
2nd Value:  
Value Percent:  
Step: **NO**  
Remarks:

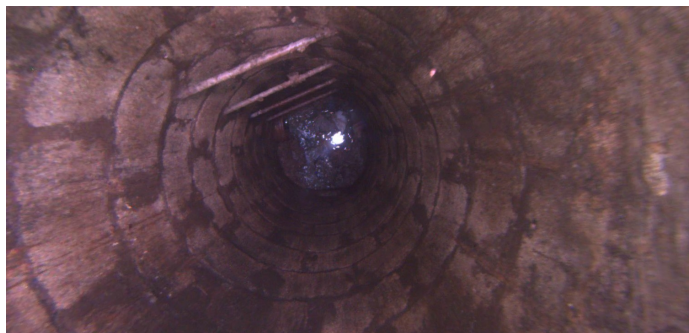
Code: **IW**  
Description: **Infil Weeper**

Distance (ft): **2.1**  
Structural Grade: **0**  
O&M Grade: **2**  
Clock Start/From: **5**  
Clock To: **7**  
1st Value:  
2nd Value:  
Value Percent:  
Step: **NO**  
Remarks:

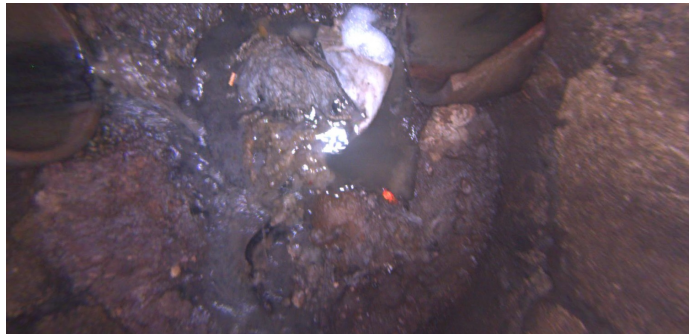
Code: **DSF**  
Description: **Deposits Settled Fine**

Distance (ft): **9.6**  
Structural Grade: **0**  
O&M Grade: **2**  
Clock Start/From: **12**  
Clock To: **12**  
1st Value:  
2nd Value:  
Value Percent: **10.000**  
Step: **NO**  
Remarks:

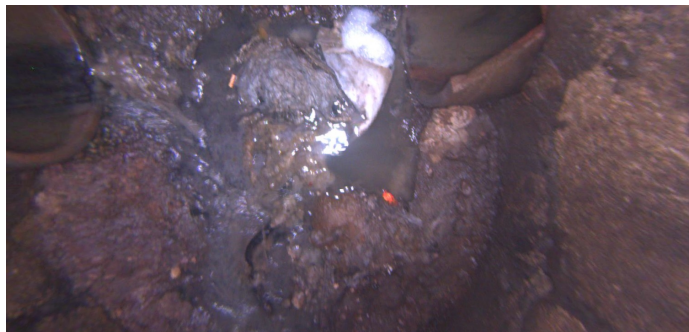
Code: **SAV**  
Description: **Surface Aggregate Visible**

Distance (ft): **9.6**  
Structural Grade: **3**  
O&M Grade: **0**  
Clock Start/From: **12**  
Clock To: **12**  
1st Value:  
2nd Value:  
Value Percent:  
Step: **NO**  
Remarks:
