Manhole Inspection Report

Date:	05/13/2018	Weather:		Coding:	RZMACP
MH#:	M-504-035	Owner:	NA	Len. Surveyed:	8.3
P.O.#:		Surveyor:	Jen Costello	Rim to Invert:	8.3
Customer:		Cert. #:	U-907-5518	Wall Material:	Brick

Street:	Colorado St. 165' South of Home Av	Project:	Hobart, IN
City:	Hobart, IN	GPS Northing:	41.53777695
Location:		GPS Easting:	-87.27422333
Drain Area:	West	GPS Accuracy:	Nearest Meter
Cover Shape:	Circular	Evidence of Surcharge:	No
Cover Size:	22.5	Potential for Runoff:	None
Comments:

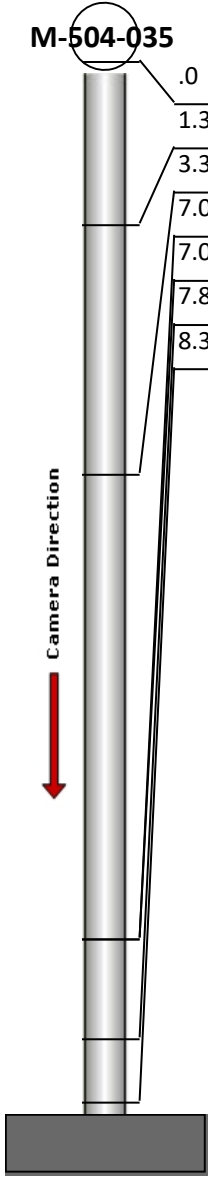
.0	MGO	General Observation	10	NA
	1.3	DAE	Deposits Attached Encrustation	24	M 2
	3.3	MGO	General Observation	42	NA
	7.0	DAE	Deposits Attached Encrustation	63	M 2
	7.0	OBR	Obstacle Rocks	74	M 2
	7.8	OBZ	Obstacle Other	87	M 2
	8.3	MGO	General Observation	100	NA

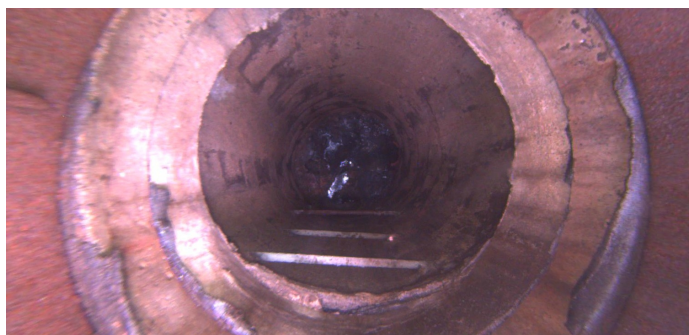
Code: **MGO**
Description: **General Observation**

Distance (ft): **.0**
Structural Grade: **0**
O&M Grade: **0**
Clock Start/From:
Clock To:
1st Value:
2nd Value:
Value Percent:
Step: **NO**
Remarks: **ACCESS MH**

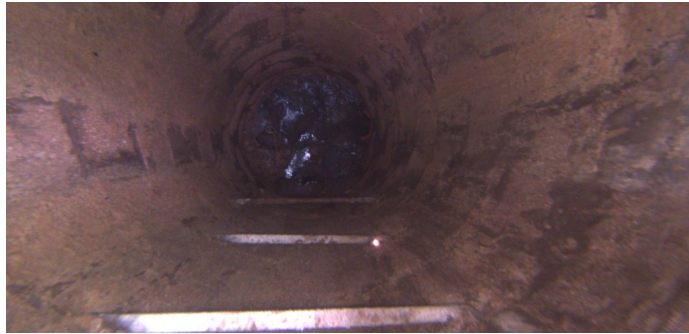
Code: **DAE**
Description: **Deposits Attached Encrustation**

Distance (ft): **1.3**
Structural Grade: **0**
O&M Grade: **2**
Clock Start/From: **12**
Clock To: **12**
1st Value:
2nd Value:
Value Percent: **5.000**
Step: **NO**
Remarks:

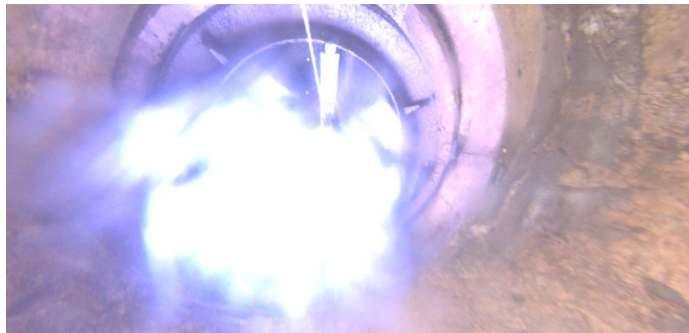
Code: **MGO**
Description: **General Observation**

Distance (ft): **3.3**
Structural Grade: **0**
O&M Grade: **0**
Clock Start/From:
Clock To:
1st Value:
2nd Value:
Value Percent:
Step: **NO**
Remarks: **UNDERSIDE OF FRAME**

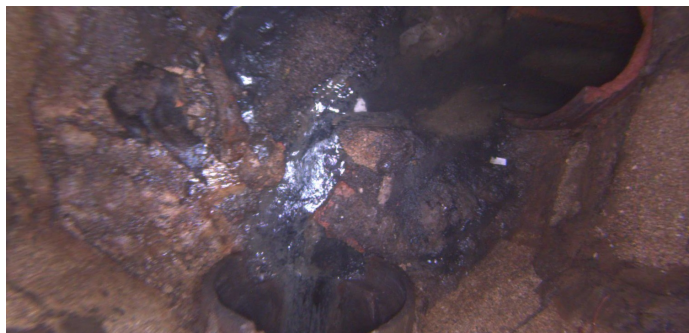
Code: **DAE**
Description: **Deposits Attached Encrustation**

Distance (ft): **7.0**
Structural Grade: **0**
O&M Grade: **2**
Clock Start/From: **12**
Clock To: **12**
1st Value:
2nd Value:
Value Percent: **5.000**
Step: **NO**
Remarks:

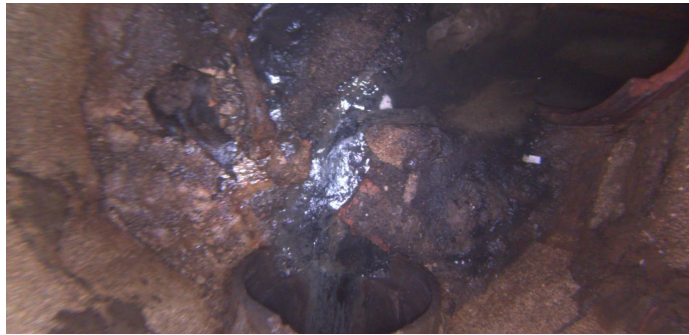
Code: **OBR**
Description: **Obstacle Rocks**

Distance (ft): **7.0**
Structural Grade: **0**
O&M Grade: **2**
Clock Start/From: **5**
Clock To:
1st Value:
2nd Value:
Value Percent: **5.000**
Step: **NO**
Remarks:

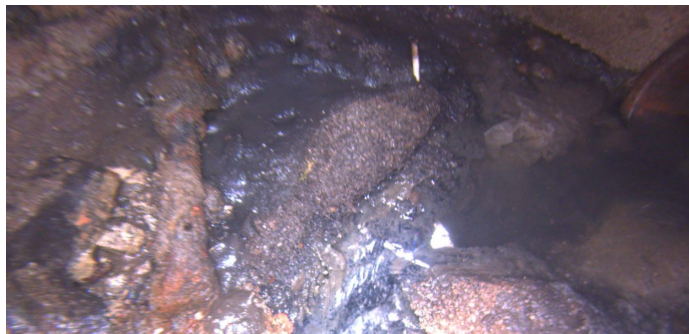
Code: **OBZ**
Description: **Obstacle Other**

Distance (ft): **7.8**
Structural Grade: **0**
O&M Grade: **2**
Clock Start/From: **12**
Clock To: **12**
1st Value:
2nd Value:
Value Percent: **10.000**
Step: **NO**
Remarks: **MISC**

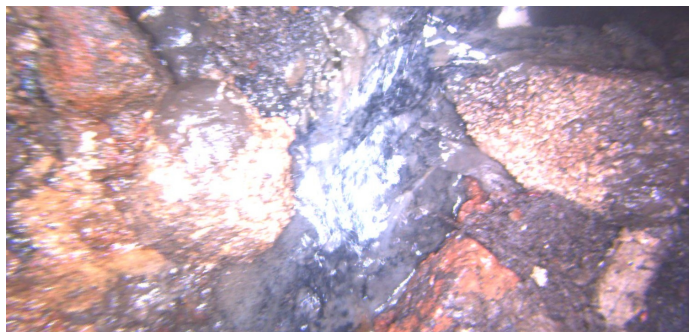
Code: **MGO**
Description: **General Observation**

Distance (ft): **8.3**
Structural Grade: **0**
O&M Grade: **0**
Clock Start/From:
Clock To:
1st Value:
2nd Value:
Value Percent:
Step: **NO**
Remarks: **END SURVEY**
