Manhole Inspection Report

Date:	10/14/2022	Weather:		Coding:	RZMACP
MH#:	M-504-036	Owner:	NA	Len. Surveyed:	7.6
P.O.#:		Surveyor:	Jen Costello	Rim to Invert:	8.6
Customer:		Cert. #:	U-907-5518	Wall Material:	Brick

Street:	North of 44th Pl. and 247' East of Ca	Project:	Hobart, IN
City:	Hobart, IN	GPS Northing:	2290996.164
Location:	Local Rural Streets	GPS Easting:	2900289.435
Drain Area:	West	GPS Accuracy:	Sub-Meter
Cover Shape:	Circular	Evidence of Surcharge:	No
Cover Size:	24.0	Potential for Runoff:	None
Comments:

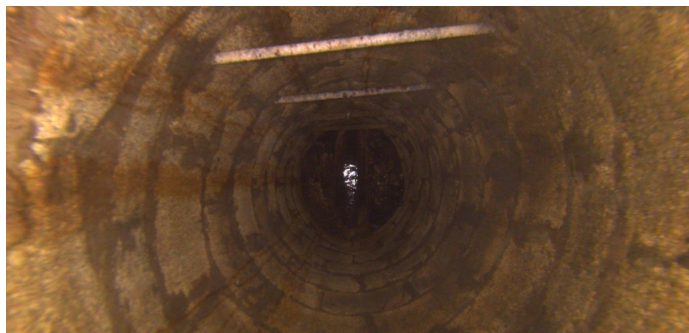
Code: **MGO**
 Description: **General Observation**

Distance (ft): **.0**
 Structural Grade: **0**
 O&M Grade: **0**
 Clock Start/From:
 Clock To:
 1st Value:
 2nd Value:
 Value Percent:
 Step: **NO**
 Remarks: **access mh**

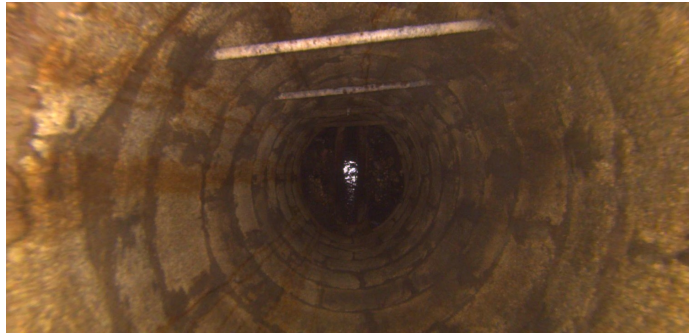
Code: **SAV**
Description: **Surface Aggregate Visible**

Distance (ft): **.0**
Structural Grade: **3**
O&M Grade: **0**
Clock Start/From: **12**
Clock To: **12**
1st Value:
2nd Value:
Value Percent:
Step: **NO**
Remarks:

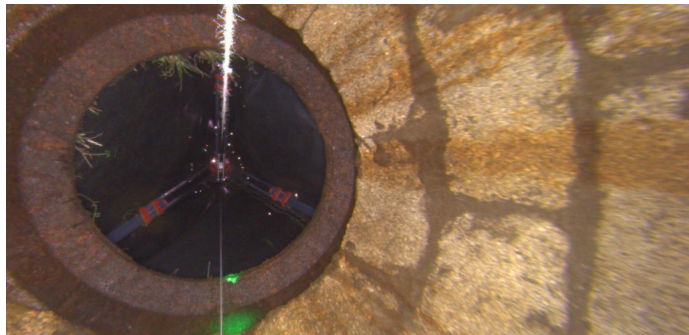
Code: **MGO**
Description: **General Observation**

Distance (ft): **2.6**
Structural Grade: **0**
O&M Grade: **0**
Clock Start/From:
Clock To:
1st Value:
2nd Value:
Value Percent:
Step: **NO**
Remarks: **underside of frame**

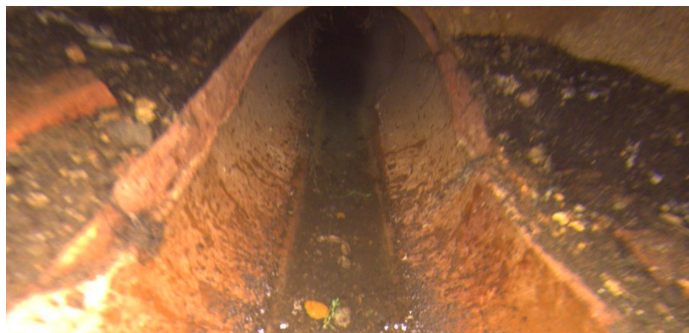
Code: **OBM**
Description: **Obstacle Pipe Material**

Distance (ft): **7.4**
Structural Grade: **0**
O&M Grade: **2**
Clock Start/From: **10**
Clock To:
1st Value:
2nd Value:
Value Percent: **5.000**
Step: **NO**
Remarks:

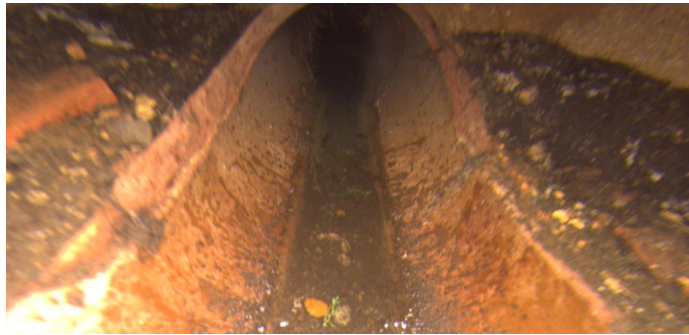
Code:	SAV
Description:	Surface Aggregate Visible
Distance (ft):	7.4
Structural Grade:	3
O&M Grade:	0
Clock Start/From:	12
Clock To:	12
1st Value:	
2nd Value:	
Value Percent:	
Step:	NO
Remarks:

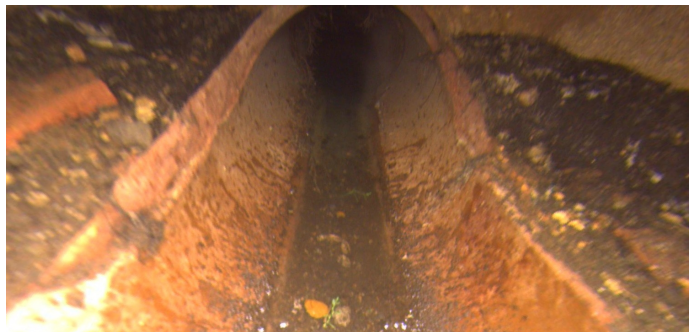
Code:	DSF
Description:	Deposits Settled Fine
Distance (ft):	7.4
Structural Grade:	0
O&M Grade:	2
Clock Start/From:	12
Clock To:	12
1st Value:	
2nd Value:	
Value Percent:	5.000
Step:	NO
Remarks:

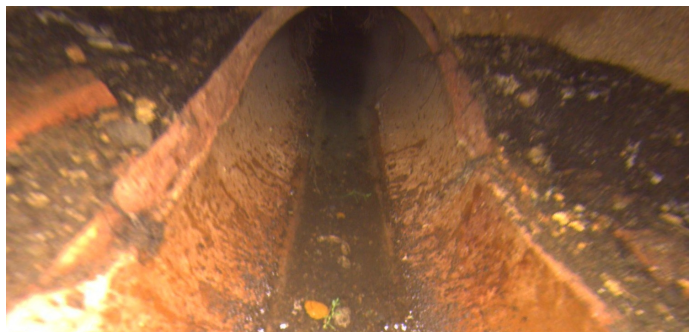
Code:	MGO
Description:	General Observation
Distance (ft):	7.4
Structural Grade:	0
O&M Grade:	0
Clock Start/From:	
Clock To:	
1st Value:	
2nd Value:	
Value Percent:	
Step:	NO
Remarks:	end of survey
