Manhole Inspection Report

Date:	05/13/2018	Weather:		Coding:	RZMACP
MH#:	M-504-037	Owner:	NA	Len. Surveyed:	6.7
P.O.#:		Surveyor:	Jen Costello	Rim to Invert:	7.8
Customer:		Cert. #:	U-907-5518	Wall Material:	Brick

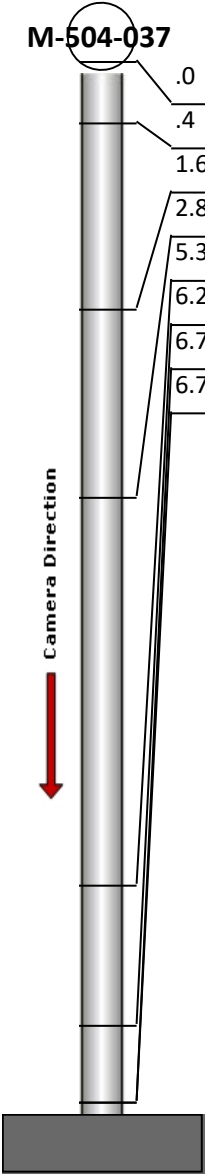
Position	Code	Observation	Video (sec)	Grade
M-504-037

.0	MGO	General Observation	10	NA
	.4	SAV	Surface Aggregate Visible	22	S 3
	1.6	MGO	General Observation	38	NA
	2.8	FM	Fracture Multiple	53	S 4
	5.3	DSF	Deposits Settled Fine	70	M 3
	6.2	RBB	Roots Ball Barrel	83	M 5
	6.7	SAV	Surface Aggregate Visible	96	S 3
	6.7	MGO	General Observation	107	NA

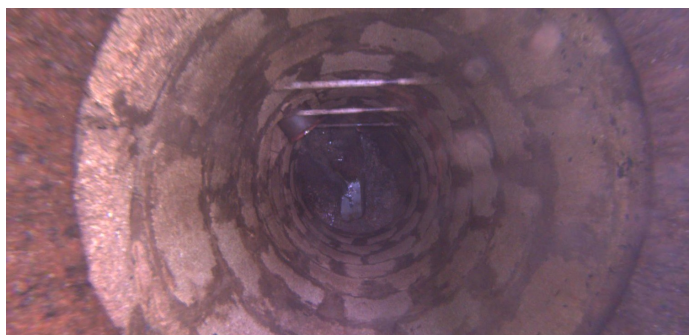
Code: **MGO**
Description: **General Observation**

Distance (ft): **.0**
Structural Grade: **0**
O&M Grade: **0**
Clock Start/From:
Clock To:
1st Value:
2nd Value:
Value Percent:
Step: **NO**
Remarks: **ACCESS MH**

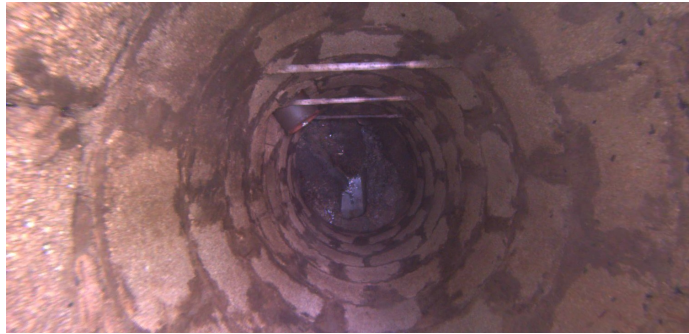
Code: **SAV**
Description: **Surface Aggregate Visible**

Distance (ft): **.4**
Structural Grade: **3**
O&M Grade: **0**
Clock Start/From: **12**
Clock To: **12**
1st Value:
2nd Value:
Value Percent:
Step: **NO**
Remarks:

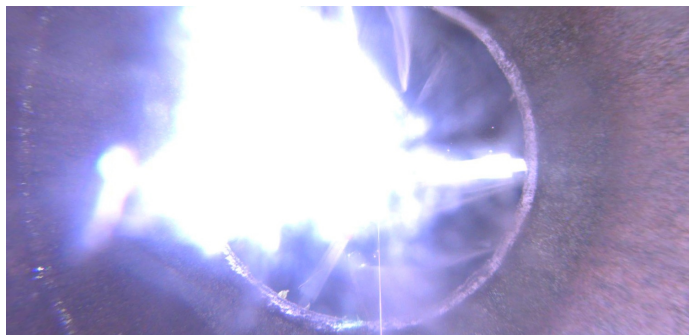
Code: **MGO**
Description: **General Observation**

Distance (ft): **1.6**
Structural Grade: **0**
O&M Grade: **0**
Clock Start/From:
Clock To:
1st Value:
2nd Value:
Value Percent:
Step: **NO**
Remarks: **UNDERSIDE OF FRAME**

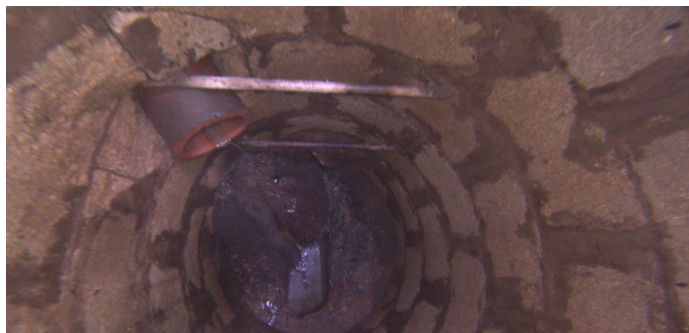
Code: **FM**
Description: **Fracture Multiple**

Distance (ft): **2.8**
Structural Grade: **4**
O&M Grade: **0**
Clock Start/From: **9**
Clock To: **11**
1st Value:
2nd Value:
Value Percent:
Step: **NO**
Remarks:

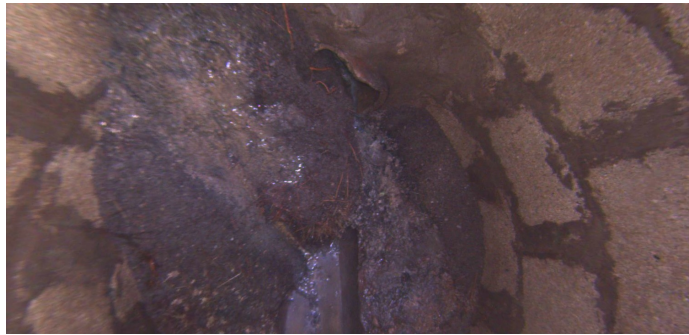
Code: **DSF**
Description: **Deposits Settled Fine**

Distance (ft): **5.3**
Structural Grade: **0**
O&M Grade: **3**
Clock Start/From: **9**
Clock To: **12**
1st Value:
2nd Value:
Value Percent: **15.000**
Step: **NO**
Remarks:

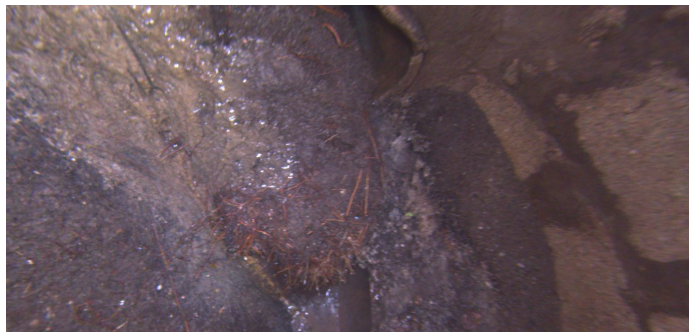
Code: **RBB**
Description: **Roots Ball Barrel**

Distance (ft): **6.2**
Structural Grade: **0**
O&M Grade: **5**
Clock Start/From: **3**
Clock To: **9**
1st Value:
2nd Value:
Value Percent: **80.000**
Step: **NO**
Remarks:

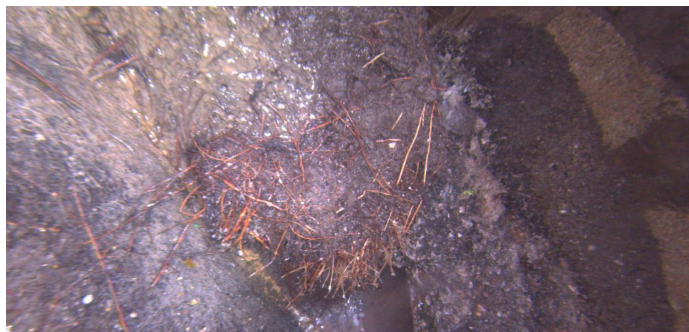
Code: **SAV**
Description: **Surface Aggregate Visible**

Distance (ft): **6.7**
Structural Grade: **3**
O&M Grade: **0**
Clock Start/From: **12**
Clock To: **12**
1st Value:
2nd Value:
Value Percent:
Step: **NO**
Remarks:

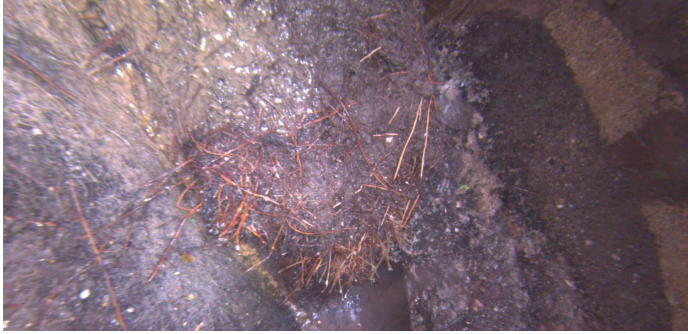
Code:	MGO
Description:	General Observation
Distance (ft):	6.7
Structural Grade:	0
O&M Grade:	0
Clock Start/From:	
Clock To:	
1st Value:	
2nd Value:	
Value Percent:	
Step:	NO
Remarks:	END SURVEY
