Manhole Inspection Report

Date:	05/14/2018	Weather:		Coding:	RZMACP
MH#:	M-504-043	Owner:	NA	Len. Surveyed:	9.5
P.O.#:		Surveyor:	Jen Costello	Rim to Invert:	8.7
Customer:		Cert. #:	U-907-5518	Wall Material:	Concrete (reinforced)

Street:	Cavender St. and Home Ave. to the	Project:	Hobart, IN
City:	Hobart, IN	GPS Northing:	41.53870773
Location:		GPS Easting:	-87.27571106
Drain Area:	West	GPS Accuracy:	Nearest Meter
Cover Shape:	Circular	Evidence of Surcharge:	No
Cover Size:	22.5	Potential for Runoff:	None
Comments:

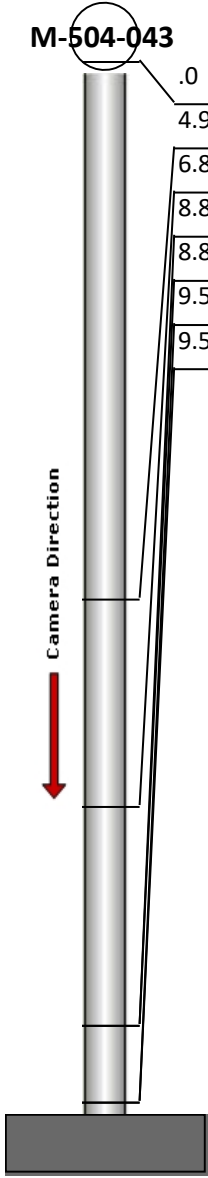
.0	MGO	General Observation	10	NA
	4.9	IW	Infil Weeper	31	M 2
	6.8	IW	Infil Weeper	46	M 2
	8.8	OBM	Obstacle Pipe Material	62	M 2
	8.8	DSF	Deposits Settled Fine	74	M 2
	9.5	DSF	Deposits Settled Fine	87	M 2
	9.5	MGO	General Observation	98	NA

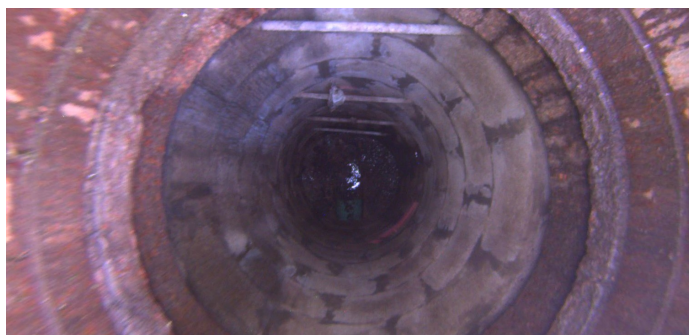
Code: **MGO**
Description: **General Observation**

Distance (ft): **.0**
Structural Grade: **0**
O&M Grade: **0**
Clock Start/From:
Clock To:
1st Value:
2nd Value:
Value Percent:
Step: **NO**
Remarks: **ACCESS MH**

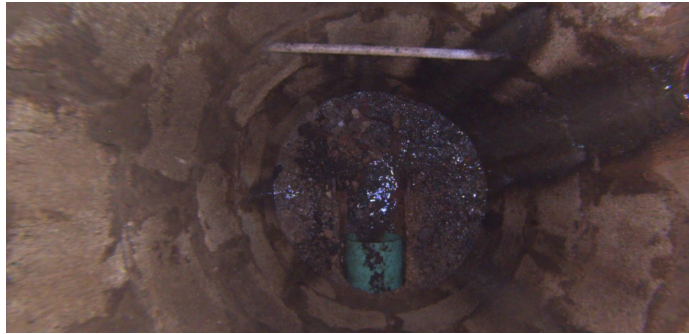
Code: **IW**
Description: **Infil Weeper**

Distance (ft): **4.9**
Structural Grade: **0**
O&M Grade: **2**
Clock Start/From: **2**
Clock To: **5**
1st Value:
2nd Value:
Value Percent:
Step: **NO**
Remarks:

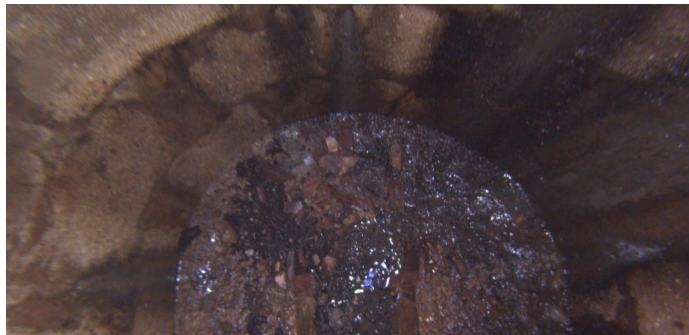
Code: **IW**
Description: **Infil Weeper**

Distance (ft): **6.8**
Structural Grade: **0**
O&M Grade: **2**
Clock Start/From: **12**
Clock To: **12**
1st Value:
2nd Value:
Value Percent:
Step: **NO**
Remarks:

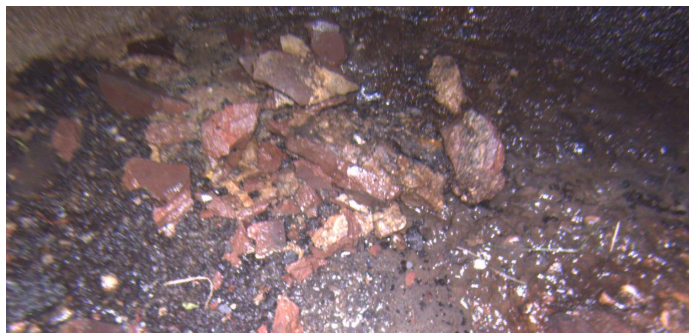
Code: **OBM**
Description: **Obstacle Pipe Material**

Distance (ft): **8.8**
Structural Grade: **0**
O&M Grade: **2**
Clock Start/From: **10**
Clock To: **2**
1st Value:
2nd Value:
Value Percent: **10.000**
Step: **NO**
Remarks:

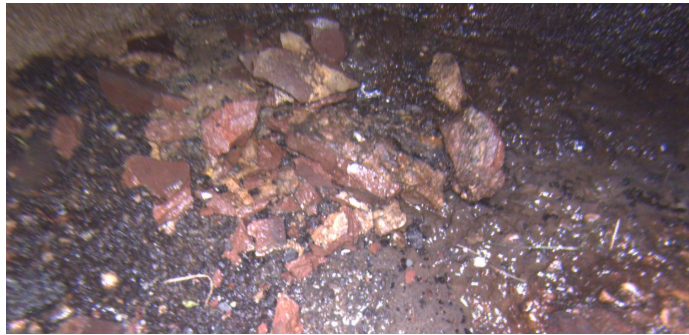
Code: **DSF**
Description: **Deposits Settled Fine**

Distance (ft): **8.8**
Structural Grade: **0**
O&M Grade: **2**
Clock Start/From: **12**
Clock To: **12**
1st Value:
2nd Value:
Value Percent: **5.000**
Step: **NO**
Remarks:

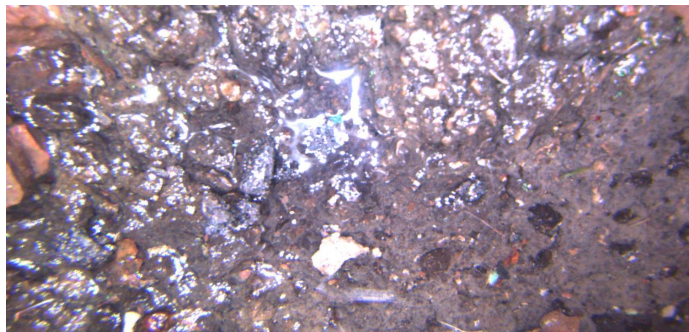
Code: **DSF**
Description: **Deposits Settled Fine**

Distance (ft): **9.5**
Structural Grade: **0**
O&M Grade: **2**
Clock Start/From: **5**
Clock To: **7**
1st Value:
2nd Value:
Value Percent: **10.000**
Step: **NO**
Remarks:

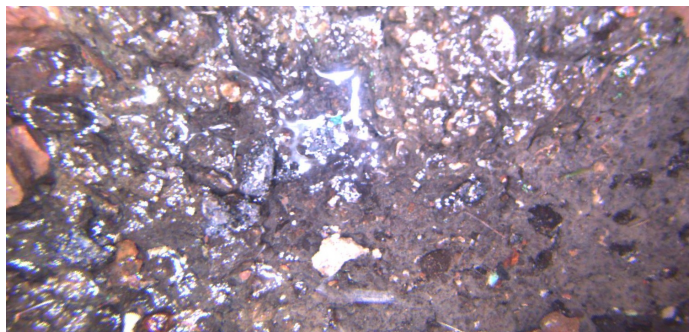
Code: **MGO**
Description: **General Observation**

Distance (ft): **9.5**
Structural Grade: **0**
O&M Grade: **0**
Clock Start/From:
Clock To:
1st Value:
2nd Value:
Value Percent:
Step: **NO**
Remarks: **END SURVEY**
