Manhole Inspection Report

Date:	05/14/2018	Weather:		Coding:	RZMACP
MH#:	M-504-045	Owner:	NA	Len. Surveyed:	11.9
P.O.#:		Surveyor:	Jen Costello	Rim to Invert:	13.5
Customer:		Cert. #:	U-907-5518	Wall Material:	Corrugated Metal

Street:	188' North of 44th Ave. East of Color	Project:	Hobart, IN
City:	Hobart, IN	GPS Northing:	41.53871536
Location:		GPS Easting:	-87.27359009
Drain Area:	West	GPS Accuracy:	Nearest Meter
Cover Shape:	Circular	Evidence of Surcharge:	No
Cover Size:	22.5	Potential for Runoff:	None
Comments:

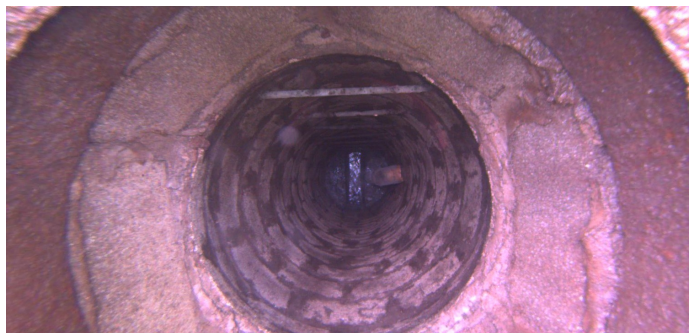
Code: **MGO**
Description: **General Observation**

Distance (ft): **.0**
Structural Grade: **0**
O&M Grade: **0**
Clock Start/From:
Clock To:
1st Value:
2nd Value:
Value Percent:
Step: **NO**
Remarks: **ACCESS MH**

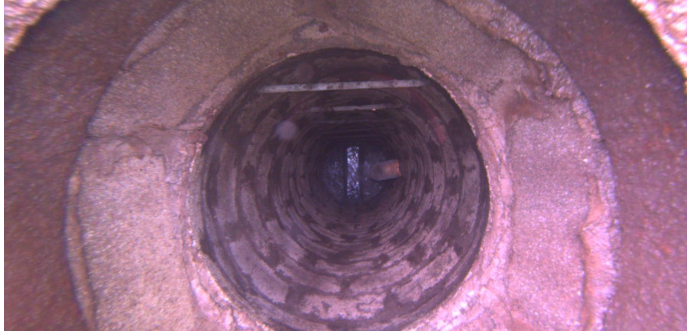
Code: **FM**
Description: **Fracture Multiple**

Distance (ft): **.0**
Structural Grade: **4**
O&M Grade: **0**
Clock Start/From: **12**
Clock To: **12**
1st Value:
2nd Value:
Value Percent:
Step: **NO**
Remarks:

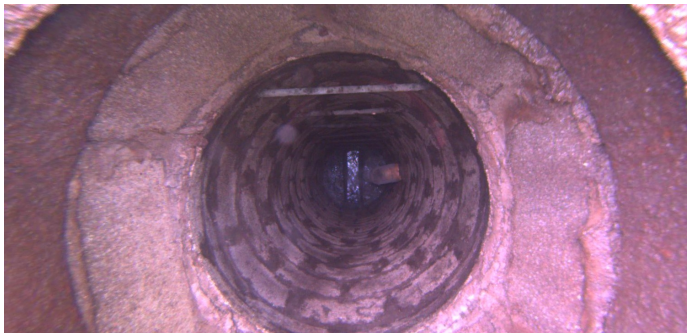
Code: **SAV**
Description: **Surface Aggregate Visible**

Distance (ft): **.0**
Structural Grade: **3**
O&M Grade: **0**
Clock Start/From: **12**
Clock To: **12**
1st Value:
2nd Value:
Value Percent:
Step: **NO**
Remarks:

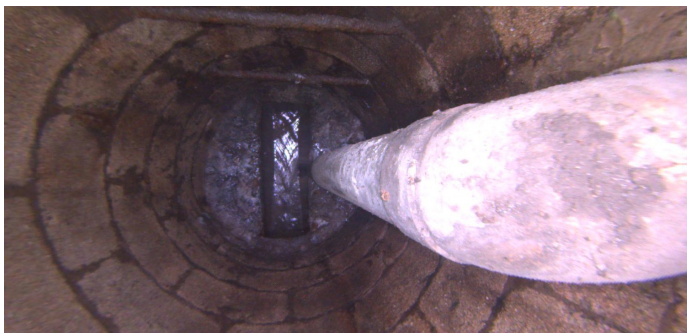
Code: **OBP**
Description: **Obstacle External Pipe or Cable**

Distance (ft): **8.0**
Structural Grade: **0**
O&M Grade: **2**
Clock Start/From: **2**
Clock To: **3**
1st Value:
2nd Value:
Value Percent: **10.000**
Step: **NO**
Remarks:

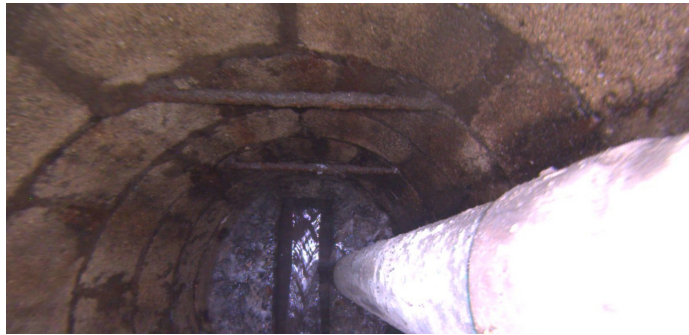
Code: **IW**
Description: **Infil Weeper**

Distance (ft): **8.6**
Structural Grade: **0**
O&M Grade: **2**
Clock Start/From: **2**
Clock To:
1st Value:
2nd Value:
Value Percent:
Step: **NO**
Remarks:

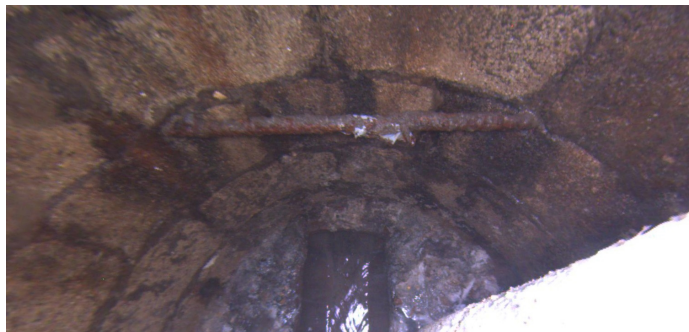
Code: **IW**
Description: **Infil Weeper**

Distance (ft): **10.4**
Structural Grade: **0**
O&M Grade: **2**
Clock Start/From: **10**
Clock To: **2**
1st Value:
2nd Value:
Value Percent:
Step: **NO**
Remarks:

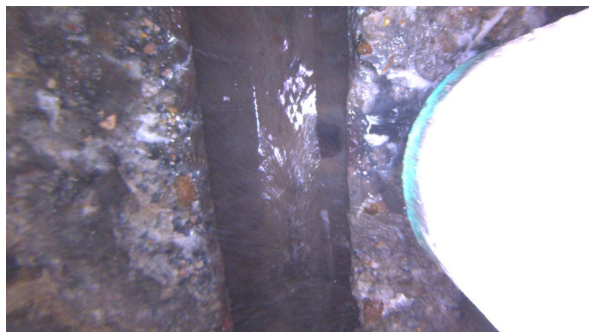
Code: **DSF**
Description: **Deposits Settled Fine**

Distance (ft): **11.9**
Structural Grade: **0**
O&M Grade: **2**
Clock Start/From: **12**
Clock To: **12**
1st Value:
2nd Value:
Value Percent: **5.000**
Step: **NO**
Remarks:
