# Manhole Inspection Report

Date:	05/14/2018	Weather:		Coding:	RZMACP
MH#:	M-504-046	Owner:	NA	Len. Surveyed:	13.0
P.O.#:		Surveyor:	Jen Costello	Rim to Invert:	13.5
Customer:		Cert. #:	U-907-5518	Wall Material:	Concrete (reinforced)

Street:	North of 44th Ave. 206' East of Color	Project:	Hobart, IN
City:	Hobart, IN	GPS Northing:	41.53918839
Location:		GPS Easting:	-87.27363586
Drain Area:	West	GPS Accuracy:	Nearest Meter
Cover Shape:	Circular	Evidence of Surcharge:	No
Cover Size:	22.5	Potential for Runoff:	None
Comments:

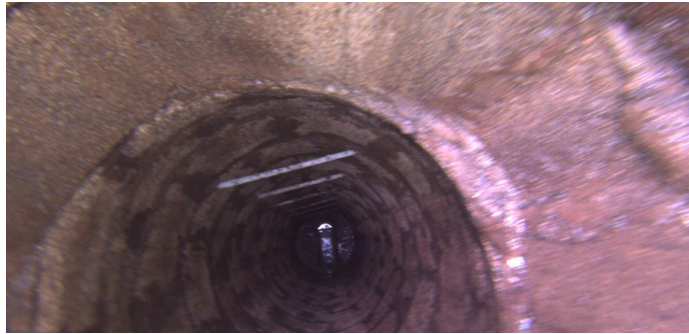
Code:	<b>DAE</b>
Description:	<b>Deposits Attached Encrustation</b>
Distance (ft):	<b>.6</b>
Structural Grade:	<b>0</b>
O&M Grade:	<b>2</b>
Clock Start/From:	<b>1</b>
Clock To:	<b>2</b>
1st Value:	
2nd Value:	
Value Percent:	<b>5.000</b>
Step:	<b>NO</b>
Remarks:

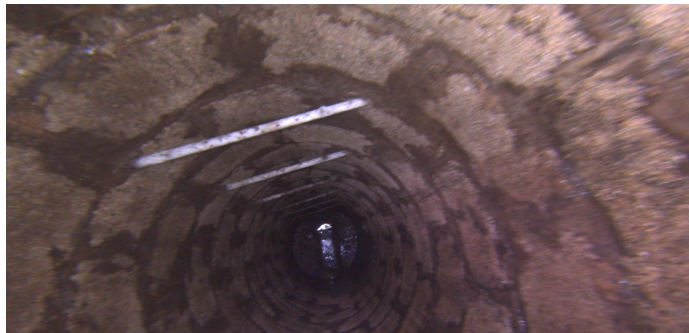
Code:	<b>SAV</b>
Description:	<b>Surface Aggregate Visible</b>
Distance (ft):	<b>2.0</b>
Structural Grade:	<b>3</b>
O&M Grade:	<b>0</b>
Clock Start/From:	<b>12</b>
Clock To:	<b>12</b>
1st Value:	
2nd Value:	
Value Percent:	
Step:	<b>NO</b>
Remarks:

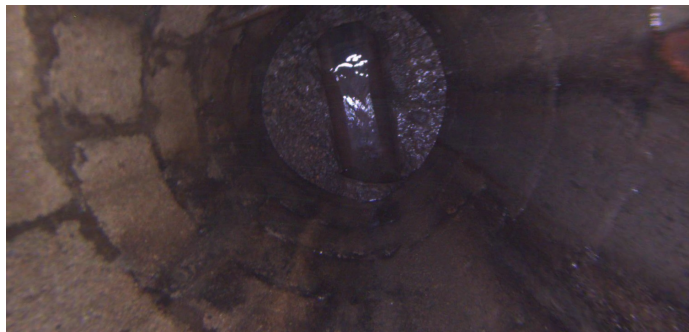
Code: **IW**  
Description: **Infil Weeper**

Distance (ft): **9.3**  
Structural Grade: **0**  
O&M Grade: **2**  
Clock Start/From: **6**  
Clock To: **8**  
1st Value:  
2nd Value:  
Value Percent:  
Step: **NO**  
Remarks:

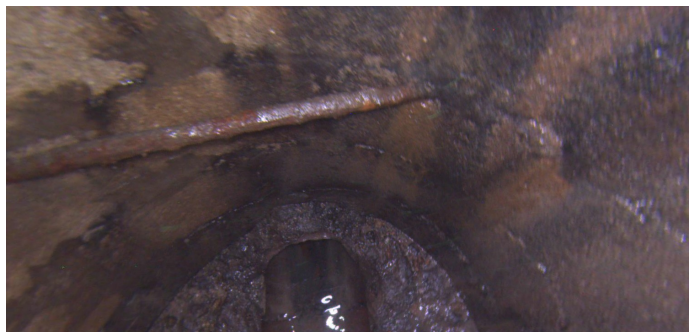
Code: **IW**  
Description: **Infil Weeper**

Distance (ft): **11.2**  
Structural Grade: **0**  
O&M Grade: **2**  
Clock Start/From: **11**  
Clock To: **2**  
1st Value:  
2nd Value:  
Value Percent:  
Step: **NO**  
Remarks:

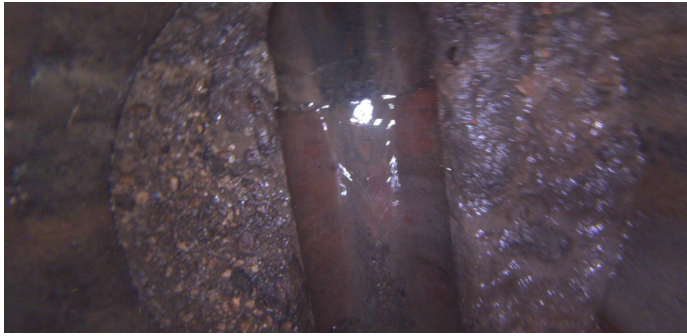
Code: **DSGV**  
Description: **Deposits Settled Gravel**

Distance (ft): **12.4**  
Structural Grade: **0**  
O&M Grade: **2**  
Clock Start/From: **12**  
Clock To: **12**  
1st Value:  
2nd Value:  
Value Percent: **5.000**  
Step: **NO**  
Remarks:

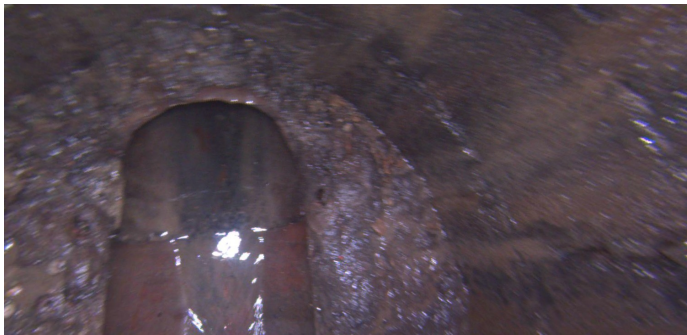
Code: **FL**  
Description: **Fracture Longitudinal**

Distance (ft): **12.4**  
Structural Grade: **3**  
O&M Grade: **0**  
Clock Start/From: **3**  
Clock To:  
1st Value:  
2nd Value:  
Value Percent:  
Step: **NO**  
Remarks:

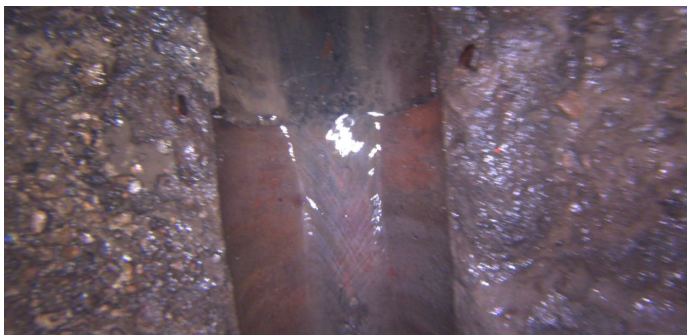
Code: **VC**  
Description: **Vermin Cockroach**

Distance (ft): **13.0**  
Structural Grade: **0**  
O&M Grade: **1**  
Clock Start/From:  
Clock To:  
1st Value:  
2nd Value:  
Value Percent:  
Step: **NO**  
Remarks:

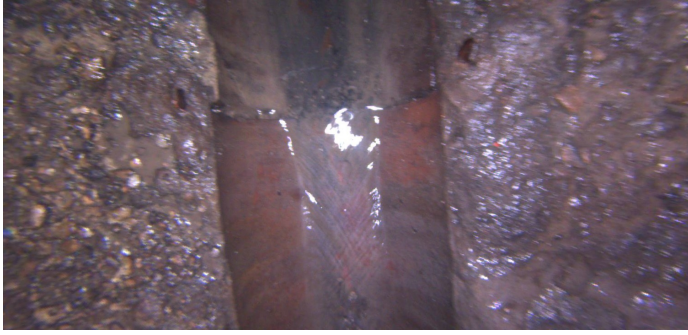
Code: **SAV**  
Description: **Surface Aggregate Visible**

Distance (ft): **13.0**  
Structural Grade: **3**  
O&M Grade: **0**  
Clock Start/From: **12**  
Clock To: **12**  
1st Value:  
2nd Value:  
Value Percent:  
Step: **NO**  
Remarks:

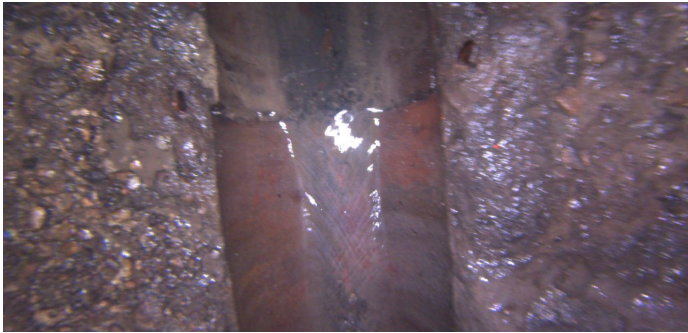
Code: **MGO**  
Description: **General Observation**

Distance (ft): **13.0**  
Structural Grade: **0**  
O&M Grade: **0**  
Clock Start/From:  
Clock To:  
1st Value:  
2nd Value:  
Value Percent:  
Step: **NO**  
Remarks: **END SURVEY**
