# Manhole Inspection Report

Date:	10/12/2022	Weather:		Coding:	RZMACP
MH#:	M-504-047	Owner:	NA	Len. Surveyed:	8.8
P.O.#:		Surveyor:	Jen Costello	Rim to Invert:	9.3
Customer:		Cert. #:	U-907-5518	Wall Material:	Brick

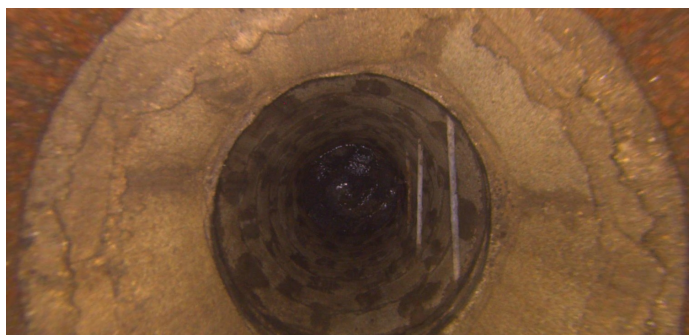
Code: **MGO**  
Description: **General Observation**

Distance (ft): **.0**  
Structural Grade: **0**  
O&M Grade: **0**  
Clock Start/From:  
Clock To:  
1st Value:  
2nd Value:  
Value Percent:  
Step: **NO**  
Remarks: **access mh**

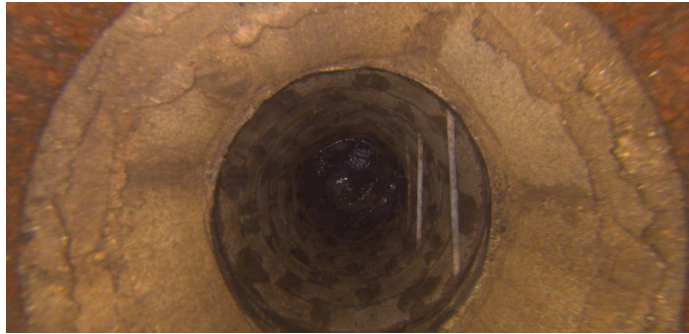
Code: **SAV**  
Description: **Surface Aggregate Visible**

Distance (ft): **.0**  
Structural Grade: **3**  
O&M Grade: **0**  
Clock Start/From: **12**  
Clock To: **12**  
1st Value:  
2nd Value:  
Value Percent:  
Step: **NO**  
Remarks:

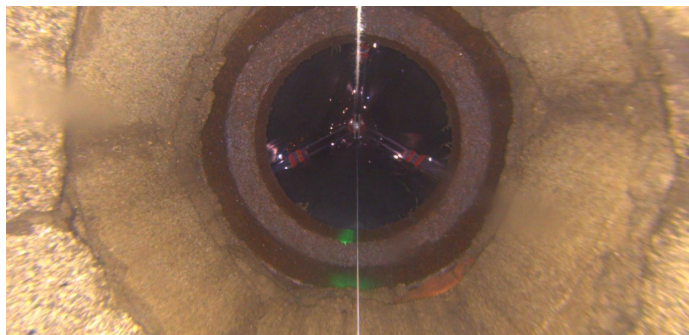
Code: **MGO**  
Description: **General Observation**

Distance (ft): **3.0**  
Structural Grade: **0**  
O&M Grade: **0**  
Clock Start/From:  
Clock To:  
1st Value:  
2nd Value:  
Value Percent:  
Step: **NO**  
Remarks: **underside of frame**

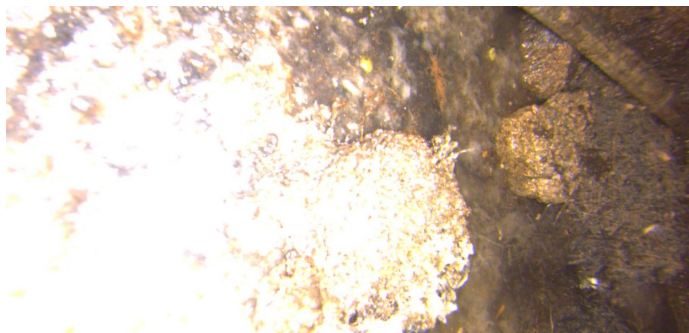
Code: **DSF**  
Description: **Deposits Settled Fine**

Distance (ft): **8.8**  
Structural Grade: **0**  
O&M Grade: **2**  
Clock Start/From: **12**  
Clock To: **12**  
1st Value:  
2nd Value:  
Value Percent: **10.000**  
Step: **NO**  
Remarks:

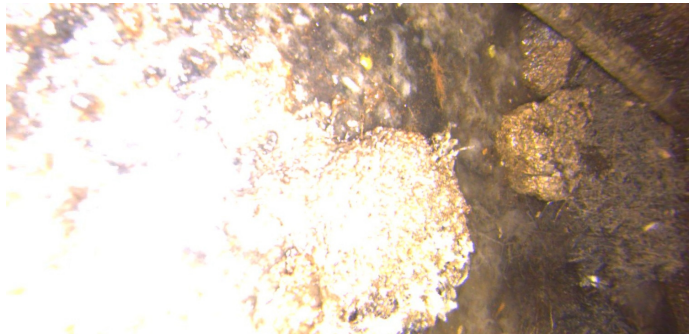
Code: **MGO**  
Description: **General Observation**

Distance (ft): **8.8**  
Structural Grade: **0**  
O&M Grade: **0**  
Clock Start/From:  
Clock To:  
1st Value:  
2nd Value:  
Value Percent:  
Step: **NO**  
Remarks: **end of survey**

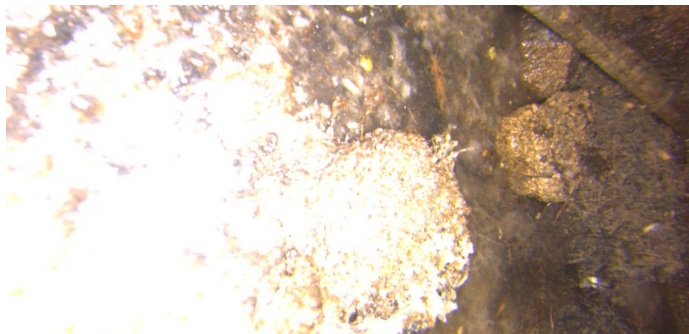
Code: **SAV**  
Description: **Surface Aggregate Visible**

Distance (ft): **8.8**  
Structural Grade: **3**  
O&M Grade: **0**  
Clock Start/From: **12**  
Clock To: **12**  
1st Value:  
2nd Value:  
Value Percent:  
Step: **NO**  
Remarks:
