Manhole Inspection Report

Date:	05/14/2018	Weather:		Coding:	RZMACP
MH#:	M-504-050	Owner:	NA	Len. Surveyed:	9.3
P.O.#:		Surveyor:	Jen Costello	Rim to Invert:	9.2
Customer:		Cert. #:	U-907-5518	Wall Material:	Brick

Street:	South of Old Ridge Rd. 167' East of C	Project:	Hobart, IN
City:	Hobart, IN	GPS Northing:	41.53991318
Location:		GPS Easting:	-87.27532959
Drain Area:	West	GPS Accuracy:	Nearest Meter
Cover Shape:	Circular	Evidence of Surcharge:	No
Cover Size:	22.5	Potential for Runoff:	None
Comments:

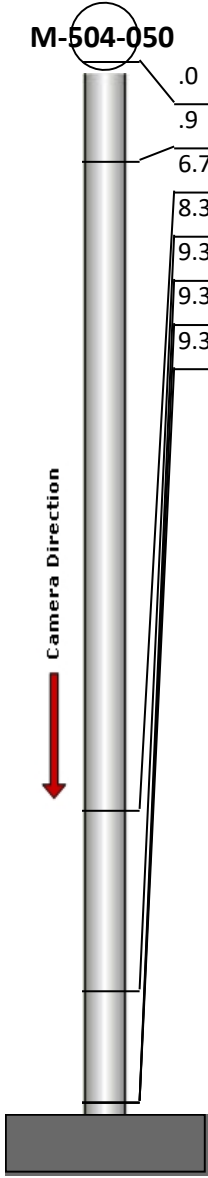
.0	MGO	General Observation	10	NA
	.9	SAV	Surface Aggregate Visible	23	S 3
	6.7	DAR	Deposits Attached Ragging	45	M 2
	8.3	RFB	Roots Fine Barrel	59	M 2
	9.3	DSF	Deposits Settled Fine	73	M 2
	9.3	SAV	Surface Aggregate Visible	83	S 3
	9.3	MGO	General Observation	94	NA

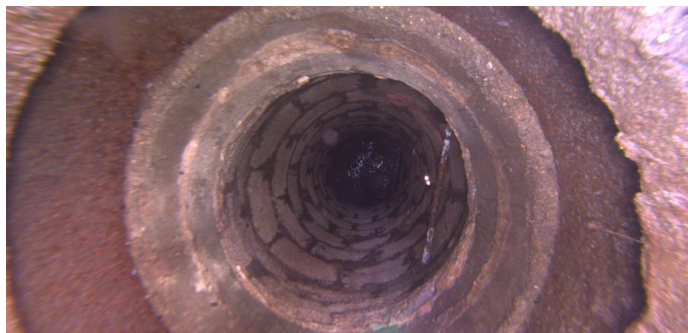
Code: **MGO**
Description: **General Observation**

Distance (ft): **.0**
Structural Grade: **0**
O&M Grade: **0**
Clock Start/From:
Clock To:
1st Value:
2nd Value:
Value Percent:
Step: **NO**
Remarks: **ACCESS MH**

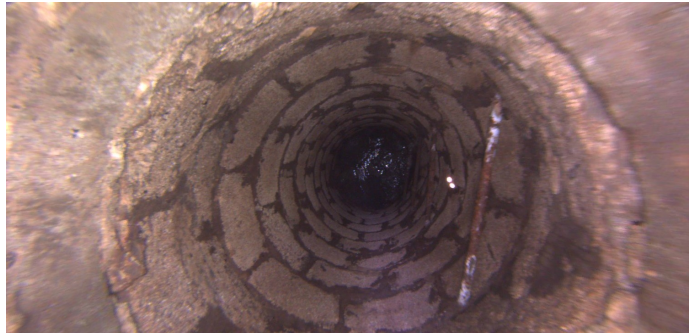
Code:	SAV
Description:	Surface Aggregate Visible
Distance (ft):	.9
Structural Grade:	3
O&M Grade:	0
Clock Start/From:	12
Clock To:	12
1st Value:	
2nd Value:	
Value Percent:	
Step:	NO
Remarks:

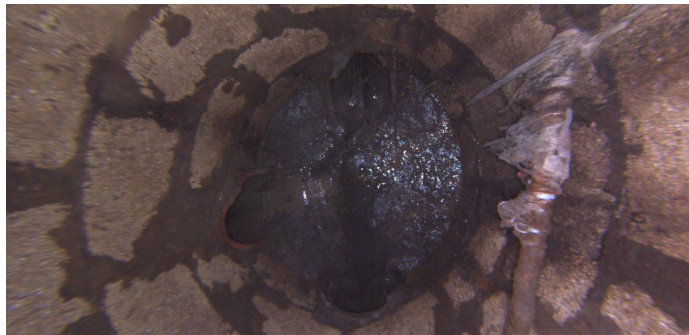
Code:	DAR
Description:	Deposits Attached Ragging
Distance (ft):	6.7
Structural Grade:	0
O&M Grade:	2
Clock Start/From:	1
Clock To:	3
1st Value:	
2nd Value:	
Value Percent:	5.000
Step:	YES
Remarks:

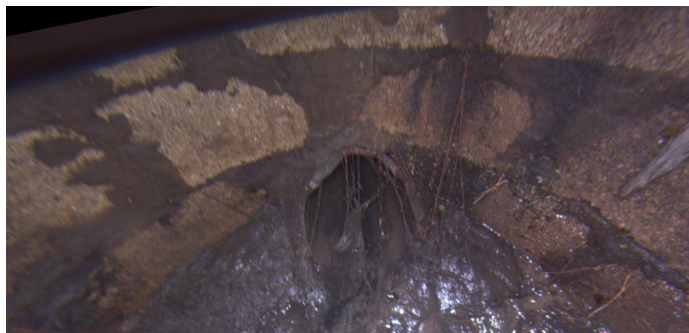
Code:	RFB
Description:	Roots Fine Barrel
Distance (ft):	8.3
Structural Grade:	0
O&M Grade:	2
Clock Start/From:	12
Clock To:	3
1st Value:	
2nd Value:	
Value Percent:	
Step:	NO
Remarks:

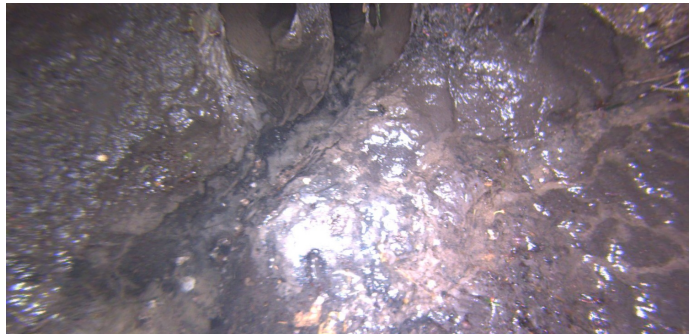
Code: **DSF**
Description: **Deposits Settled Fine**

Distance (ft): **9.3**
Structural Grade: **0**
O&M Grade: **2**
Clock Start/From: **12**
Clock To: **12**
1st Value:
2nd Value:
Value Percent: **5.000**
Step: **NO**
Remarks:

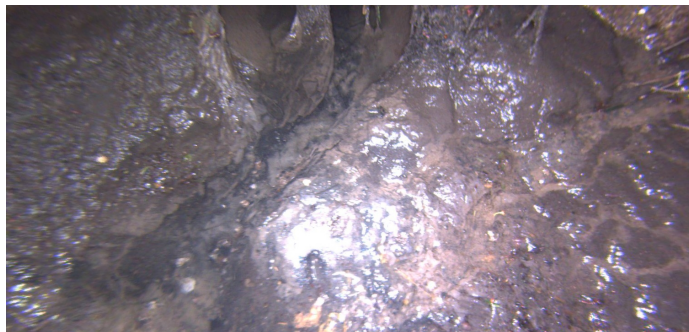
Code: **SAV**
Description: **Surface Aggregate Visible**

Distance (ft): **9.3**
Structural Grade: **3**
O&M Grade: **0**
Clock Start/From: **12**
Clock To: **12**
1st Value:
2nd Value:
Value Percent:
Step: **NO**
Remarks:

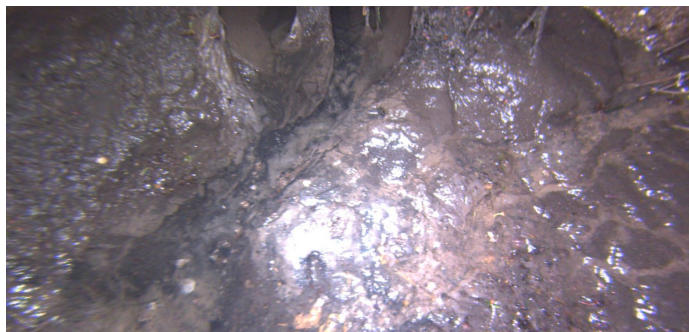
Code: **MGO**
Description: **General Observation**

Distance (ft): **9.3**
Structural Grade: **0**
O&M Grade: **0**
Clock Start/From:
Clock To:
1st Value:
2nd Value:
Value Percent:
Step: **NO**
Remarks: **END SURVEY**
