# Manhole Inspection Report

Date:	<b>05/14/2018</b>	Weather:		Coding:	<b>RZMACP</b>
MH#:	<b>M-504-051</b>	Owner:	<b>NA</b>	Len. Surveyed:	<b>9.5</b>
P.O.#:		Surveyor:	<b>Jen Costello</b>	Rim to Invert:	<b>9.2</b>
Customer:		Cert. #:	<b>U-907-5518</b>	Wall Material:	<b>Brick</b>

Street:	<b>South of Old Ridge Rd. 37' East of Ca</b>	Project:	<b>Hobart, IN</b>
City:	<b>Hobart, IN</b>	GPS Northing:	<b>41.54005814</b>
Location:		GPS Easting:	<b>-87.27571869</b>
Drain Area:	<b>West</b>	GPS Accuracy:	<b>Nearest Meter</b>
Cover Shape:	<b>Circular</b>	Evidence of Surcharge:	<b>No</b>
Cover Size:	<b>22.5</b>	Potential for Runoff:	<b>None</b>
Comments:

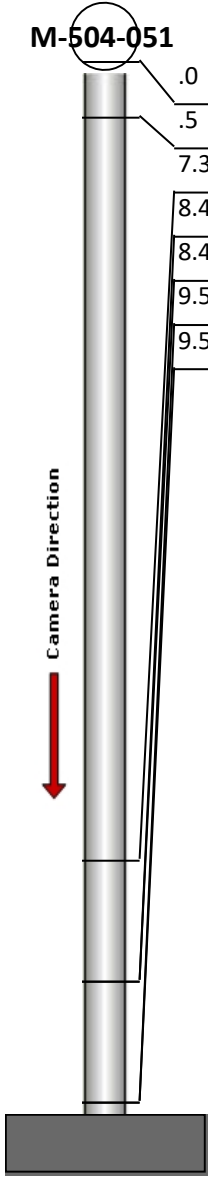
.0	MGO	General Observation	10	NA
	.5	SRI	Surface Roughness Increased	22	S 1
	7.3	IW	Infil Weeper	47	M 2
	8.4	RFB	Roots Fine Barrel	61	M 2
	8.4	DSF	Deposits Settled Fine	72	M 2
	9.5	MGO	General Observation	85	NA
	9.5	SRI	Surface Roughness Increased	96	S 1

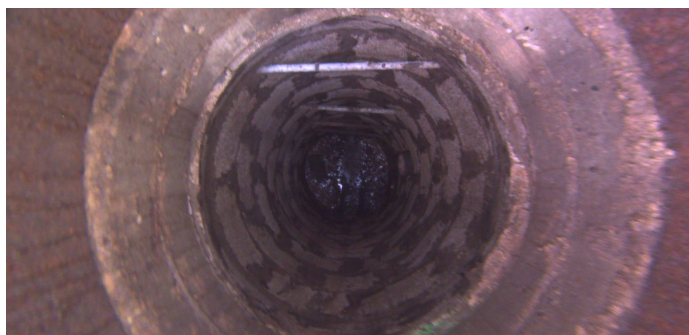
Code: **MGO**  
Description: **General Observation**

Distance (ft): **.0**  
Structural Grade: **0**  
O&M Grade: **0**  
Clock Start/From:  
Clock To:  
1st Value:  
2nd Value:  
Value Percent:  
Step: **NO**  
Remarks: **ACCESS MH**

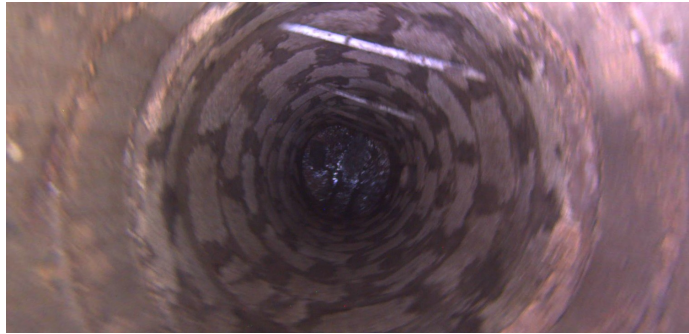
Code: **SRI**  
Description: **Surface Roughness Increased**

Distance (ft): **.5**  
Structural Grade: **1**  
O&M Grade: **0**  
Clock Start/From: **12**  
Clock To: **12**  
1st Value:  
2nd Value:  
Value Percent:  
Step: **NO**  
Remarks:

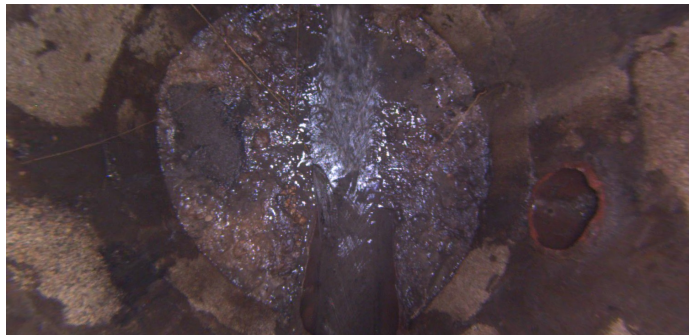
Code: **IW**  
Description: **Infil Weeper**

Distance (ft): **7.3**  
Structural Grade: **0**  
O&M Grade: **2**  
Clock Start/From: **9**  
Clock To:  
1st Value:  
2nd Value:  
Value Percent:  
Step: **NO**  
Remarks:

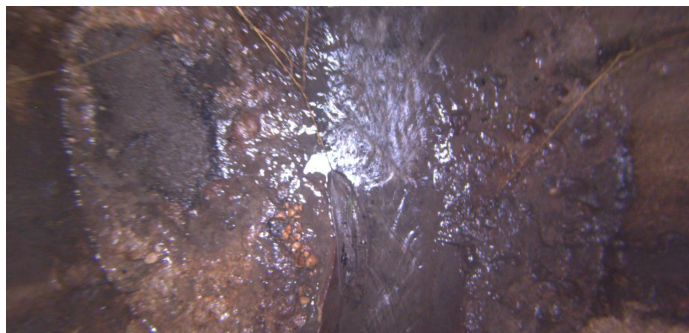
Code: **RFB**  
Description: **Roots Fine Barrel**

Distance (ft): **8.4**  
Structural Grade: **0**  
O&M Grade: **2**  
Clock Start/From: **2**  
Clock To:  
1st Value:  
2nd Value:  
Value Percent:  
Step: **NO**  
Remarks:

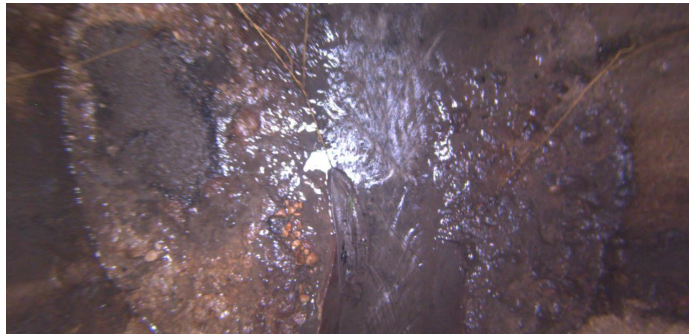
Code: **DSF**  
Description: **Deposits Settled Fine**

Distance (ft): **8.4**  
Structural Grade: **0**  
O&M Grade: **2**  
Clock Start/From: **12**  
Clock To: **12**  
1st Value:  
2nd Value:  
Value Percent: **5.000**  
Step: **NO**  
Remarks:

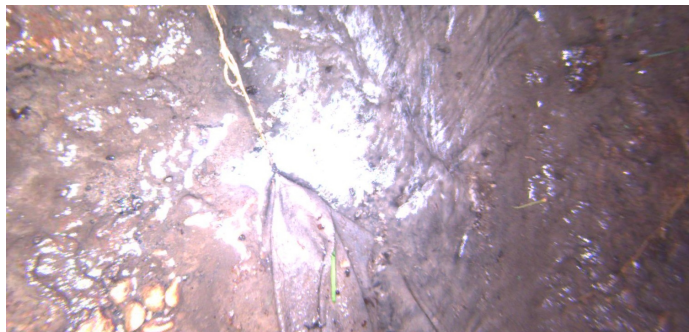
Code: **MGO**  
Description: **General Observation**

Distance (ft): **9.5**  
Structural Grade: **0**  
O&M Grade: **0**  
Clock Start/From:  
Clock To:  
1st Value:  
2nd Value:  
Value Percent:  
Step: **NO**  
Remarks: **END SURVEY**

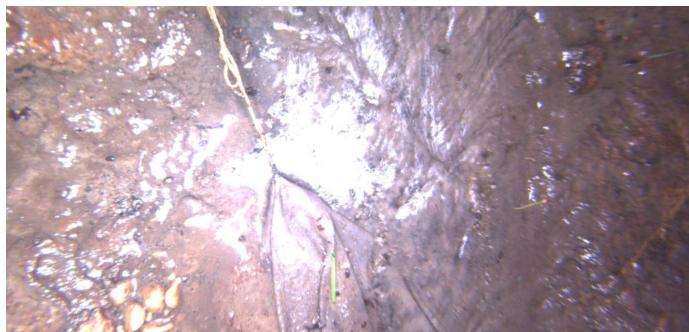
Code: **SRI**  
Description: **Surface Roughness Increased**

Distance (ft): **9.5**  
Structural Grade: **1**  
O&M Grade: **0**  
Clock Start/From: **12**  
Clock To: **12**  
1st Value:  
2nd Value:  
Value Percent:  
Step: **NO**  
Remarks:
