Manhole Inspection Report

Date:	05/13/2018	Weather:		Coding:	RZMACP
MH#:	M-504-052	Owner:	NA	Len. Surveyed:	9.1
P.O.#:		Surveyor:	Jen Costello	Rim to Invert:	9.2
Customer:		Cert. #:	U-907-5518	Wall Material:	Brick

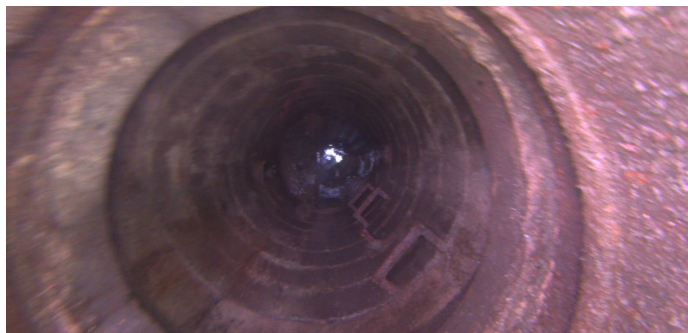
Code: **MGO**
Description: **General Observation**

Distance (ft): **.0**
Structural Grade: **0**
O&M Grade: **0**
Clock Start/From:
Clock To:
1st Value:
2nd Value:
Value Percent:
Step: **NO**
Remarks: **ACCESS MH**

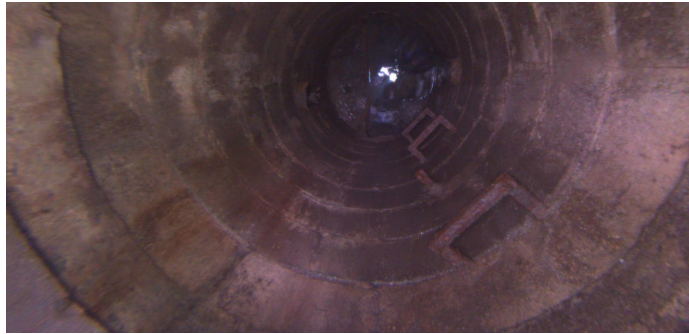
Code: **IS**
Description: **Infil Stain**

Distance (ft): **1.0**
Structural Grade: **0**
O&M Grade: **0**
Clock Start/From: **7**
Clock To: **8**
1st Value:
2nd Value:
Value Percent:
Step: **NO**
Remarks:

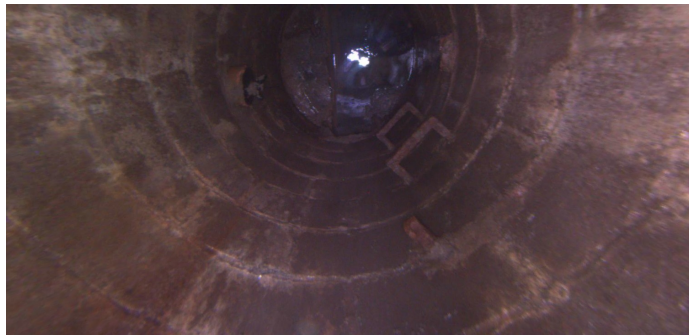
Code: **MGO**
Description: **General Observation**

Distance (ft): **2.5**
Structural Grade: **0**
O&M Grade: **0**
Clock Start/From:
Clock To:
1st Value:
2nd Value:
Value Percent:
Step: **NO**
Remarks: **MISSING AND BROKENS TEPS**

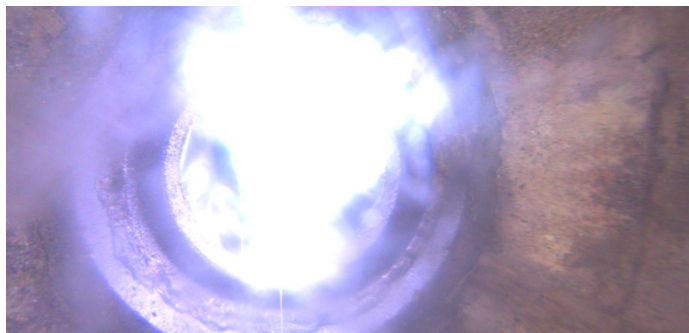
Code: **MGO**
Description: **General Observation**

Distance (ft): **3.3**
Structural Grade: **0**
O&M Grade: **0**
Clock Start/From:
Clock To:
1st Value:
2nd Value:
Value Percent:
Step: **NO**
Remarks: **UNDERSIDE OF FRAME**

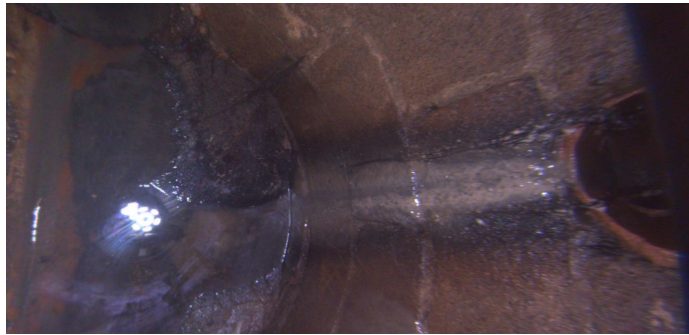
Code: **RFL**
Description: **Roots Fine Lateral**

Distance (ft): **6.9**
Structural Grade: **0**
O&M Grade: **1**
Clock Start/From: **3**
Clock To:
1st Value:
2nd Value:
Value Percent:
Step: **NO**
Remarks:

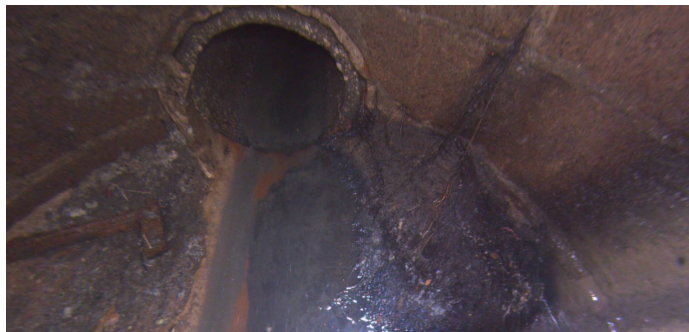
Code: **RFB**
Description: **Roots Fine Barrel**

Distance (ft): **8.1**
Structural Grade: **0**
O&M Grade: **2**
Clock Start/From: **2**
Clock To:
1st Value:
2nd Value:
Value Percent:
Step: **NO**
Remarks:

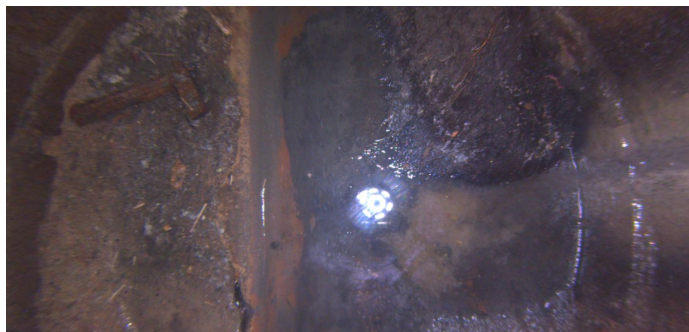
Code: **DSF**
Description: **Deposits Settled Fine**

Distance (ft): **8.1**
Structural Grade: **0**
O&M Grade: **2**
Clock Start/From: **12**
Clock To: **12**
1st Value:
2nd Value:
Value Percent: **5.000**
Step: **NO**
Remarks:

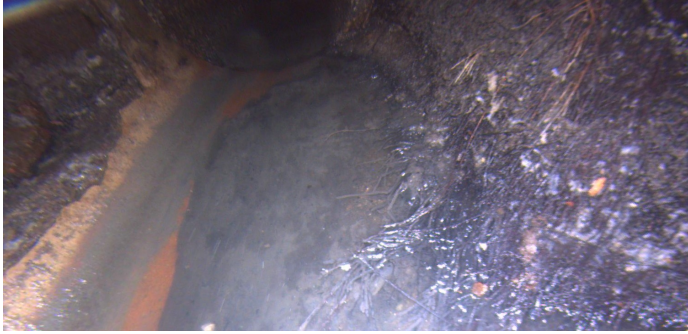
Code:	MGO
Description:	General Observation
Distance (ft):	9.1
Structural Grade:	0
O&M Grade:	0
Clock Start/From:	
Clock To:	
1st Value:	
2nd Value:	
Value Percent:	
Step:	NO
Remarks:	END SURVEY
