Manhole Inspection Report

Date:	05/14/2018	Weather:		Coding:	RZMACP
MH#:	M-504-055	Owner:	NA	Len. Surveyed:	4.3
P.O.#:		Surveyor:	Jen Costello	Rim to Invert:	5.2
Customer:		Cert. #:	U-907-5518	Wall Material:	Concrete (reinforced)

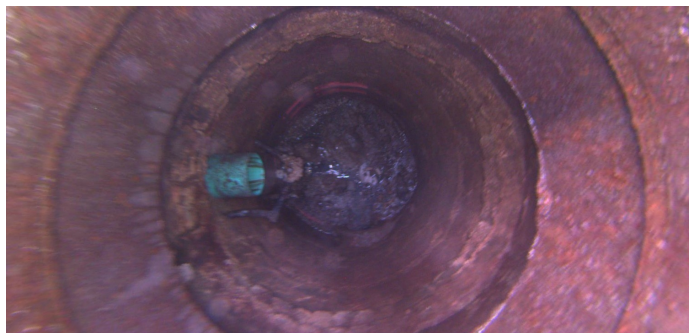
Code: **MGO**
Description: **General Observation**

Distance (ft): **.0**
Structural Grade: **0**
O&M Grade: **0**
Clock Start/From:
Clock To:
1st Value:
2nd Value:
Value Percent:
Step: **NO**
Remarks: **ACCESS MH**

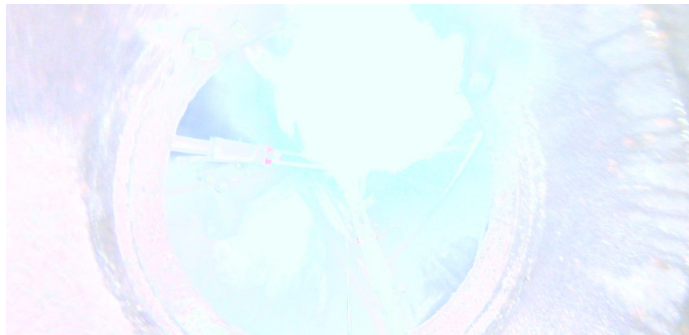
Code: **MGO**
Description: **General Observation**

Distance (ft): **2.0**
Structural Grade: **0**
O&M Grade: **0**
Clock Start/From:
Clock To:
1st Value:
2nd Value:
Value Percent:
Step: **NO**
Remarks: **UNDERSIDE OF FRAME**

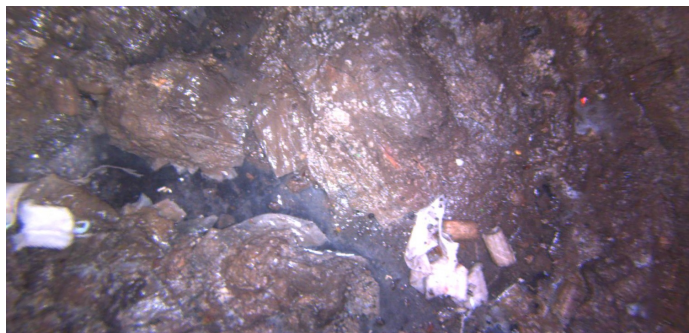
Code: **DSZ**
Description: **Deposits Settled Other**

Distance (ft): **4.3**
Structural Grade: **0**
O&M Grade: **2**
Clock Start/From: **12**
Clock To: **12**
1st Value:
2nd Value:
Value Percent: **5.000**
Step: **NO**
Remarks: **MISC**
