Manhole Inspection Report

Date:	05/13/2018	Weather:		Coding:	RZMACP
MH#:	M-504-057	Owner:	NA	Len. Surveyed:	9.6
P.O.#:		Surveyor:	Jen Costello	Rim to Invert:	9.5
Customer:		Cert. #:	U-907-5518	Wall Material:	Brick

Street:	Home Ave. 161' West of Guyer St.	Project:	Hobart, IN
City:	Hobart, IN	GPS Northing:	41.53828812
Location:		GPS Easting:	-87.27754211
Drain Area:	West	GPS Accuracy:	Nearest Meter
Cover Shape:	Circular	Evidence of Surcharge:	No
Cover Size:	22.5	Potential for Runoff:	None
Comments:

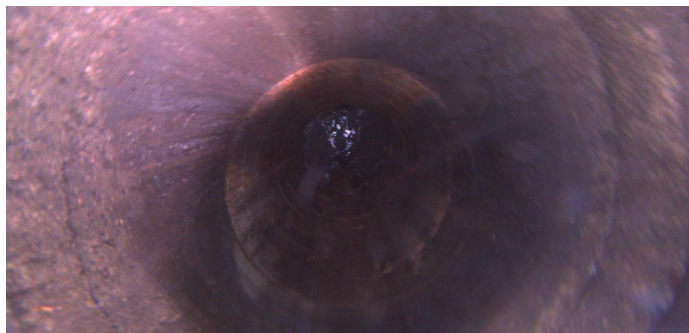
Code: **MGO**
Description: **General Observation**

Distance (ft): **.0**
Structural Grade: **0**
O&M Grade: **0**
Clock Start/From:
Clock To:
1st Value:
2nd Value:
Value Percent:
Step: **NO**
Remarks: **ACCESS MH**

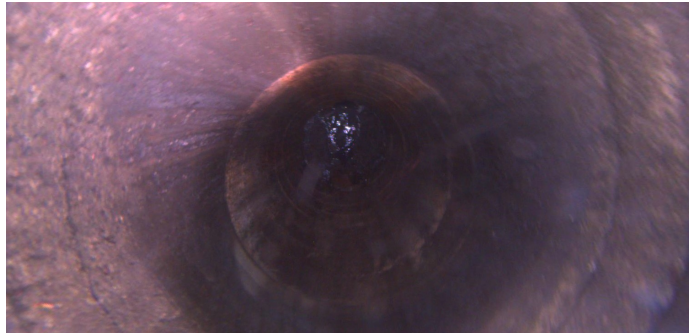
Code:	SAV
Description:	Surface Aggregate Visible
Distance (ft):	.0
Structural Grade:	3
O&M Grade:	0
Clock Start/From:	12
Clock To:	12
1st Value:	
2nd Value:	
Value Percent:	
Step:	NO
Remarks:

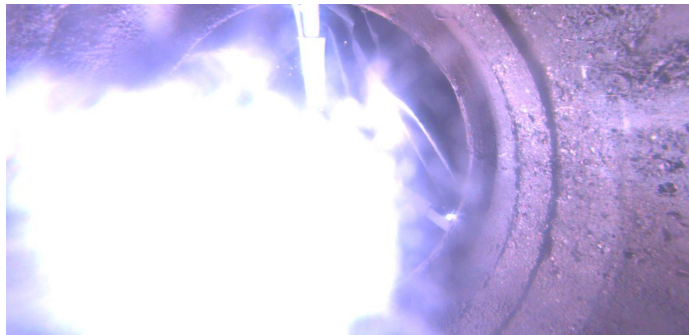
Code:	MGO
Description:	General Observation
Distance (ft):	2.3
Structural Grade:	0
O&M Grade:	0
Clock Start/From:	
Clock To:	
1st Value:	
2nd Value:	
Value Percent:	
Step:	NO
Remarks:	END SURVEY

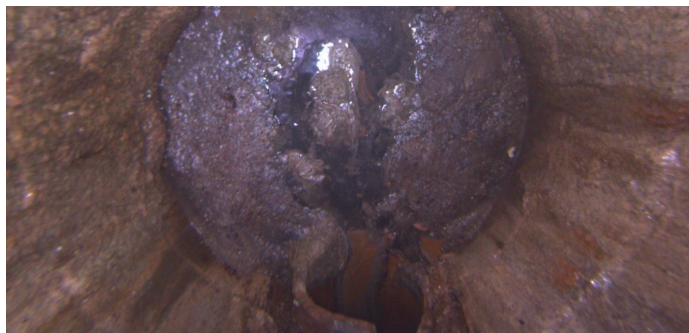
Code:	IW
Description:	Infil Weeper
Distance (ft):	7.9
Structural Grade:	0
O&M Grade:	2
Clock Start/From:	3
Clock To:	7
1st Value:	
2nd Value:	
Value Percent:	
Step:	NO
Remarks:

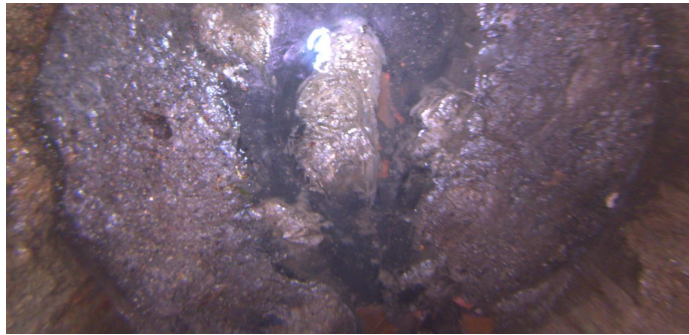
Code: **DSF**
Description: **Deposits Settled Fine**

Distance (ft): **8.8**
Structural Grade: **0**
O&M Grade: **2**
Clock Start/From: **12**
Clock To: **12**
1st Value:
2nd Value:
Value Percent: **5.000**
Step: **NO**
Remarks:

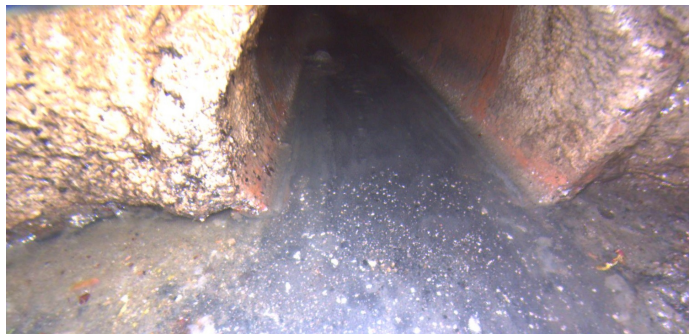
Code: **MGO**
Description: **General Observation**

Distance (ft): **9.6**
Structural Grade: **0**
O&M Grade: **0**
Clock Start/From:
Clock To:
1st Value:
2nd Value:
Value Percent:
Step: **NO**
Remarks: **END SURVEY**

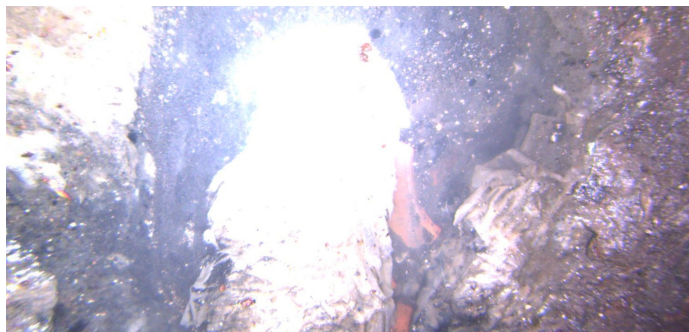
Code: **SAV**
Description: **Surface Aggregate Visible**

Distance (ft): **9.6**
Structural Grade: **3**
O&M Grade: **0**
Clock Start/From: **12**
Clock To: **12**
1st Value:
2nd Value:
Value Percent:
Step: **NO**
Remarks:
