# Manhole Inspection Report

Date:	<b>05/14/2018</b>	Weather:		Coding:	<b>RZMACP</b>
MH#:	<b>M-504-059</b>	Owner:	<b>NA</b>	Len. Surveyed:	<b>4.6</b>
P.O.#:		Surveyor:	<b>Jen Costello</b>	Rim to Invert:	<b>5.0</b>
Customer:		Cert. #:	<b>U-907-5518</b>	Wall Material:	<b>Brick</b>

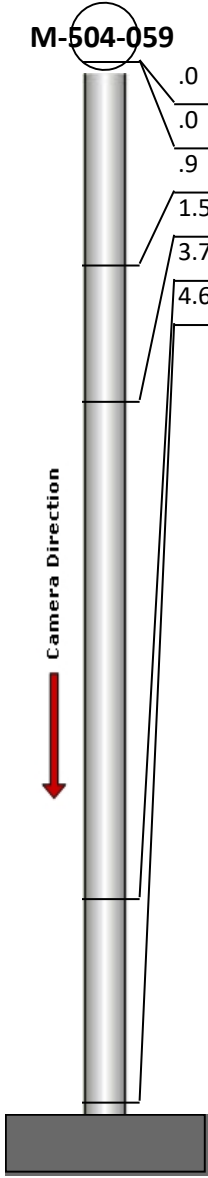
.0	MGO	General Observation	10	NA
	.0	ISSR	Intruding Sealing Ring	21	M 2
	.9	SAV	Surface Aggregate Visible	34	S 3
	1.5	MGO	General Observation	49	NA
	3.7	DSC	Deposits Settled Compacted	66	M 2
	4.6	MGO	General Observation	80	NA

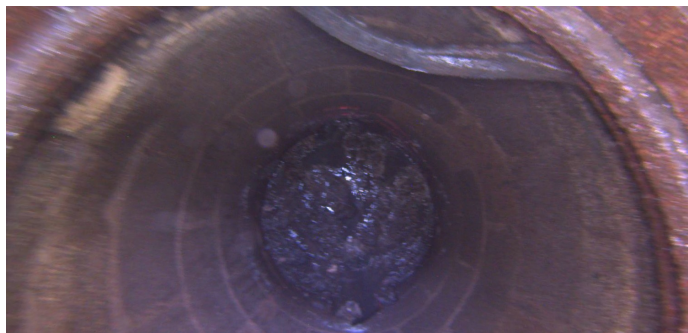
Code: **MGO**  
Description: **General Observation**

Distance (ft): **.0**  
Structural Grade: **0**  
O&M Grade: **0**  
Clock Start/From:  
Clock To:  
1st Value:  
2nd Value:  
Value Percent:  
Step: **NO**  
Remarks: **access MH**

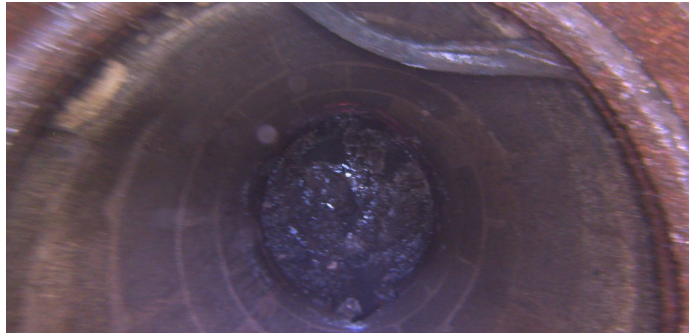
Code: **ISSR**  
Description: **Intruding Sealing Ring**

Distance (ft): **.0**  
Structural Grade: **0**  
O&M Grade: **2**  
Clock Start/From: **12**  
Clock To: **1**  
1st Value:  
2nd Value:  
Value Percent: **5.000**  
Step: **NO**  
Remarks:

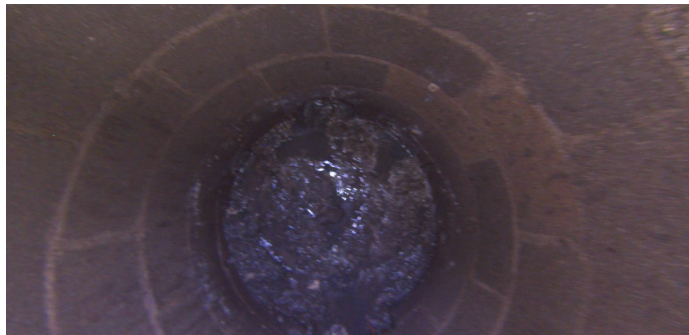
Code: **SAV**  
Description: **Surface Aggregate Visible**

Distance (ft): **.9**  
Structural Grade: **3**  
O&M Grade: **0**  
Clock Start/From: **12**  
Clock To: **12**  
1st Value:  
2nd Value:  
Value Percent:  
Step: **NO**  
Remarks:

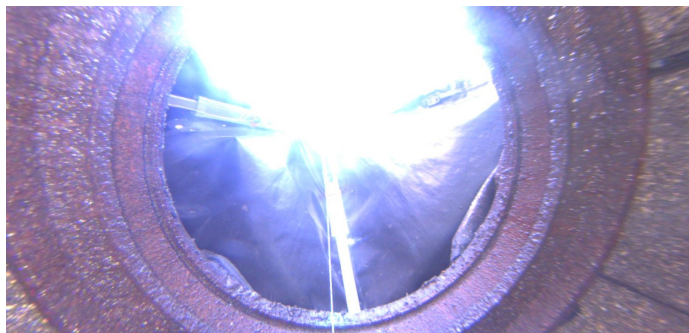
Code: **MGO**  
Description: **General Observation**

Distance (ft): **1.5**  
Structural Grade: **0**  
O&M Grade: **0**  
Clock Start/From:  
Clock To:  
1st Value:  
2nd Value:  
Value Percent:  
Step: **NO**  
Remarks: **UNDERSIDE OF FRAME**

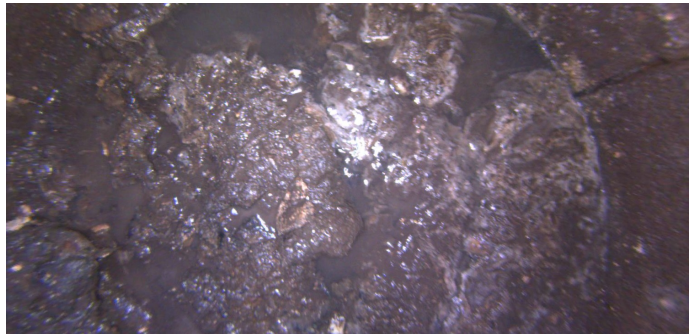
Code:	<b>DSC</b>
Description:	<b>Deposits Settled Compacted</b>
Distance (ft):	<b>3.7</b>
Structural Grade:	<b>0</b>
O&M Grade:	<b>2</b>
Clock Start/From:	<b>12</b>
Clock To:	<b>12</b>
1st Value:	
2nd Value:	
Value Percent:	<b>10.000</b>
Step:	<b>NO</b>
Remarks:

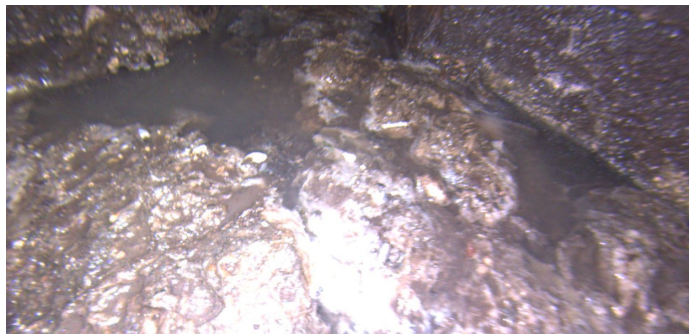
Code:	<b>MGO</b>
Description:	<b>General Observation</b>
Distance (ft):	<b>4.6</b>
Structural Grade:	<b>0</b>
O&M Grade:	<b>0</b>
Clock Start/From:	
Clock To:	
1st Value:	
2nd Value:	
Value Percent:	
Step:	<b>NO</b>
Remarks:	<b>END SURVEY</b>
