# Manhole Inspection Report

| MH#: | <b>M-504-062</b> | Owner: | <b>NA</b> | Len. Surveyed: | <b>18.9</b> |

| Street: | <b>Ridge Rd. 139' West of Delaware St.</b> | Project: | <b>Hobart, IN</b> |

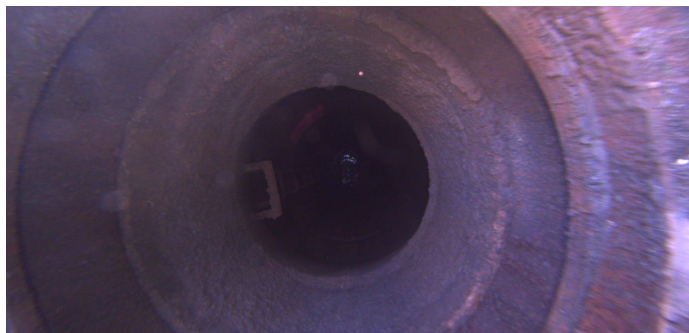
Code: **MGO**  
Description: **General Observation**

Distance (ft): **.0**  
Structural Grade: **0**  
O&M Grade: **0**  
Clock Start/From:  
Clock To:  
1st Value:  
2nd Value:  
Value Percent:  
Step: **NO**  
Remarks: **ACCESS MH**

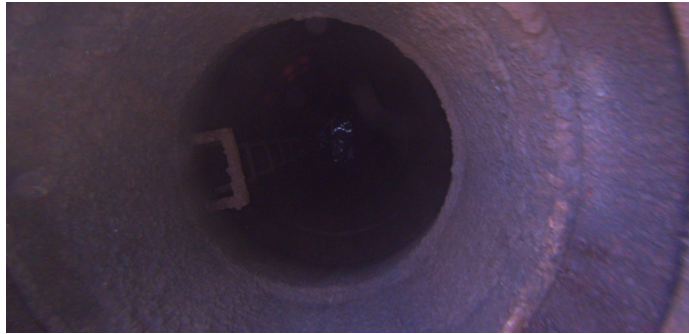
| Code: | <b>DAE</b> |
| Description: | <b>Deposits Attached Encrustation</b> |
| Distance (ft): | <b>.2</b> |
| O&M Grade: | <b>2</b> |
| Clock Start/From: | <b>12</b> |
| Value Percent: | <b>5.000</b> |

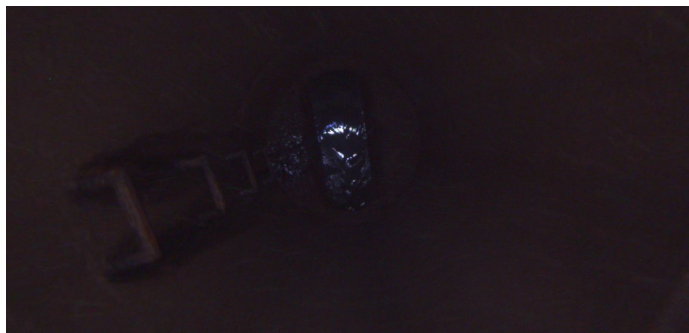
| Code: | <b>IW</b> |
| Description: | <b>Infil Weeper</b> |
| Distance (ft): | <b>12.7</b> |
| O&M Grade: | <b>2</b> |
| Clock Start/From: | <b>8</b> |
| Clock To: | <b>9</b> |

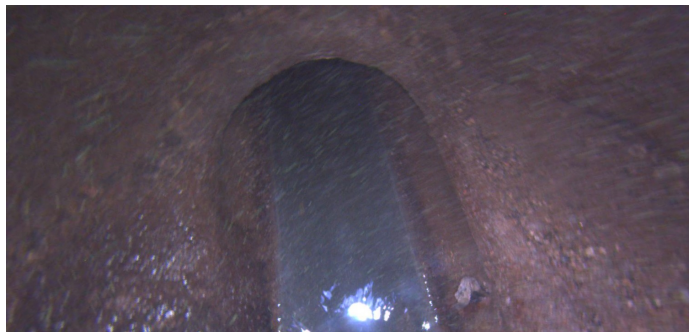
Code: **MGO**  
Description: **General Observation**

Distance (ft): **18.9**  
Structural Grade: **0**  
O&M Grade: **0**  
Clock Start/From:  
Clock To:  
1st Value:  
2nd Value:  
Value Percent:  
Step: **NO**  
Remarks: **END SURVEY**

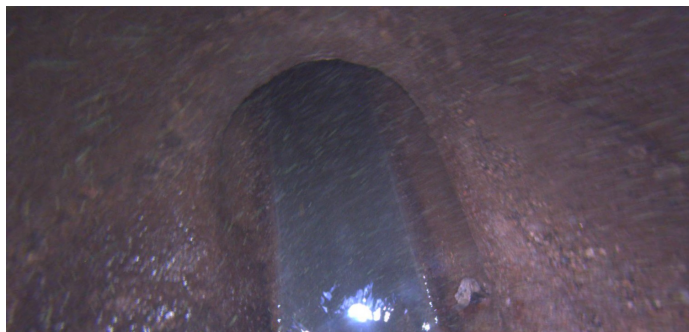
Code: **DAE**  
Description: **Deposits Attached Encrustation**

Distance (ft): **18.9**  
Structural Grade: **0**  
O&M Grade: **2**  
Clock Start/From: **12**  
Clock To: **12**  
1st Value:  
2nd Value:  
Value Percent: **5.000**  
Step: **NO**  
Remarks:
