Manhole Inspection Report

Date:	05/16/2018	Weather:		Coding:	RZMACP
MH#:	M-504-063	Owner:	NA	Len. Surveyed:	17.9
P.O.#:		Surveyor:	Jen Costello	Rim to Invert:	18.4
Customer:		Cert. #:	U-907-5518	Wall Material:	Concrete (reinforced)

Street:	Ridge Rd. 64' West of Colorado St.	Project:	Hobart, IN
City:	Hobart, IN	GPS Northing:	41.5402832
Location:		GPS Easting:	-87.27502441
Drain Area:	Northwest	GPS Accuracy:	Nearest Meter
Cover Shape:	Circular	Evidence of Surcharge:	No
Cover Size:	22.5	Potential for Runoff:	None
Comments:

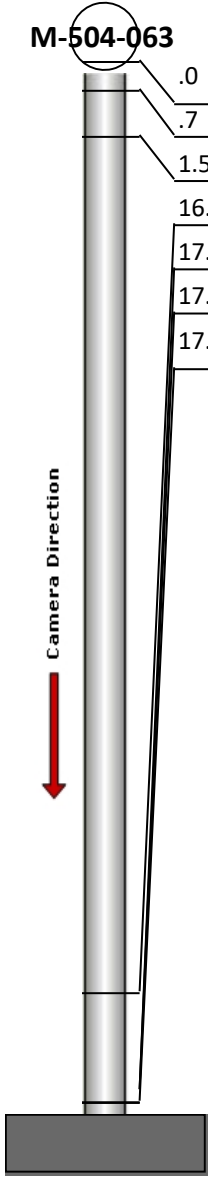
Position	Code	Observation	Video (sec)	Grade

.0	MGO	General Observation	10	NA
	.7	DAE	Deposits Attached Encrustation	23	M 2
	1.5	MGO	General Observation	37	NA
	16.2	DSF	Deposits Settled Fine	80	M 2
	17.9	OBR	Obstacle Rocks	94	M 2
	17.9	DAE	Deposits Attached Encrustation	105	M 2
	17.9	MGO	General Observation	115	NA

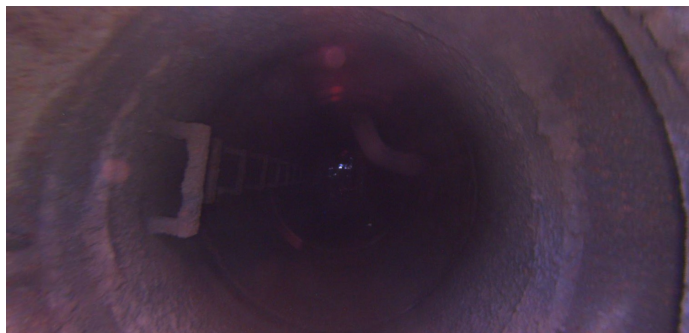
Code: **MGO**
Description: **General Observation**

Distance (ft): **.0**
Structural Grade: **0**
O&M Grade: **0**
Clock Start/From:
Clock To:
1st Value:
2nd Value:
Value Percent:
Step: **NO**
Remarks: **access MH**

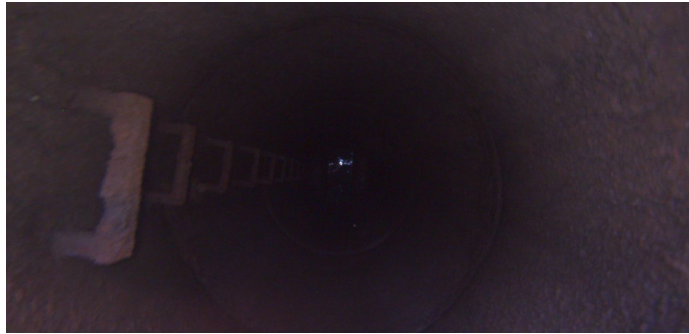
Code:	DAE
Description:	Deposits Attached Encrustation
Distance (ft):	.7
Structural Grade:	0
O&M Grade:	2
Clock Start/From:	12
Clock To:	12
1st Value:	
2nd Value:	
Value Percent:	5.000
Step:	NO
Remarks:

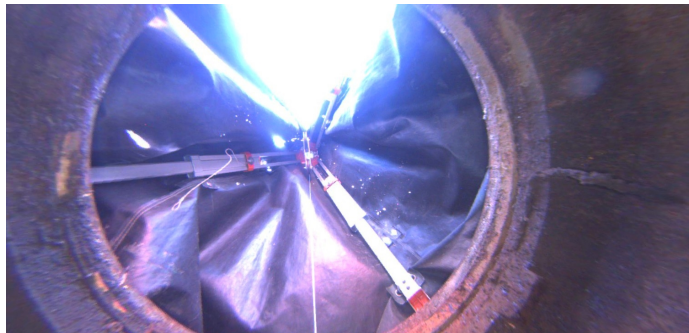
Code:	MGO
Description:	General Observation
Distance (ft):	1.5
Structural Grade:	0
O&M Grade:	0
Clock Start/From:	
Clock To:	
1st Value:	
2nd Value:	
Value Percent:	
Step:	NO
Remarks:	UNDERSIDE OF FRAME

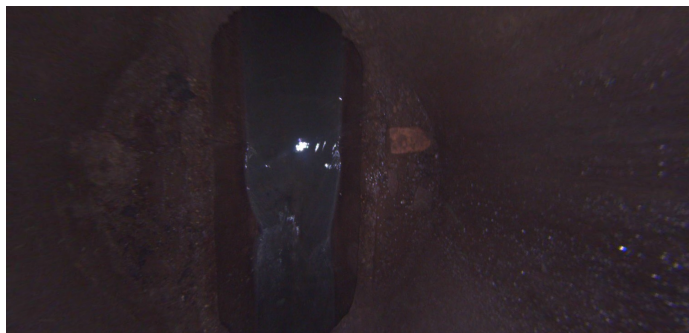
Code:	DSF
Description:	Deposits Settled Fine
Distance (ft):	16.2
Structural Grade:	0
O&M Grade:	2
Clock Start/From:	12
Clock To:	12
1st Value:	
2nd Value:	
Value Percent:	5.000
Step:	NO
Remarks:

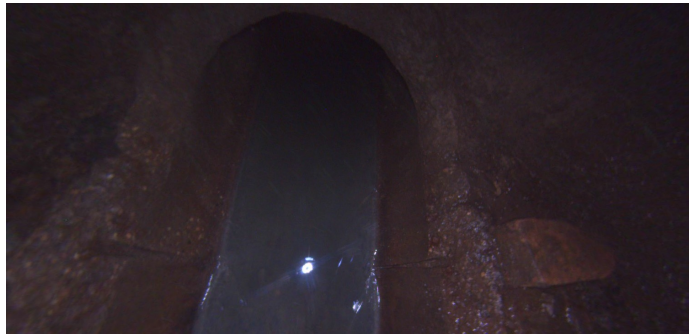
Code: **OBR**
Description: **Obstacle Rocks**

Distance (ft): **17.9**
Structural Grade: **0**
O&M Grade: **2**
Clock Start/From: **3**
Clock To:
1st Value:
2nd Value:
Value Percent: **5.000**
Step: **NO**
Remarks:

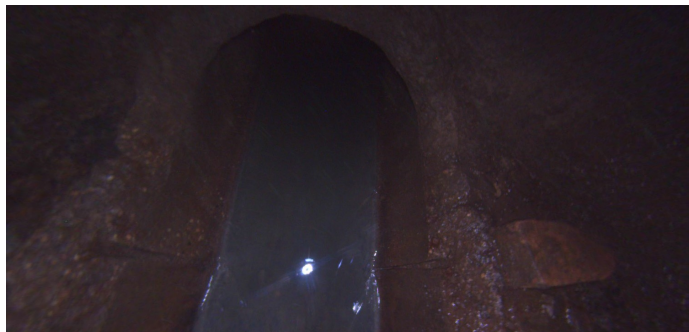
Code: **DAE**
Description: **Deposits Attached Encrustation**

Distance (ft): **17.9**
Structural Grade: **0**
O&M Grade: **2**
Clock Start/From: **12**
Clock To: **12**
1st Value:
2nd Value:
Value Percent: **5.000**
Step: **NO**
Remarks:

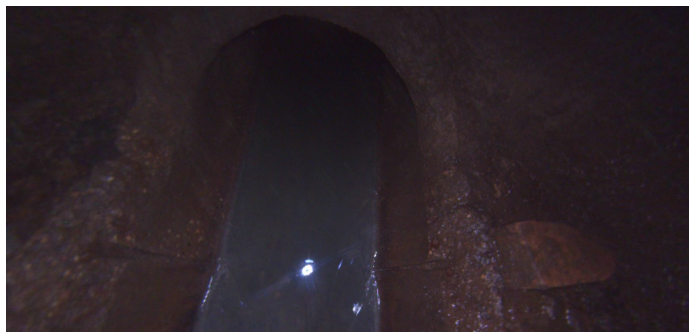
Code: **MGO**
Description: **General Observation**

Distance (ft): **17.9**
Structural Grade: **0**
O&M Grade: **0**
Clock Start/From:
Clock To:
1st Value:
2nd Value:
Value Percent:
Step: **NO**
Remarks: **END SURVEY**
