Manhole Inspection Report

Street:	Guyer St. 166' South of Old Ridge Rd	Project:	Hobart, IN
City:	Hobart, IN	GPS Northing:	2291894.046
Location:	Local Rural Streets	GPS Easting:	2899706.818
Drain Area:	West	GPS Accuracy:	Sub-Meter
Cover Shape:	Circular	Evidence of Surcharge:	No
Cover Size:	24.0	Potential for Runoff:	None
Comments:

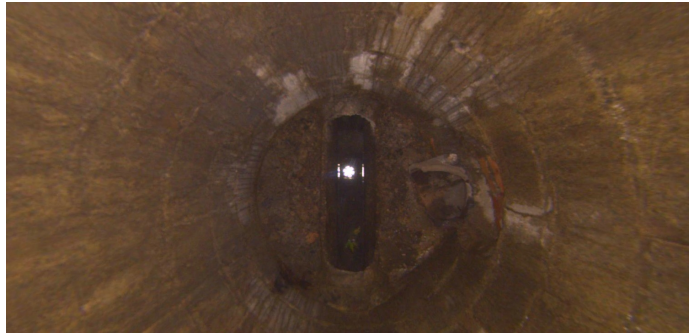
Code: **MMC**
Description: **Material Change**

Distance (ft): **1.6**
Structural Grade: **0**
O&M Grade: **0**
Clock Start/From:
Clock To:
1st Value:
2nd Value:
Value Percent:
Step: **NO**
Remarks: **concrete**

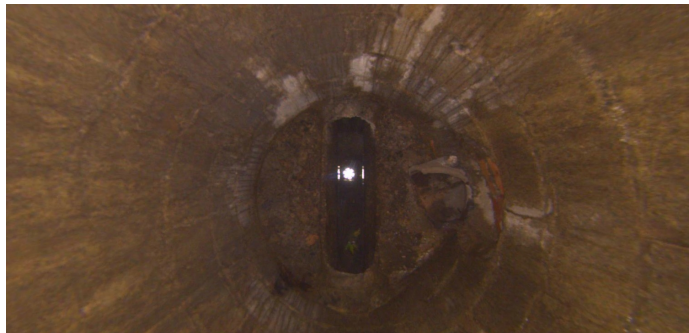
Code: **SRI**
Description: **Surface Roughness Increased**

Distance (ft): **1.6**
Structural Grade: **1**
O&M Grade: **0**
Clock Start/From: **12**
Clock To: **12**
1st Value:
2nd Value:
Value Percent:
Step: **NO**
Remarks:

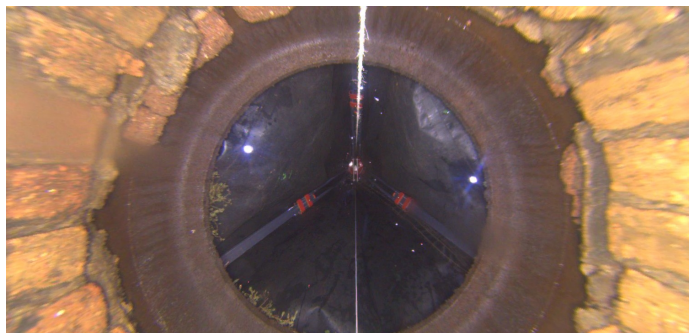
Code: **MGO**
Description: **General Observation**

Distance (ft): **1.6**
Structural Grade: **0**
O&M Grade: **0**
Clock Start/From:
Clock To:
1st Value:
2nd Value:
Value Percent:
Step: **NO**
Remarks: **underside of frame**

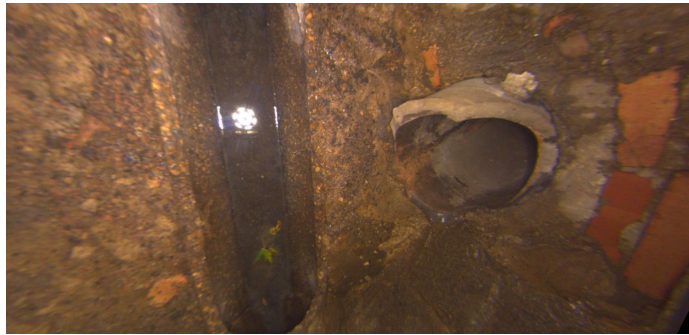
Code: **RPP**
Description: **Repair Patch**

Distance (ft): **4.6**
Structural Grade: **0**
O&M Grade: **0**
Clock Start/From: **3**
Clock To: **4**
1st Value:
2nd Value:
Value Percent:
Step: **NO**
Remarks: **brick**

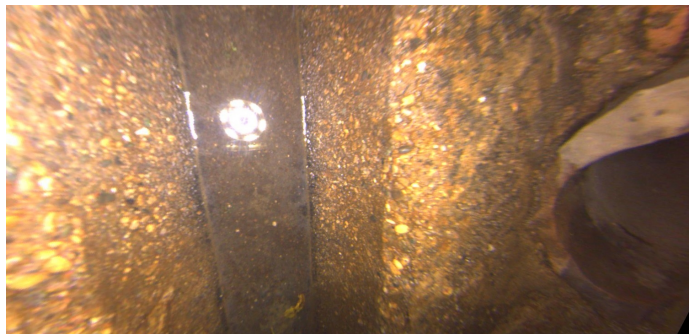
Code: **SAV**
Description: **Surface Aggregate Visible**

Distance (ft): **5.6**
Structural Grade: **3**
O&M Grade: **0**
Clock Start/From: **12**
Clock To: **12**
1st Value:
2nd Value:
Value Percent:
Step: **NO**
Remarks:

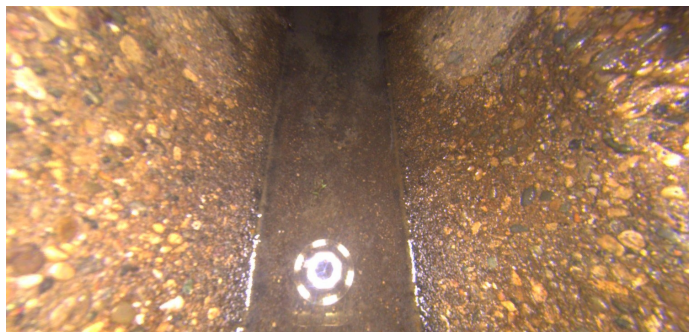
Code: **SAP**
Description: **Surface Aggregate Projecting**

Distance (ft): **6.0**
Structural Grade: **3**
O&M Grade: **0**
Clock Start/From: **3**
Clock To: **9**
1st Value:
2nd Value:
Value Percent:
Step: **NO**
Remarks:

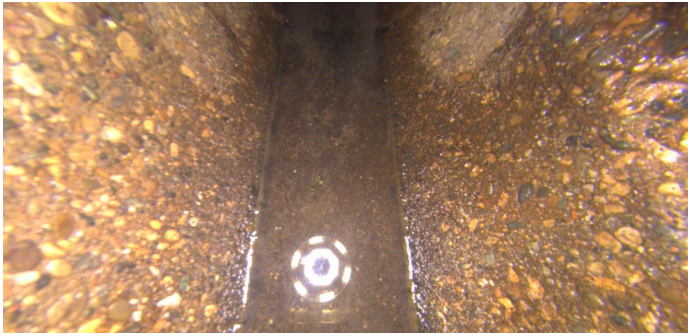
Code: **SRI**
Description: **Surface Roughness Increased**

Distance (ft): **6.0**
Structural Grade: **1**
O&M Grade: **0**
Clock Start/From: **12**
Clock To: **12**
1st Value:
2nd Value:
Value Percent:
Step: **NO**
Remarks:

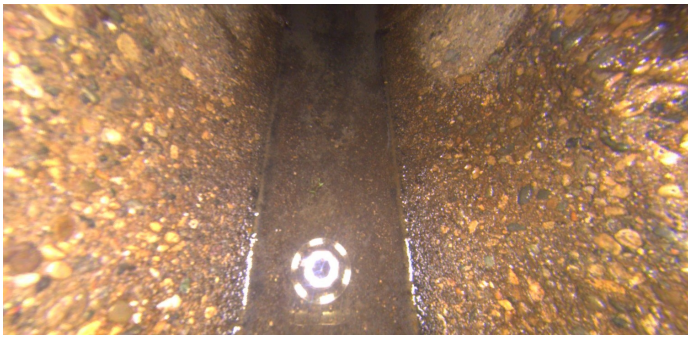
Code: **MGO**
Description: **General Observation**

Distance (ft): **6.0**
Structural Grade: **0**
O&M Grade: **0**
Clock Start/From:
Clock To:
1st Value:
2nd Value:
Value Percent:
Step: **NO**
Remarks: **end of survey**
