Manhole Inspection Report

Date:	05/14/2018	Weather:		Coding:	RZMACP
MH#:	M-504-069	Owner:	NA	Len. Surveyed:	12.2
P.O.#:		Surveyor:	Jen Costello	Rim to Invert:	12.2
Customer:		Cert. #:	U-907-5518	Wall Material:	Brick

Street:	California St. 166' North of Ridge Rd.	Project:	Hobart, IN
City:	Hobart, IN	GPS Northing:	2901474.717
Location:		GPS Easting:	2901474.717
Drain Area:	Northwest	GPS Accuracy:	Sub-Meter
Cover Shape:	Circular	Evidence of Surcharge:	No
Cover Size:	22.5	Potential for Runoff:	None
Comments:

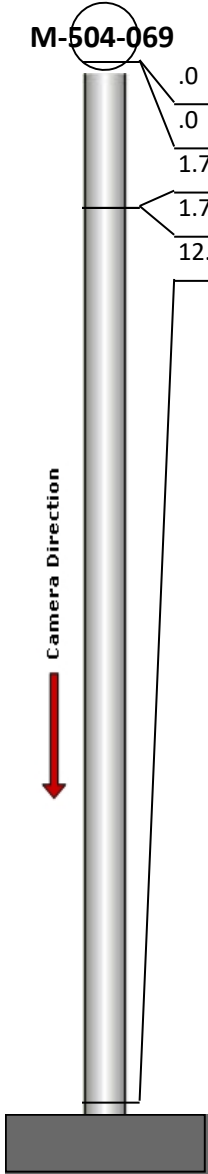
M-504-069				
	.0	MGP	General Photo	10	NA
	.0	MMM	Mortar Missing Medium	22	S 3
	1.7	MGO	General Observation	39	NA
	1.7	MGO	General Observation	52	NA
	12.2	MGO	General Observation	85	NA

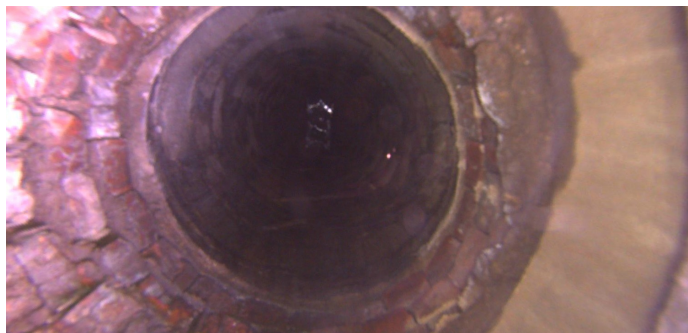
Code: **MGP**
Description: **General Photo**

Distance (ft): **.0**
Structural Grade: **0**
O&M Grade: **0**
Clock Start/From:
Clock To:
1st Value:
2nd Value:
Value Percent:
Step: **NO**
Remarks: **ACCESS MH**

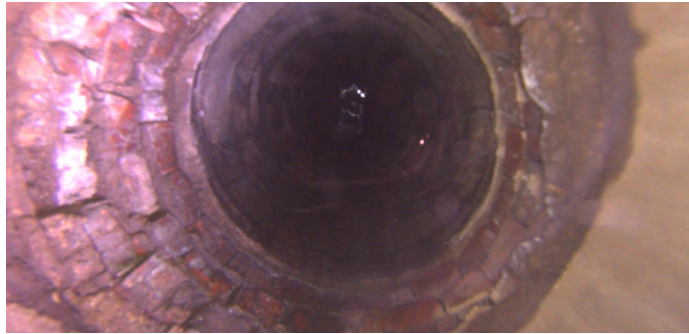
Code: **MMM**
Description: **Mortar Missing Medium**

Distance (ft): **.0**
Structural Grade: **3**
O&M Grade: **0**
Clock Start/From: **8**
Clock To:
1st Value:
2nd Value:
Value Percent:
Step: **NO**
Remarks:

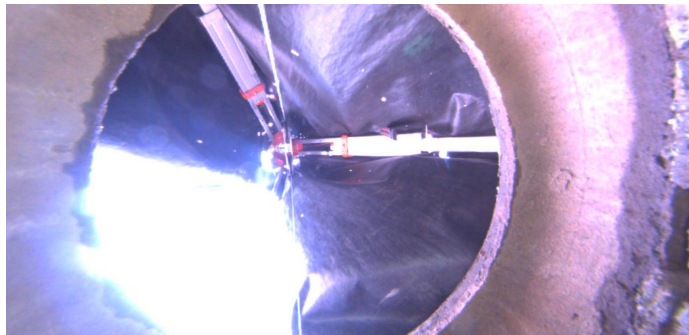
Code: **MGO**
Description: **General Observation**

Distance (ft): **1.7**
Structural Grade: **0**
O&M Grade: **0**
Clock Start/From:
Clock To:
1st Value:
2nd Value:
Value Percent:
Step: **NO**
Remarks: **UNDERSIDE OF FRAME**

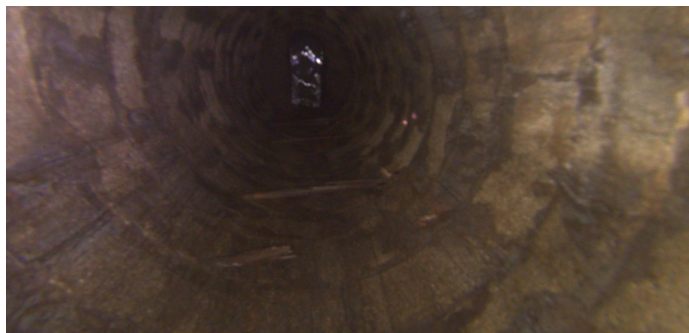
Code: **MGO**
Description: **General Observation**

Distance (ft): **1.7**
Structural Grade: **0**
O&M Grade: **0**
Clock Start/From:
Clock To:
1st Value:
2nd Value:
Value Percent:
Step: **NO**
Remarks: **BROKEN STEP**

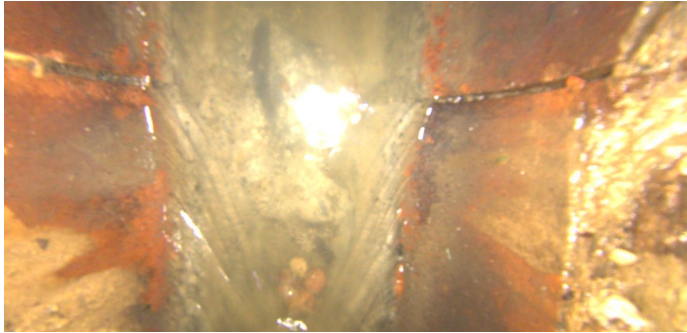
Code:	MGO
Description:	General Observation
Distance (ft):	12.2
Structural Grade:	0
O&M Grade:	0
Clock Start/From:	
Clock To:	
1st Value:	
2nd Value:	
Value Percent:	
Step:	NO
Remarks:	END SURVEY
