Manhole Inspection Report

Date:	05/15/2018	Weather:		Coding:	RZMACP
MH#:	M-504-072	Owner:	NA	Len. Surveyed:	14.1
P.O.#:		Surveyor:	Jen Costello	Rim to Invert:	15.7
Customer:		Cert. #:	U-907-5518	Wall Material:	Brick

Street:	167' North of Ridge Rd. 170' East of	Project:	Hobart, IN
City:	Hobart, IN	GPS Northing:	41.54039383
Location:		GPS Easting:	-87.27236176
Drain Area:	Northwest	GPS Accuracy:	Nearest Meter
Cover Shape:	Circular	Evidence of Surcharge:	No
Cover Size:	22.5	Potential for Runoff:	None
Comments:

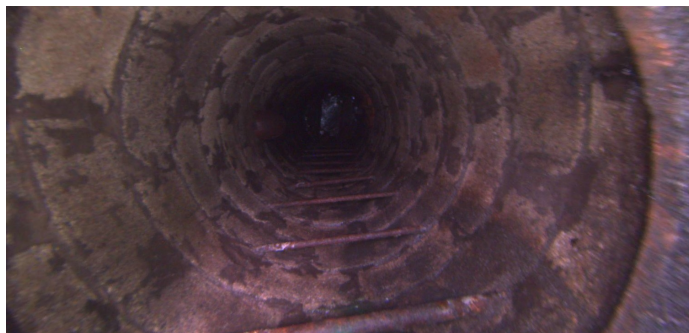
Code: **MGO**
Description: **General Observation**

Distance (ft): **.0**
Structural Grade: **0**
O&M Grade: **0**
Clock Start/From:
Clock To:
1st Value:
2nd Value:
Value Percent:
Step: **NO**
Remarks: **ACCESS MH**

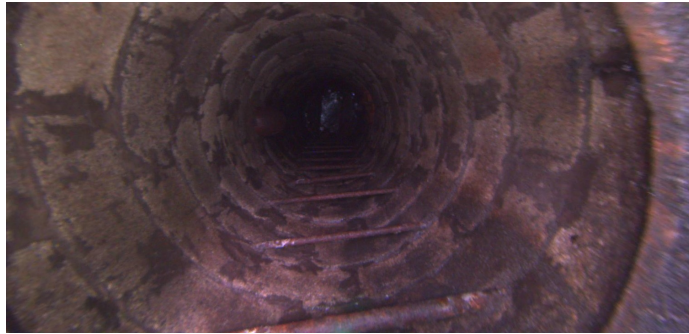
Code:	SAV
Description:	Surface Aggregate Visible
Distance (ft):	.0
Structural Grade:	3
O&M Grade:	0
Clock Start/From:	12
Clock To:	12
1st Value:	
2nd Value:	
Value Percent:	
Step:	NO
Remarks:

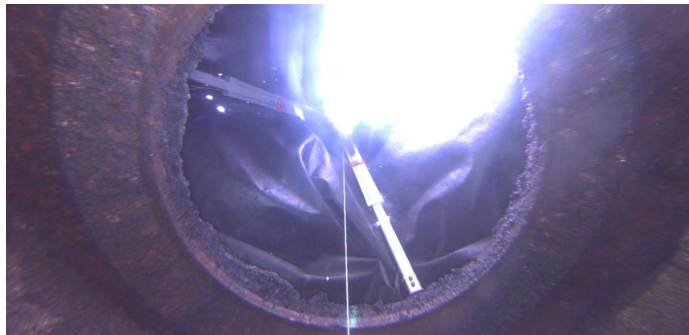
Code:	MGO
Description:	General Observation
Distance (ft):	1.7
Structural Grade:	0
O&M Grade:	0
Clock Start/From:	
Clock To:	
1st Value:	
2nd Value:	
Value Percent:	
Step:	NO
Remarks:	UNDERSIDE OF FRAME

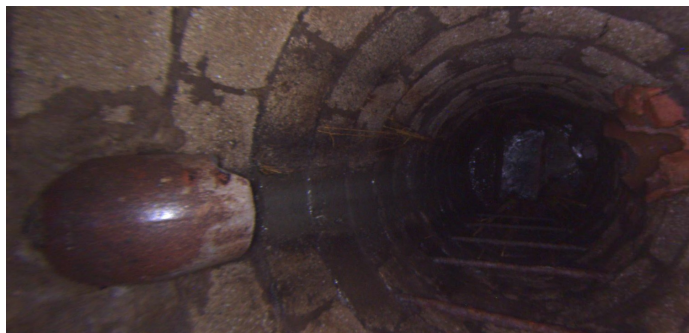
Code:	OBP
Description:	Obstacle External Pipe or Cable
Distance (ft):	5.8
Structural Grade:	0
O&M Grade:	2
Clock Start/From:	9
Clock To:	
1st Value:	
2nd Value:	
Value Percent:	10.000
Step:	NO
Remarks:

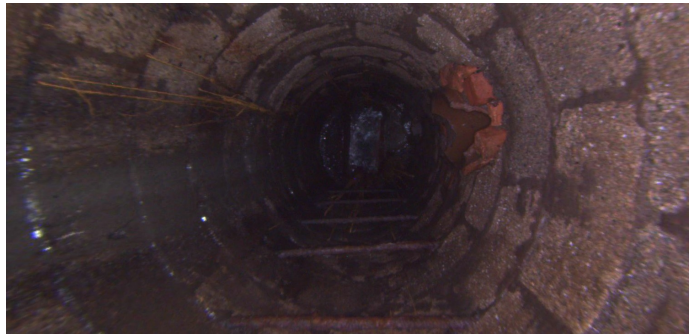
Code: **RFB**
Description: **Roots Fine Barrel**

Distance (ft): **6.5**
Structural Grade: **0**
O&M Grade: **2**
Clock Start/From: **10**
Clock To: **11**
1st Value:
2nd Value:
Value Percent:
Step: **NO**
Remarks:

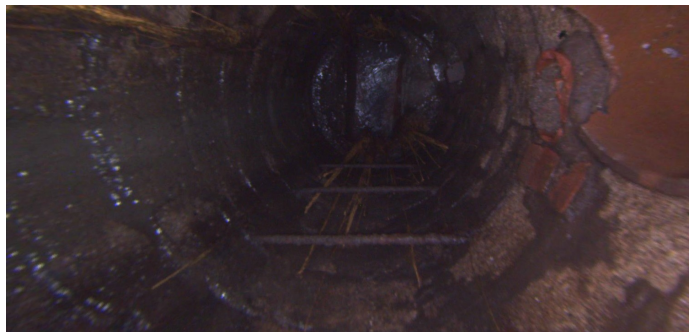
Code: **RFB**
Description: **Roots Fine Barrel**

Distance (ft): **8.9**
Structural Grade: **0**
O&M Grade: **2**
Clock Start/From: **5**
Clock To: **7**
1st Value:
2nd Value:
Value Percent:
Step: **NO**
Remarks:

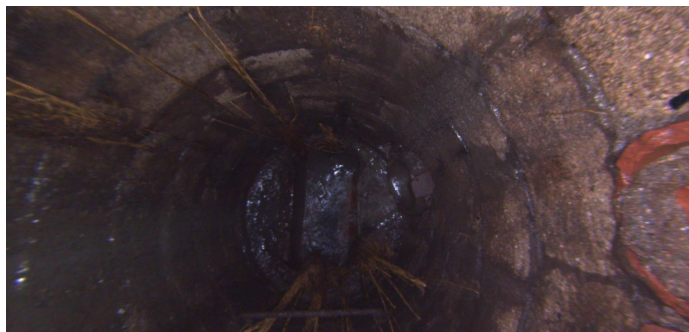
Code: **RFB**
Description: **Roots Fine Barrel**

Distance (ft): **10.2**
Structural Grade: **0**
O&M Grade: **2**
Clock Start/From: **10**
Clock To: **12**
1st Value:
2nd Value:
Value Percent:
Step: **NO**
Remarks:

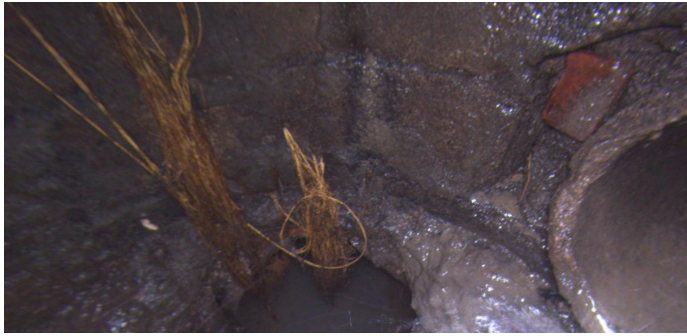
Code: **RFB**
Description: **Roots Fine Barrel**

Distance (ft): **14.0**
Structural Grade: **0**
O&M Grade: **2**
Clock Start/From: **12**
Clock To: **1**
1st Value:
2nd Value:
Value Percent:
Step: **NO**
Remarks:

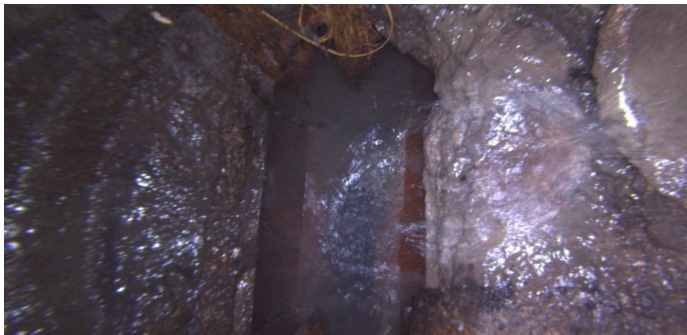
Code: **DSF**
Description: **Deposits Settled Fine**

Distance (ft): **14.0**
Structural Grade: **0**
O&M Grade: **2**
Clock Start/From: **12**
Clock To: **12**
1st Value:
2nd Value:
Value Percent: **5.000**
Step: **NO**
Remarks:

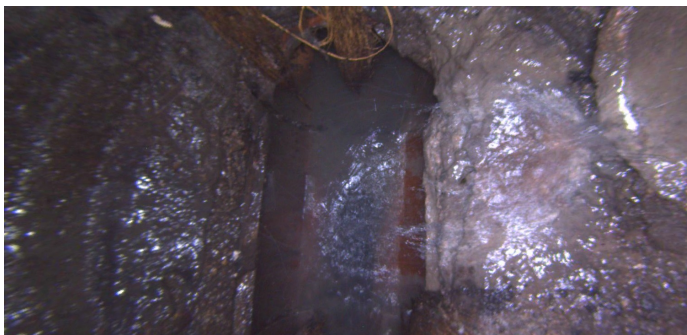
Code: **RFB**
Description: **Roots Fine Barrel**

Distance (ft): **14.1**
Structural Grade: **0**
O&M Grade: **2**
Clock Start/From: **5**
Clock To: **7**
1st Value:
2nd Value:
Value Percent:
Step: **NO**
Remarks:

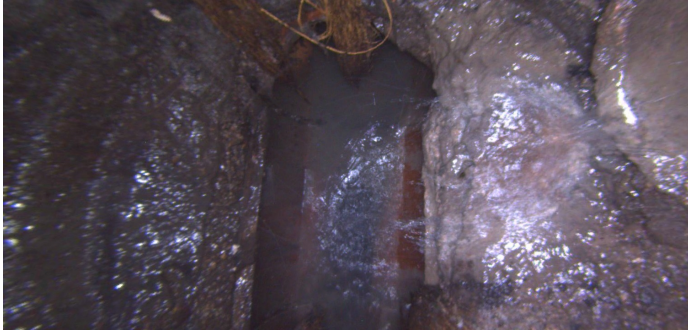
Code: **SAV**
Description: **Surface Aggregate Visible**

Distance (ft): **14.1**
Structural Grade: **3**
O&M Grade: **0**
Clock Start/From: **12**
Clock To: **12**
1st Value:
2nd Value:
Value Percent:
Step: **NO**
Remarks:

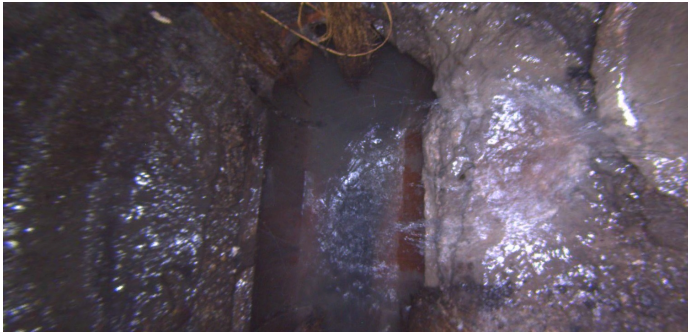
Code: **MGO**
Description: **General Observation**

Distance (ft): **14.1**
Structural Grade: **0**
O&M Grade: **0**
Clock Start/From:
Clock To:
1st Value:
2nd Value:
Value Percent:
Step: **NO**
Remarks: **END SURVEY**
