Manhole Inspection Report

Date:	05/15/2018	Weather:		Coding:	RZMACP
MH#:	M-504-073	Owner:	NA	Len. Surveyed:	16.6
P.O.#:		Surveyor:	Jen Costello	Rim to Invert:	16.8
Customer:		Cert. #:	U-907-5518	Wall Material:	Brick

Street:	Delaware St. 168' North of Ridge Rd.	Project:	Hobart, IN
City:	Hobart, IN	GPS Northing:	41.54050827
Location:		GPS Easting:	-87.2730484
Drain Area:	Northwest	GPS Accuracy:	Nearest Meter
Cover Shape:	Circular	Evidence of Surcharge:	No
Cover Size:	22.5	Potential for Runoff:	None
Comments:

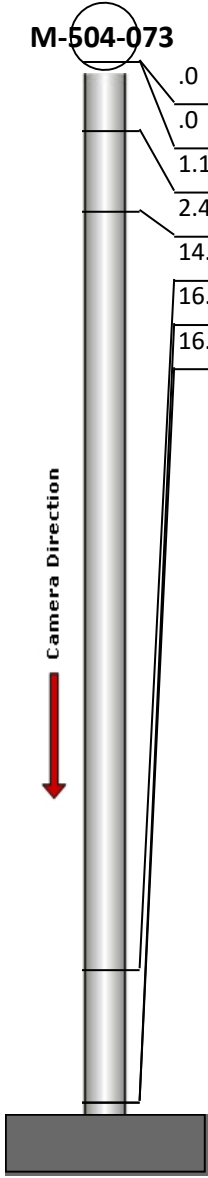
.0	MGO	General Observation	10	NA
	.0	DAE	Deposits Attached Encrustation	21	M 2
	1.1	SAV	Surface Aggregate Visible	35	S 3
	2.4	MGO	General Observation	51	NA
	14.5	DSC	Deposits Settled Compacted	89	M 2
	16.6	MGO	General Observation	105	NA
	16.6	SAV	Surface Aggregate Visible	116	S 3

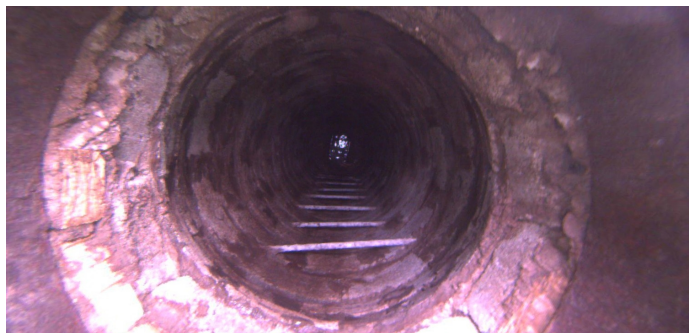
Code: **MGO**
Description: **General Observation**

Distance (ft): **.0**
Structural Grade: **0**
O&M Grade: **0**
Clock Start/From:
Clock To:
1st Value:
2nd Value:
Value Percent:
Step: **NO**
Remarks: **ACCESS MH**

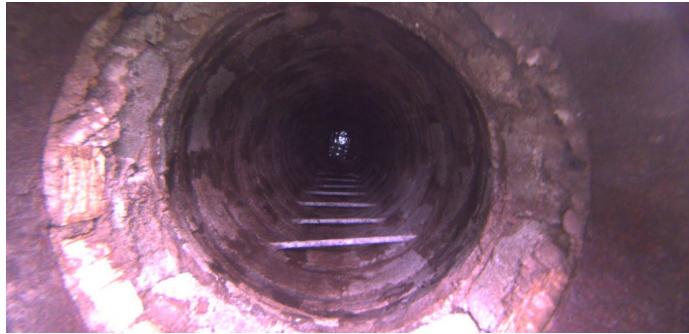
Code:	DAE
Description:	Deposits Attached Encrustation
Distance (ft):	.0
Structural Grade:	0
O&M Grade:	2
Clock Start/From:	12
Clock To:	12
1st Value:	
2nd Value:	
Value Percent:	10.000
Step:	NO
Remarks:

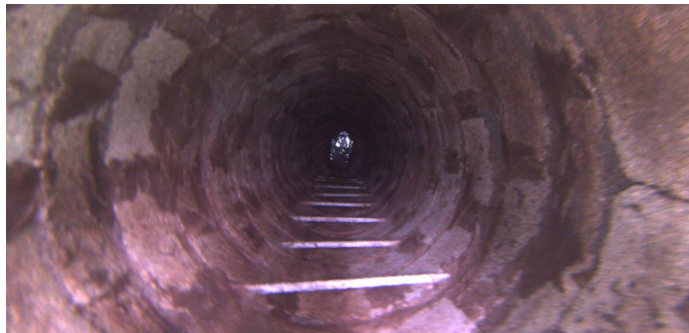
Code:	SAV
Description:	Surface Aggregate Visible
Distance (ft):	1.1
Structural Grade:	3
O&M Grade:	0
Clock Start/From:	12
Clock To:	12
1st Value:	
2nd Value:	
Value Percent:	
Step:	NO
Remarks:

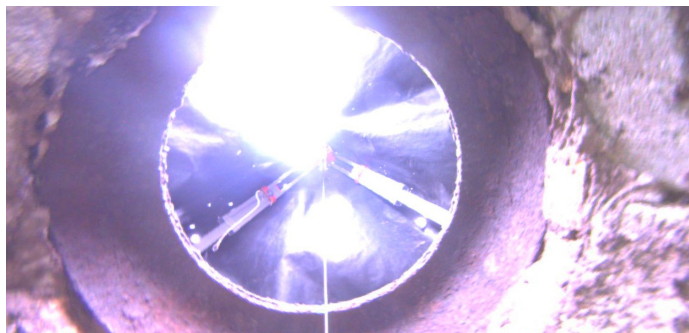
Code:	MGO
Description:	General Observation
Distance (ft):	2.4
Structural Grade:	0
O&M Grade:	0
Clock Start/From:	
Clock To:	
1st Value:	
2nd Value:	
Value Percent:	
Step:	NO
Remarks:	UNDERSIDE OF FRAME

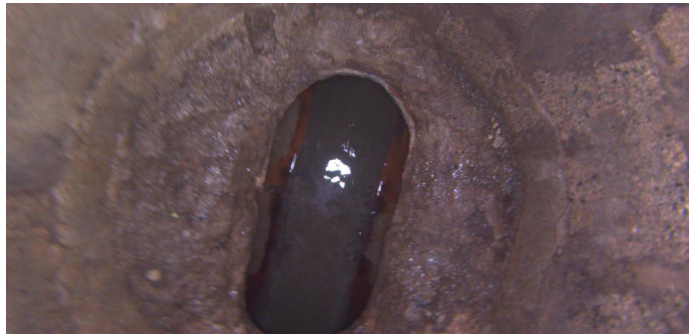
Code: **DSC**
Description: **Deposits Settled Compacted**

Distance (ft): **14.5**
Structural Grade: **0**
O&M Grade: **2**
Clock Start/From: **12**
Clock To: **12**
1st Value:
2nd Value:
Value Percent: **10.000**
Step: **NO**
Remarks:

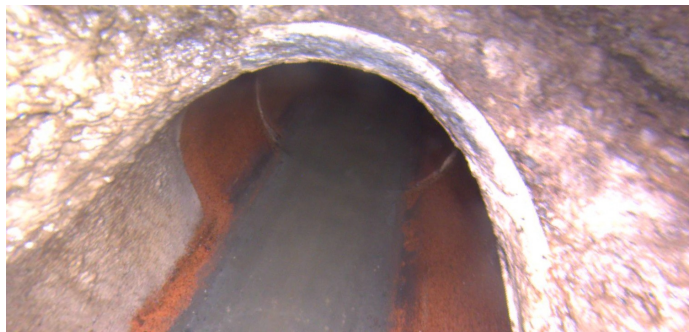
Code: **MGO**
Description: **General Observation**

Distance (ft): **16.6**
Structural Grade: **0**
O&M Grade: **0**
Clock Start/From:
Clock To:
1st Value:
2nd Value:
Value Percent:
Step: **NO**
Remarks: **END SURVEY**

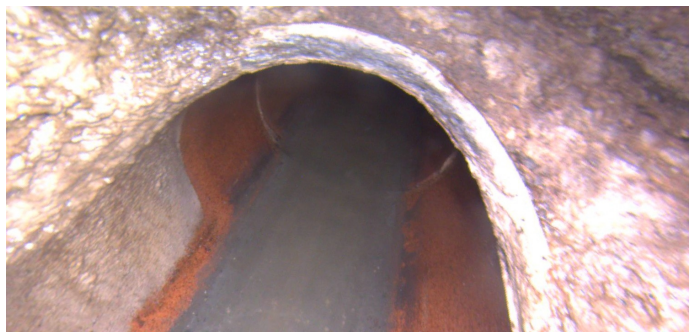
Code: **SAV**
Description: **Surface Aggregate Visible**

Distance (ft): **16.6**
Structural Grade: **3**
O&M Grade: **0**
Clock Start/From: **12**
Clock To: **12**
1st Value:
2nd Value:
Value Percent:
Step: **NO**
Remarks:
