# Manhole Inspection Report

Date:	05/15/2018	Weather:		Coding:	RZMACP
MH#:	M-504-076	Owner:	NA	Len. Surveyed:	15.0
P.O.#:		Surveyor:	Jen Costello	Rim to Invert:	15.2
Customer:		Cert. #:	U-907-5518	Wall Material:	Concrete (reinforced)

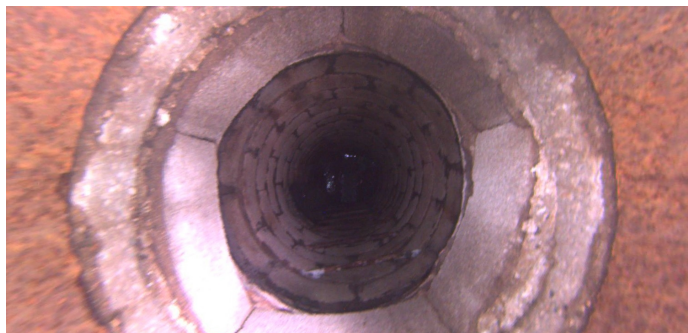
Code: **MGO**  
Description: **General Observation**

Distance (ft): **.0**  
Structural Grade: **0**  
O&M Grade: **0**  
Clock Start/From:  
Clock To:  
1st Value:  
2nd Value:  
Value Percent:  
Step: **NO**  
Remarks: **ACCESS MH**

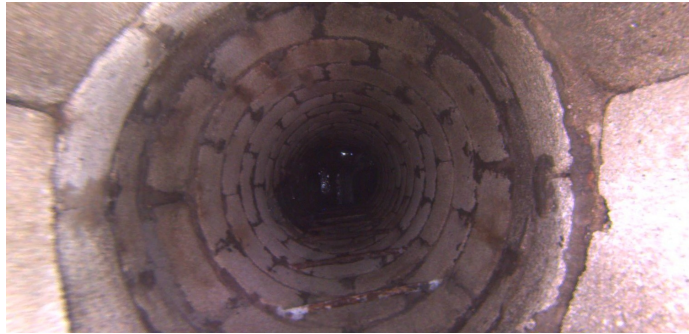
Code: **SRI**  
Description: **Surface Roughness Increased**

Distance (ft): **1.1**  
Structural Grade: **1**  
O&M Grade: **0**  
Clock Start/From: **12**  
Clock To: **12**  
1st Value:  
2nd Value:  
Value Percent:  
Step: **NO**  
Remarks:

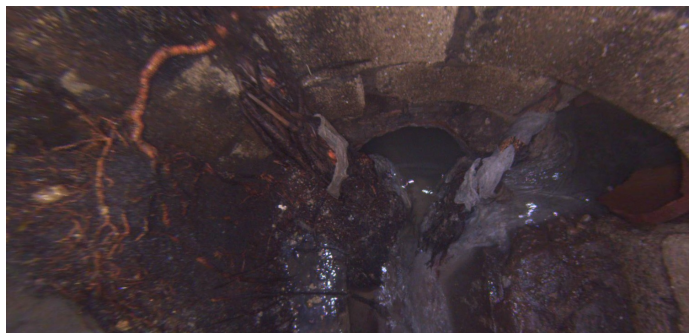
Code: **RMB**  
Description: **Roots Medium Barrel**

Distance (ft): **12.8**  
Structural Grade: **0**  
O&M Grade: **4**  
Clock Start/From: **9**  
Clock To: **10**  
1st Value:  
2nd Value:  
Value Percent: **10.000**  
Step: **NO**  
Remarks:
