# Manhole Inspection Report

Date:	10/09/2022	Weather:		Coding:	RZMACP
MH#:	M-504-085	Owner:	NA	Len. Surveyed:	8.9
P.O.#:		Surveyor:	Jen Costello	Rim to Invert:	9.8
Customer:		Cert. #:	U-907-5518	Wall Material:	Concrete (non-reinforced)

Street:	167' East of California St. 50' South	Project:	Hobart, IN
City:	Hobart, IN	GPS Northing:	2293060.09
Location:	Other	GPS Easting:	2901643.362
Drain Area:	Northwest	GPS Accuracy:	Sub-Meter
Cover Shape:	Circular	Evidence of Surcharge:	
Cover Size:	24.0	Potential for Runoff:	
Comments:

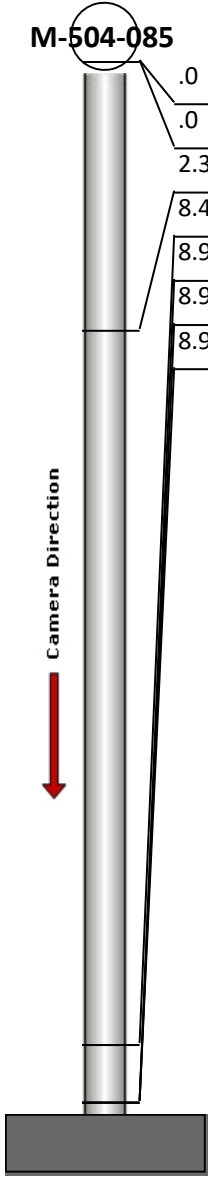
.0	MGO	General Observation	10	NA
	.0	SRI	Surface Roughness Increased	21	S 1
	2.3	MGO	General Observation	39	NA
	8.4	DSF	Deposits Settled Fine	65	M 2
	8.9	DSF	Deposits Settled Fine	78	M 5
	8.9	SRI	Surface Roughness Increased	89	S 1
	8.9	MGO	General Observation	100	NA

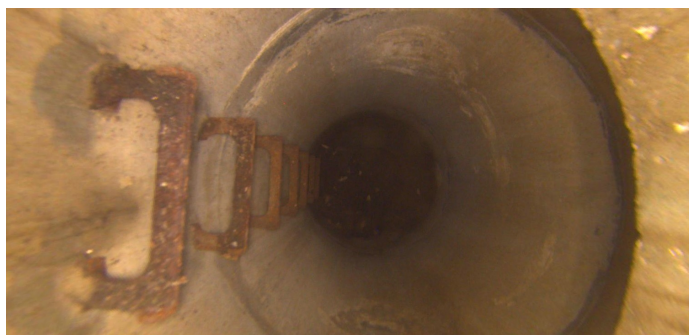
Code: **MGO**  
Description: **General Observation**

Distance (ft): **.0**  
Structural Grade: **0**  
O&M Grade: **0**  
Clock Start/From:  
Clock To:  
1st Value:  
2nd Value:  
Value Percent:  
Step: **NO**  
Remarks: **access mh**

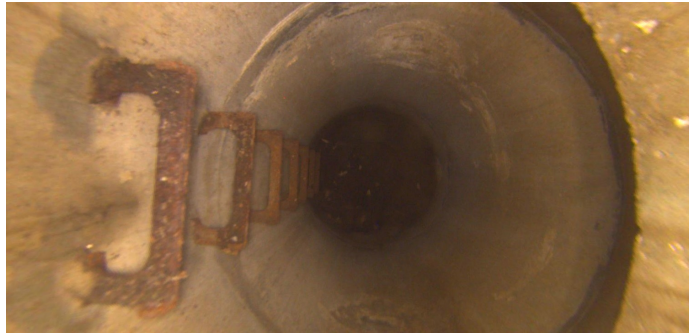
Code: **SRI**  
Description: **Surface Roughness Increased**

Distance (ft): **.0**  
Structural Grade: **1**  
O&M Grade: **0**  
Clock Start/From: **12**  
Clock To: **12**  
1st Value:  
2nd Value:  
Value Percent:  
Step: **NO**  
Remarks:

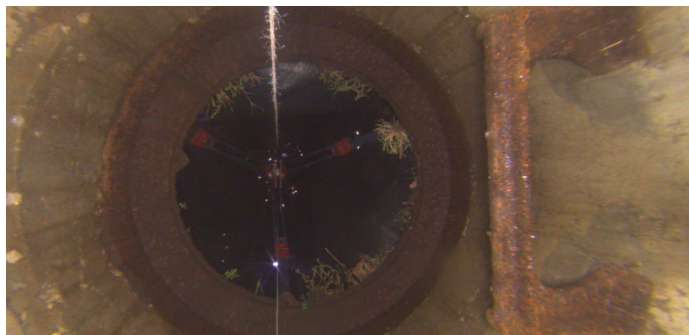
Code: **MGO**  
Description: **General Observation**

Distance (ft): **2.3**  
Structural Grade: **0**  
O&M Grade: **0**  
Clock Start/From:  
Clock To:  
1st Value:  
2nd Value:  
Value Percent:  
Step: **NO**  
Remarks: **underside of frame**

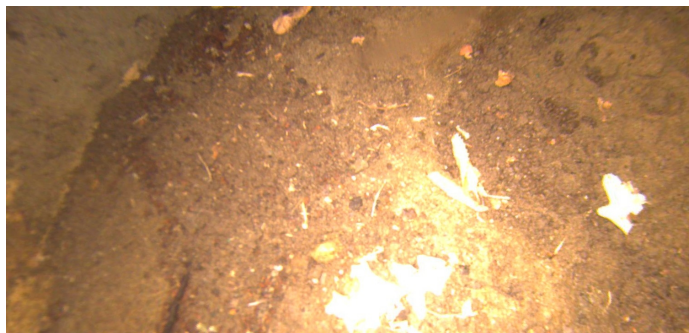
Code: **DSF**  
Description: **Deposits Settled Fine**

Distance (ft): **8.4**  
Structural Grade: **0**  
O&M Grade: **2**  
Clock Start/From: **12**  
Clock To: **12**  
1st Value:  
2nd Value:  
Value Percent: **5.000**  
Step: **NO**  
Remarks:

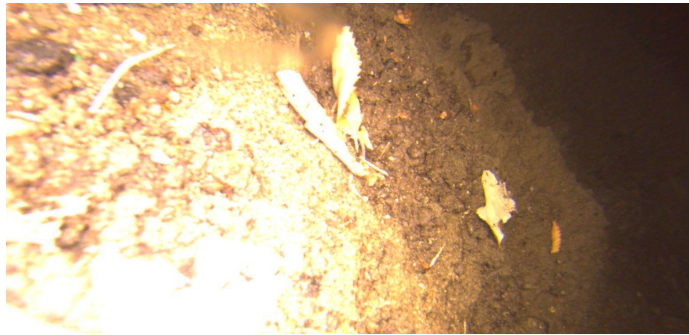
Code: **DSF**  
Description: **Deposits Settled Fine**

Distance (ft): **8.9**  
Structural Grade: **0**  
O&M Grade: **5**  
Clock Start/From: **4**  
Clock To: **8**  
1st Value:  
2nd Value:  
Value Percent: **40.000**  
Step: **NO**  
Remarks:

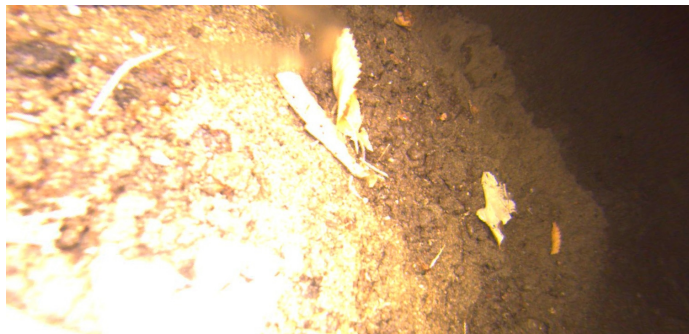
Code: **SRI**  
Description: **Surface Roughness Increased**

Distance (ft): **8.9**  
Structural Grade: **1**  
O&M Grade: **0**  
Clock Start/From: **12**  
Clock To: **12**  
1st Value:  
2nd Value:  
Value Percent:  
Step: **NO**  
Remarks:

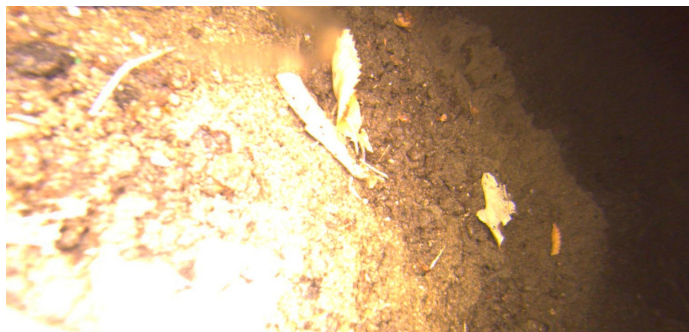
Code: **MGO**  
Description: **General Observation**

Distance (ft): **8.9**  
Structural Grade: **0**  
O&M Grade: **0**  
Clock Start/From:  
Clock To:  
1st Value:  
2nd Value:  
Value Percent:  
Step: **NO**  
Remarks: **end of survey**
