Manhole Inspection Report

O&M Index:	0.00	O&M Quick:	0000	O&M Rating:	0.00
Structural Index:	0.00	Structural Quick:	0000	Structural Rating:	0.00
Overall Index:	0.00	Overall Quick:	0000	Overall Rating:	0.00

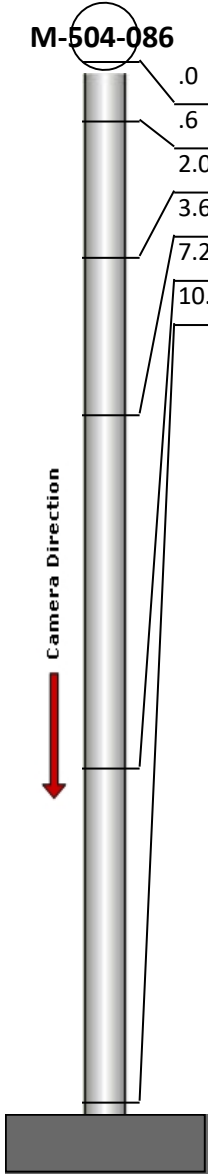
.0	MGO	General Observation	10	NA
	.6	IS	Infil Stain	23	NA
	2.0	MGO	General Observation	39	NA
	3.6	IS	Infil Stain	56	NA
	7.2	IS	Infil Stain	74	NA
	10.6	MGO	General Observation	93	NA

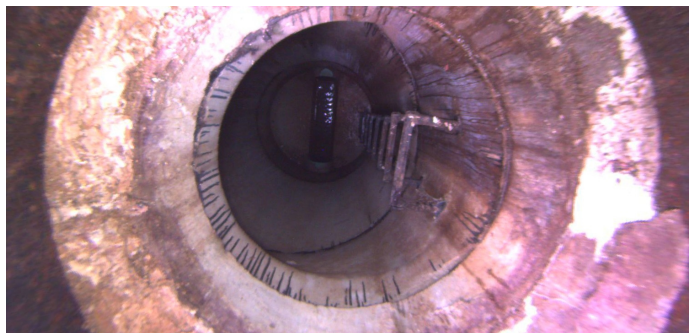
Code: **MGO**
Description: **General Observation**

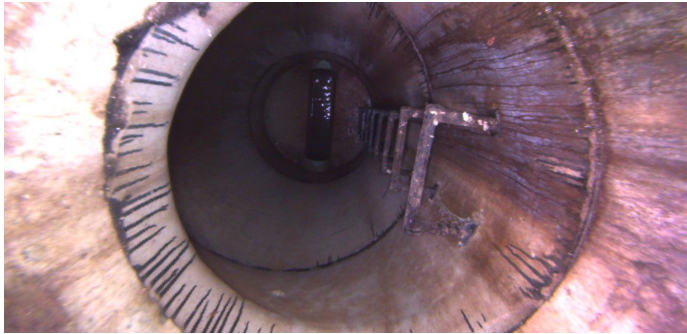
Code: **IS**
Description: **Infil Stain**

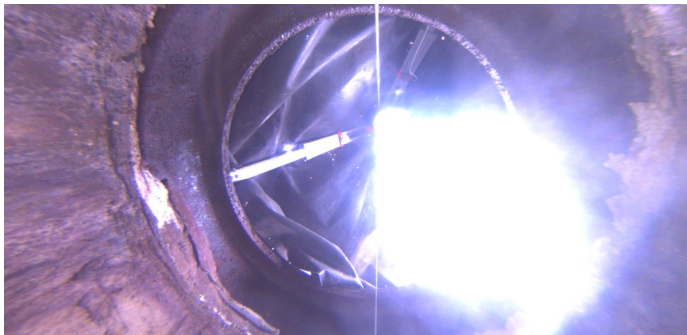
Code: **MGO**
Description: **General Observation**

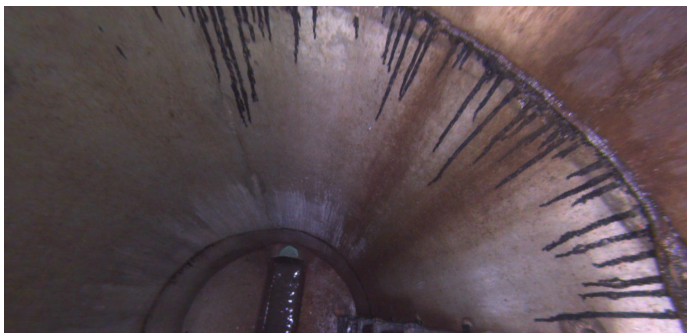
Code: **IS**
Description: **Infil Stain**

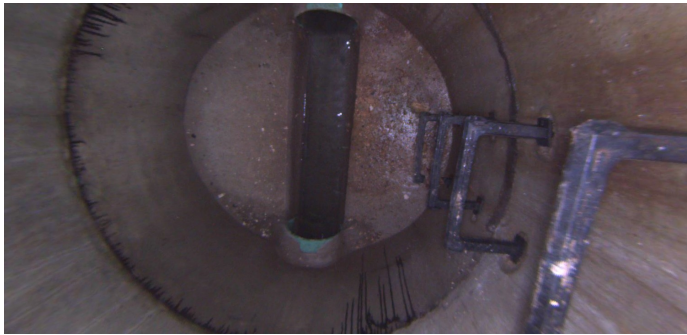
Code: **IS**
Description: **Infil Stain**

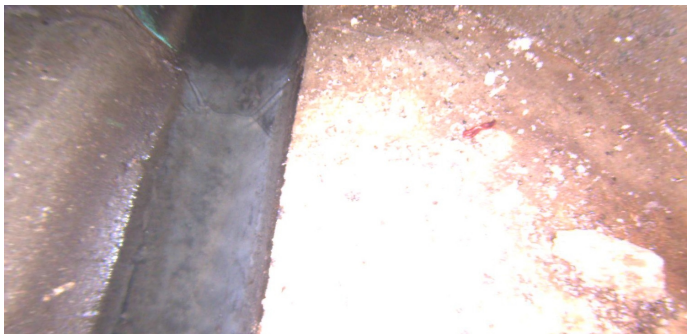
Code: **MGO**
Description: **General Observation**
