Manhole Inspection Report

Date:	05/15/2018	Weather:		Coding:	RZMACP
MH#:	M-504-089	Owner:	NA	Len. Surveyed:	11.0
P.O.#:		Surveyor:	Jen Costello	Rim to Invert:	11.2
Customer:		Cert. #:	U-907-5518	Wall Material:	Concrete (reinforced)

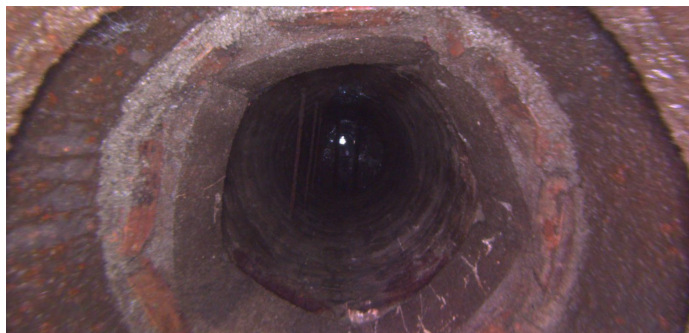
Code: **MGO**
Description: **General Observation**

Distance (ft): **.0**
Structural Grade: **0**
O&M Grade: **0**
Clock Start/From:
Clock To:
1st Value:
2nd Value:
Value Percent:
Step: **NO**
Remarks: **ACCESS MH**

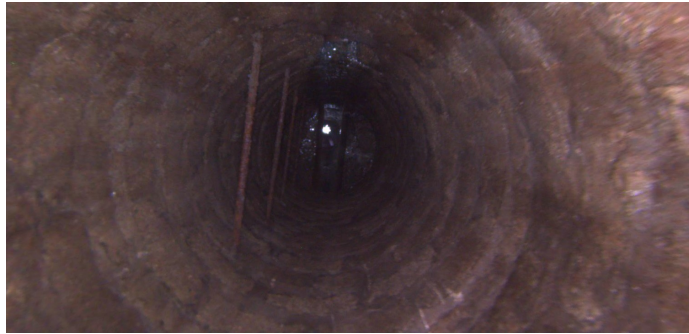
Code: **SAV**
Description: **Surface Aggregate Visible**

Distance (ft): **2.3**
Structural Grade: **3**
O&M Grade: **0**
Clock Start/From: **12**
Clock To: **12**
1st Value:
2nd Value:
Value Percent:
Step: **NO**
Remarks:

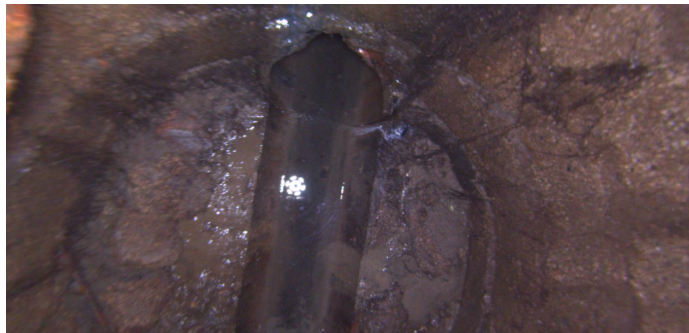
Code: **RFB**
Description: **Roots Fine Barrel**

Distance (ft): **9.3**
Structural Grade: **0**
O&M Grade: **2**
Clock Start/From: **9**
Clock To: **3**
1st Value:
2nd Value:
Value Percent:
Step: **NO**
Remarks:

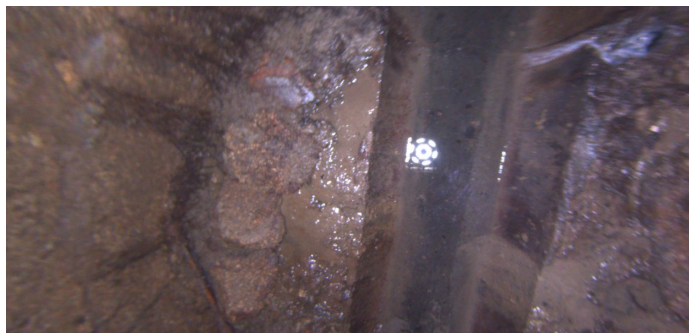
Code: **OBR**
Description: **Obstacle Rocks**

Distance (ft): **10.1**
Structural Grade: **0**
O&M Grade: **2**
Clock Start/From: **8**
Clock To: **10**
1st Value:
2nd Value:
Value Percent: **10.000**
Step: **NO**
Remarks:

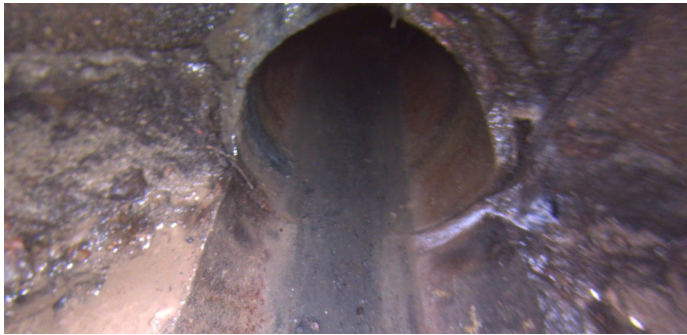
Code: **MGO**
Description: **General Observation**

Distance (ft): **11.0**
Structural Grade: **0**
O&M Grade: **0**
Clock Start/From:
Clock To:
1st Value:
2nd Value:
Value Percent:
Step: **NO**
Remarks: **END SURVEY**

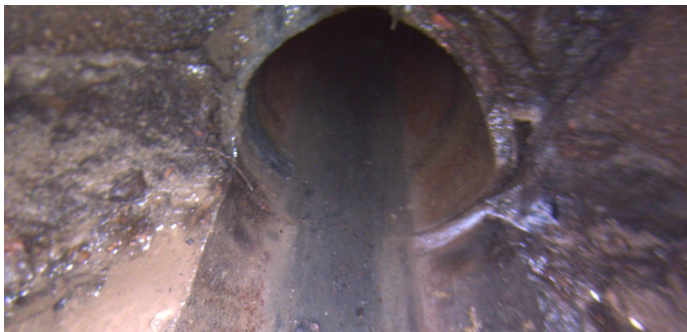
Code: **SAV**
Description: **Surface Aggregate Visible**

Distance (ft): **11.0**
Structural Grade: **3**
O&M Grade: **0**
Clock Start/From: **12**
Clock To: **12**
1st Value:
2nd Value:
Value Percent:
Step: **NO**
Remarks:
