Manhole Inspection Report

Date:	05/15/2018	Weather:		Coding:	RZMACP
MH#:	M-504-108	Owner:	NA	Len. Surveyed:	7.0
P.O.#:		Surveyor:	Jen Costello	Rim to Invert:	7.9
Customer:		Cert. #:	U-907-5518	Wall Material:	Brick

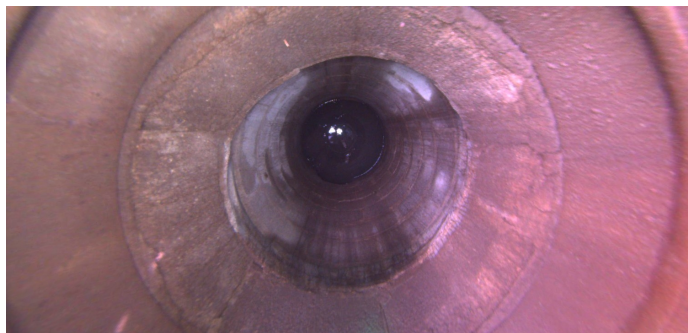
Code: **MGO**
Description: **General Observation**

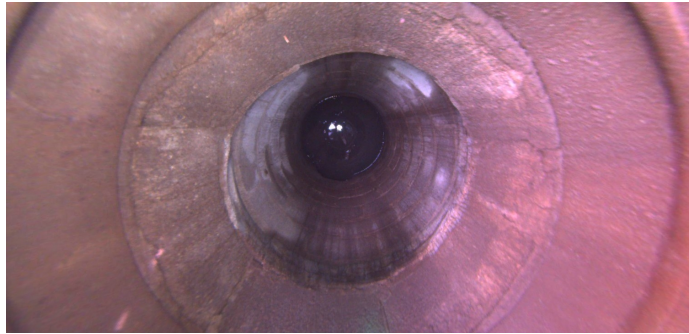
Code: **FM**
Description: **Fracture Multiple**

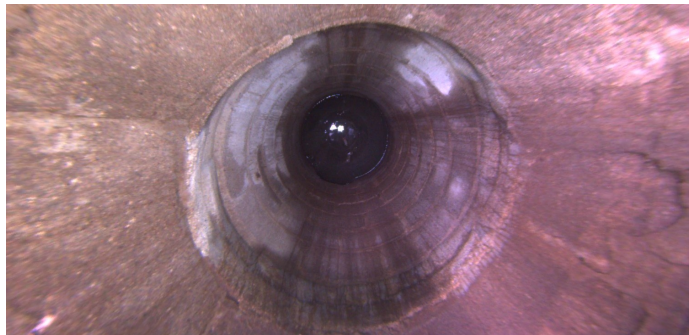
Code: **SAV**
Description: **Surface Aggregate Visible**
