Manhole Inspection Report

Date:	05/15/2018	Weather:		Coding:	RZMACP
MH#:	M-504-117	Owner:	NA	Len. Surveyed:	9.7
P.O.#:		Surveyor:	Jen Costello	Rim to Invert:	9.8
Customer:		Cert. #:	U-907-5518	Wall Material:	Brick

Street:	42nd Ave. 165' East of Cavender St.	Project:	Hobart, IN
City:	Hobart, IN	GPS Northing:	41.54184723
Location:		GPS Easting:	-87.27533722
Drain Area:	Northwest	GPS Accuracy:	Nearest Meter
Cover Shape:	Circular	Evidence of Surcharge:	No
Cover Size:	22.5	Potential for Runoff:	None
Comments:

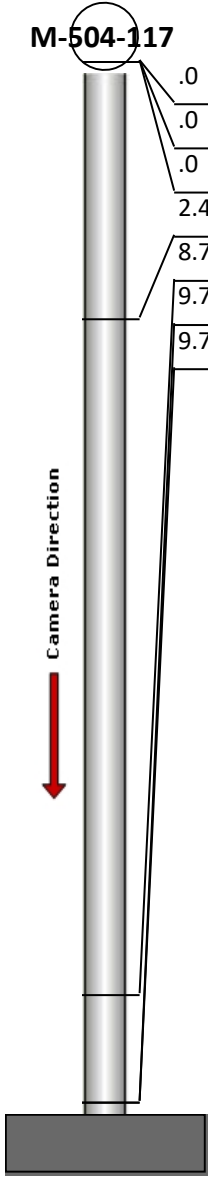
.0	MGO	General Observation	10	NA
	.0	RFJ	Roots Fine Joint	21	M 1
	.0	SAV	Surface Aggregate Visible	32	S 3
	2.4	MGO	General Observation	50	NA
	8.7	DSF	Deposits Settled Fine	76	M 2
	9.7	MGO	General Observation	89	NA
	9.7	SAV	Surface Aggregate Visible	101	S 3

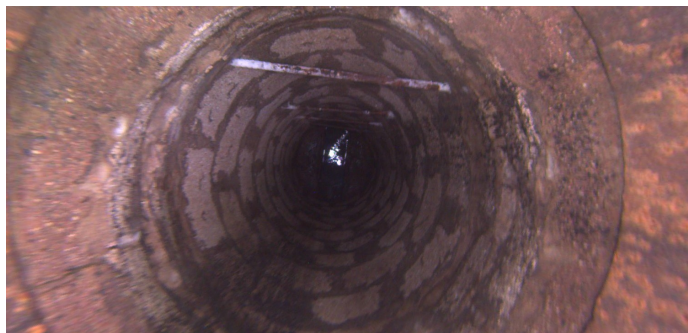
Code: **MGO**
Description: **General Observation**

Distance (ft): **.0**
Structural Grade: **0**
O&M Grade: **0**
Clock Start/From:
Clock To:
1st Value:
2nd Value:
Value Percent:
Step: **NO**
Remarks: **ACCESS MH**

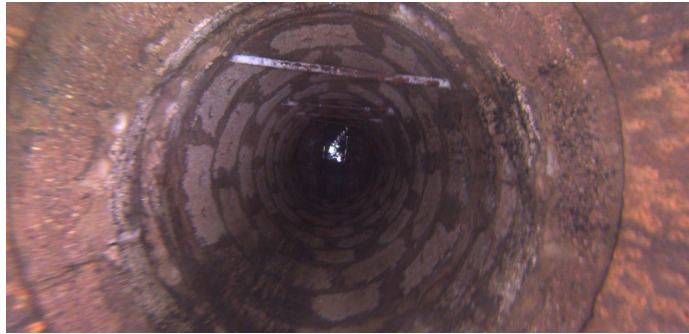
Code: **RFJ**
Description: **Roots Fine Joint**

Distance (ft): **.0**
Structural Grade: **0**
O&M Grade: **1**
Clock Start/From: **8**
Clock To:
1st Value:
2nd Value:
Value Percent:
Step: **NO**
Remarks:

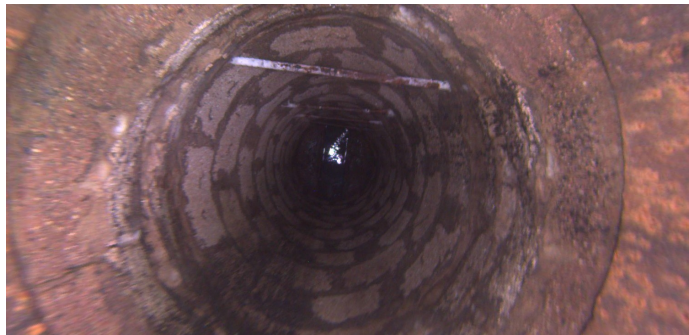
Code: **SAV**
Description: **Surface Aggregate Visible**

Distance (ft): **.0**
Structural Grade: **3**
O&M Grade: **0**
Clock Start/From: **12**
Clock To: **12**
1st Value:
2nd Value:
Value Percent:
Step: **NO**
Remarks:

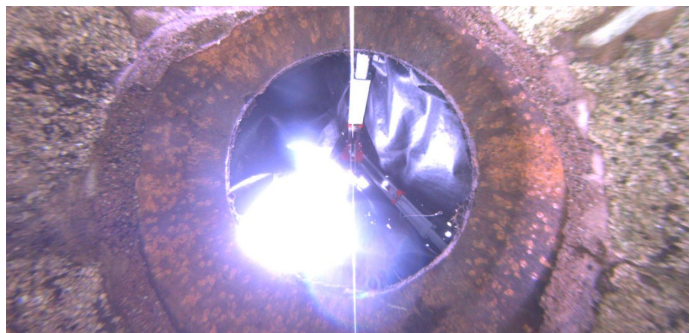
Code: **MGO**
Description: **General Observation**

Distance (ft): **2.4**
Structural Grade: **0**
O&M Grade: **0**
Clock Start/From:
Clock To:
1st Value:
2nd Value:
Value Percent:
Step: **NO**
Remarks: **UNDERSIDE OF FRAME**

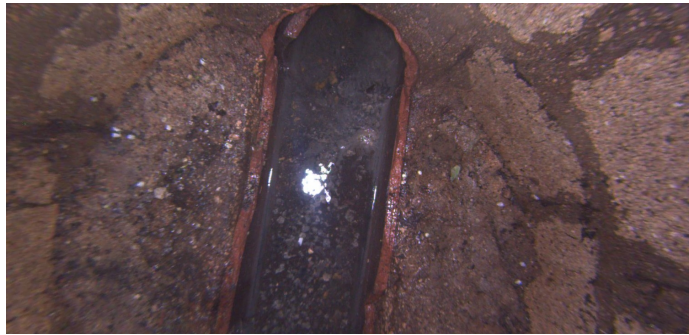
Code: **DSF**
Description: **Deposits Settled Fine**

Distance (ft): **8.7**
Structural Grade: **0**
O&M Grade: **2**
Clock Start/From: **12**
Clock To: **12**
1st Value:
2nd Value:
Value Percent: **5.000**
Step: **NO**
Remarks:

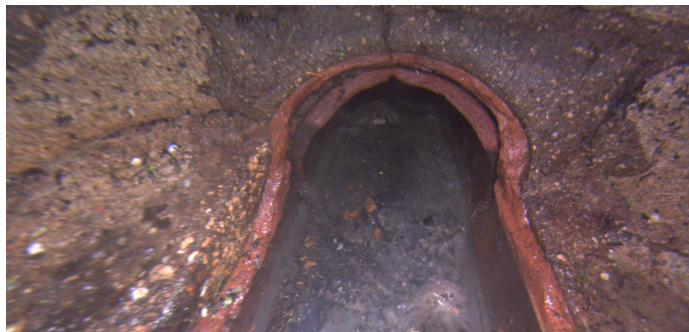
Code: **MGO**
Description: **General Observation**

Distance (ft): **9.7**
Structural Grade: **0**
O&M Grade: **0**
Clock Start/From:
Clock To:
1st Value:
2nd Value:
Value Percent:
Step: **NO**
Remarks: **END SURVEY**

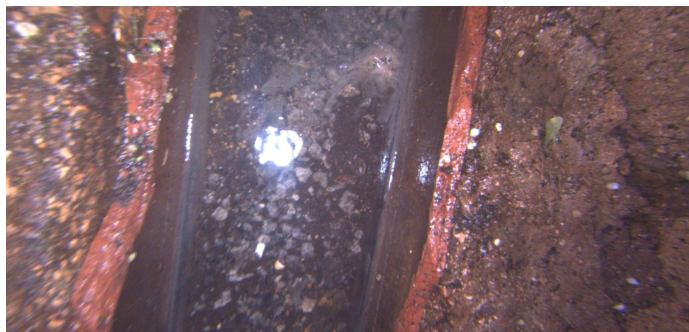
Code: **SAV**
Description: **Surface Aggregate Visible**

Distance (ft): **9.7**
Structural Grade: **3**
O&M Grade: **0**
Clock Start/From: **12**
Clock To: **12**
1st Value:
2nd Value:
Value Percent:
Step: **NO**
Remarks:
