Manhole Inspection Report

Date:	05/15/2018	Weather:		Coding:	RZMACP
MH#:	M-504-118	Owner:	NA	Len. Surveyed:	8.2
P.O.#:		Surveyor:	Jen Costello	Rim to Invert:	8.0
Customer:		Cert. #:	U-907-5518	Wall Material:	Concrete (reinforced)

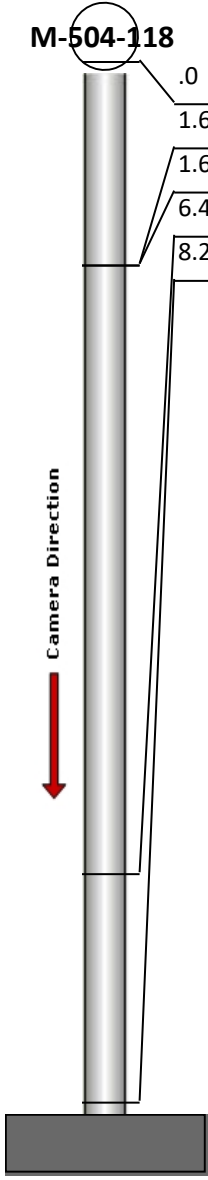
Position	Code	Observation	Video (sec)	Grade

.0	MGO	General Observation	10	NA
	1.6	DAE	Deposits Attached Encrustation	25	M 2
	1.6	MGO	General Observation	38	NA
	6.4	DSF	Deposits Settled Fine	60	M 2
	8.2	MGO	General Observation	76	NA

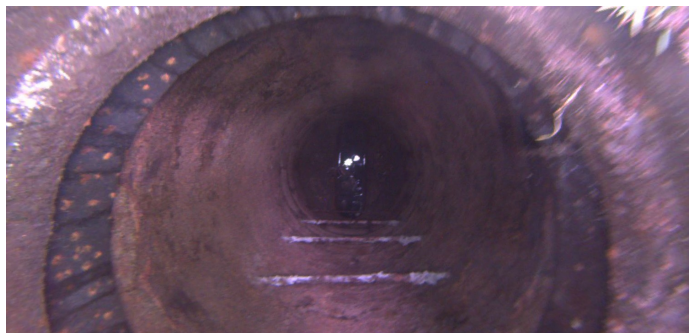
Code: **MGO**
Description: **General Observation**

Distance (ft): **.0**
Structural Grade: **0**
O&M Grade: **0**
Clock Start/From:
Clock To:
1st Value:
2nd Value:
Value Percent:
Step: **NO**
Remarks: **access mh**

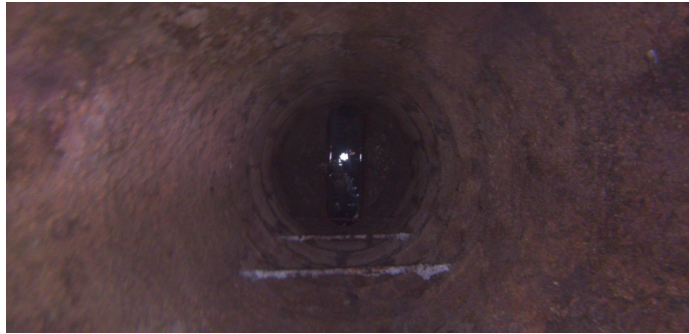
Code: **DAE**
Description: **Deposits Attached Encrustation**

Distance (ft): **1.6**
Structural Grade: **0**
O&M Grade: **2**
Clock Start/From: **12**
Clock To: **12**
1st Value:
2nd Value:
Value Percent: **5.000**
Step: **NO**
Remarks:

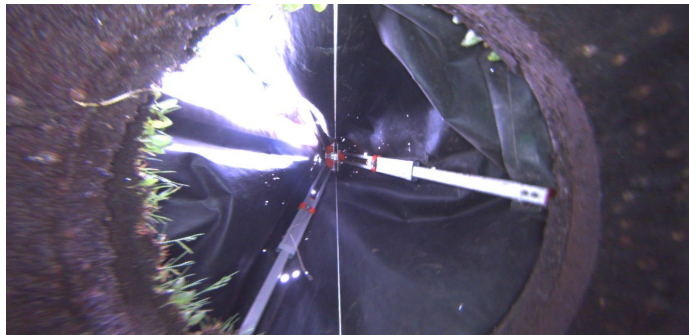
Code: **MGO**
Description: **General Observation**

Distance (ft): **1.6**
Structural Grade: **0**
O&M Grade: **0**
Clock Start/From:
Clock To:
1st Value:
2nd Value:
Value Percent:
Step: **NO**
Remarks: **underside of frame**

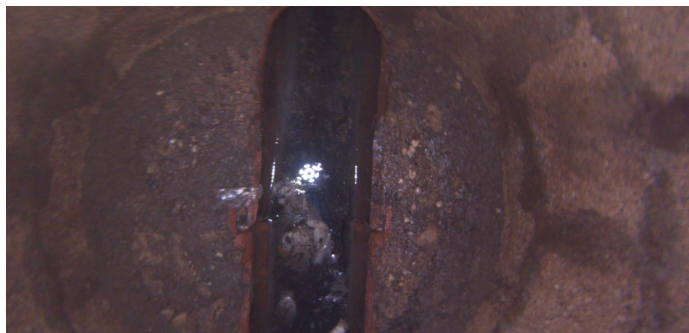
Code: **DSF**
Description: **Deposits Settled Fine**

Distance (ft): **6.4**
Structural Grade: **0**
O&M Grade: **2**
Clock Start/From: **12**
Clock To: **12**
1st Value:
2nd Value:
Value Percent: **5.000**
Step: **NO**
Remarks:

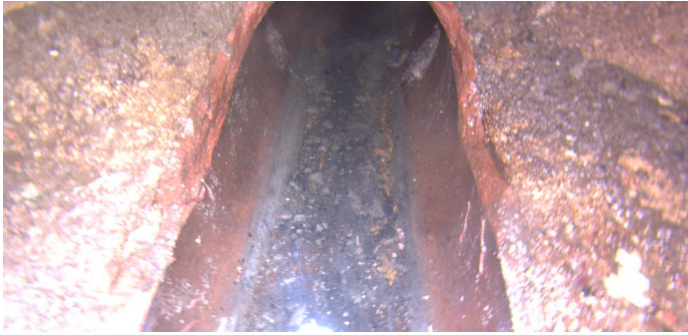
Code: **MGO**
Description: **General Observation**

Distance (ft): **8.2**
Structural Grade: **0**
O&M Grade: **0**
Clock Start/From:
Clock To:
1st Value:
2nd Value:
Value Percent:
Step: **NO**
Remarks: **end survey**
