Manhole Inspection Report

Date:	05/15/2018	Weather:		Coding:	RZMACP
MH#:	M-504-119	Owner:	NA	Len. Surveyed:	6.3
P.O.#:		Surveyor:	Jen Costello	Rim to Invert:	6.5
Customer:		Cert. #:	U-907-5518	Wall Material:	Brick

Street:	165' East of Cavender St. 261' South	Project:	Hobart, IN
City:	Hobart, IN	GPS Northing:	41.5430069
Location:		GPS Easting:	-87.27534485
Drain Area:	Northwest	GPS Accuracy:	Nearest Meter
Cover Shape:	Circular	Evidence of Surcharge:	No
Cover Size:	22.5	Potential for Runoff:	None
Comments:

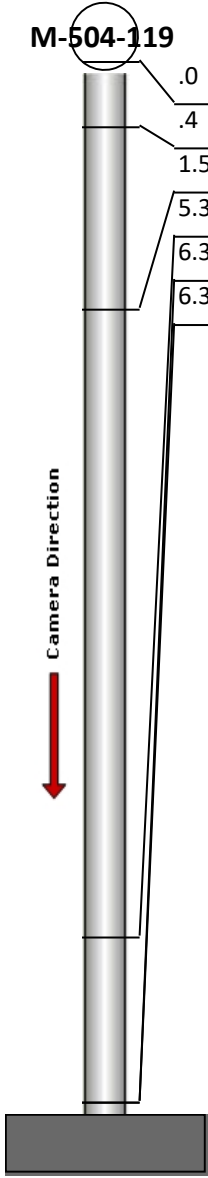
.0	MGO	General Observation	10	NA
	.4	SAV	Surface Aggregate Visible	23	S 3
	1.5	MGO	General Observation	38	NA
	5.3	DSF	Deposits Settled Fine	58	M 2
	6.3	MGO	General Observation	71	NA
	6.3	SAV	Surface Aggregate Visible	81	S 3

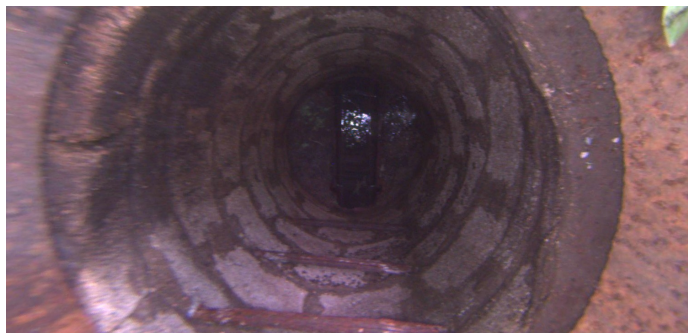
Code: **MGO**
Description: **General Observation**

Distance (ft): **.0**
Structural Grade: **0**
O&M Grade: **0**
Clock Start/From:
Clock To:
1st Value:
2nd Value:
Value Percent:
Step: **NO**
Remarks: **ACCESS mh**

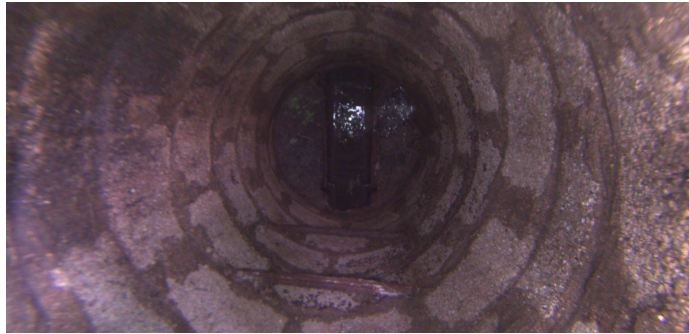
Code: **SAV**
Description: **Surface Aggregate Visible**

Distance (ft): **.4**
Structural Grade: **3**
O&M Grade: **0**
Clock Start/From: **12**
Clock To: **12**
1st Value:
2nd Value:
Value Percent:
Step: **NO**
Remarks:

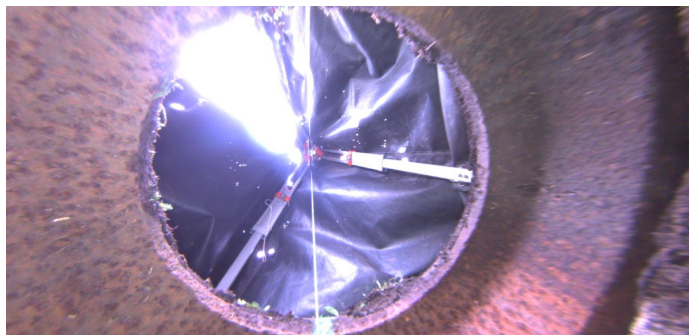
Code: **MGO**
Description: **General Observation**

Distance (ft): **1.5**
Structural Grade: **0**
O&M Grade: **0**
Clock Start/From:
Clock To:
1st Value:
2nd Value:
Value Percent:
Step: **NO**
Remarks: **underside of frame**

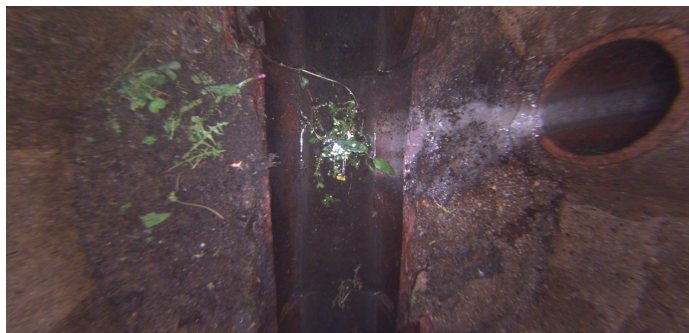
Code: **DSF**
Description: **Deposits Settled Fine**

Distance (ft): **5.3**
Structural Grade: **0**
O&M Grade: **2**
Clock Start/From: **12**
Clock To: **12**
1st Value:
2nd Value:
Value Percent: **5.000**
Step: **NO**
Remarks:

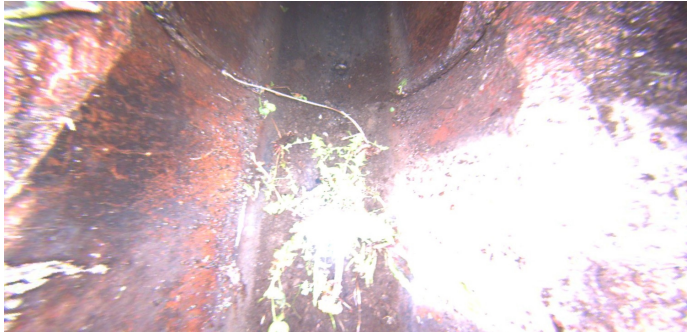
Code: **MGO**
Description: **General Observation**

Distance (ft): **6.3**
Structural Grade: **0**
O&M Grade: **0**
Clock Start/From:
Clock To:
1st Value:
2nd Value:
Value Percent:
Step: **NO**
Remarks: **end survey**

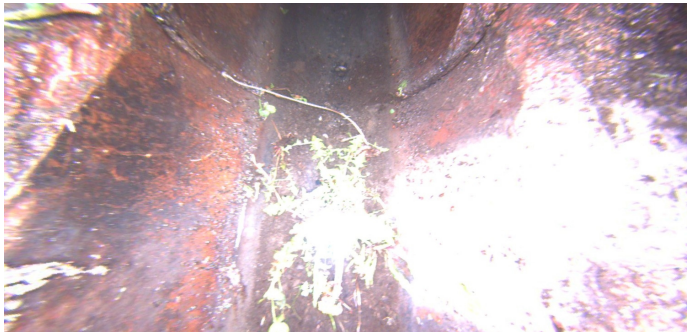
Code: **SAV**
Description: **Surface Aggregate Visible**

Distance (ft): **6.3**
Structural Grade: **3**
O&M Grade: **0**
Clock Start/From: **12**
Clock To: **12**
1st Value:
2nd Value:
Value Percent:
Step: **NO**
Remarks:
