Manhole Inspection Report

Date:	05/15/2018	Weather:		Coding:	RZMACP
MH#:	M-504-121	Owner:	NA	Len. Surveyed:	10.5
P.O.#:		Surveyor:	Jen Costello	Rim to Invert:	11.2
Customer:		Cert. #:	U-907-5518	Wall Material:	Brick

Street:	42nd Ave. 111' East of Guyer St.	Project:	Hobart, IN
City:	Hobart, IN	GPS Northing:	41.54190063
Location:		GPS Easting:	-87.27670288
Drain Area:	Northwest	GPS Accuracy:	Nearest Meter
Cover Shape:	Circular	Evidence of Surcharge:	No
Cover Size:	22.5	Potential for Runoff:	None
Comments:

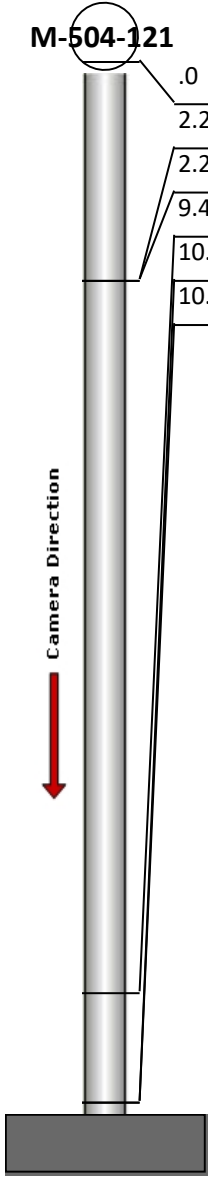
Position	Code	Observation	Video (sec)	Grade

.0	MGO	General Observation	10	NA
	2.2	SRI	Surface Roughness Increased	26	S 1
	2.2	MGO	General Observation	40	NA
	9.4	DSF	Deposits Settled Fine	68	M 2
	10.5	SRI	Surface Roughness Increased	82	S 1
	10.5	MGO	General Observation	93	NA

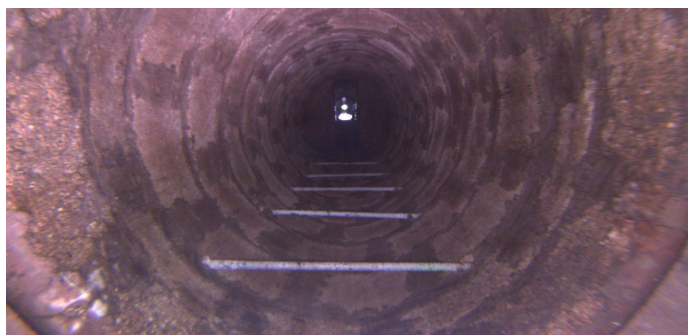
Code: **MGO**
Description: **General Observation**

Distance (ft): **.0**
Structural Grade: **0**
O&M Grade: **0**
Clock Start/From:
Clock To:
1st Value:
2nd Value:
Value Percent:
Step: **NO**
Remarks: **ACCESS MH**

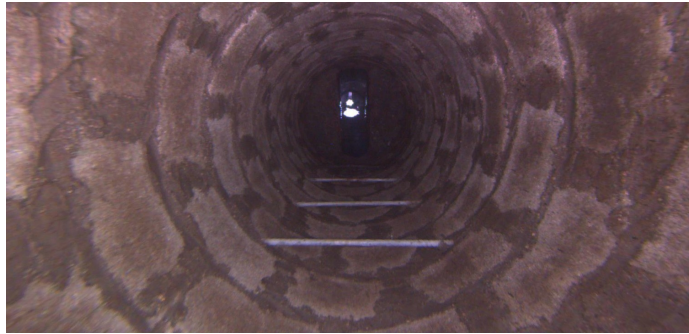
Code: **SRI**
Description: **Surface Roughness Increased**

Distance (ft): **2.2**
Structural Grade: **1**
O&M Grade: **0**
Clock Start/From: **12**
Clock To: **12**
1st Value:
2nd Value:
Value Percent:
Step: **NO**
Remarks:

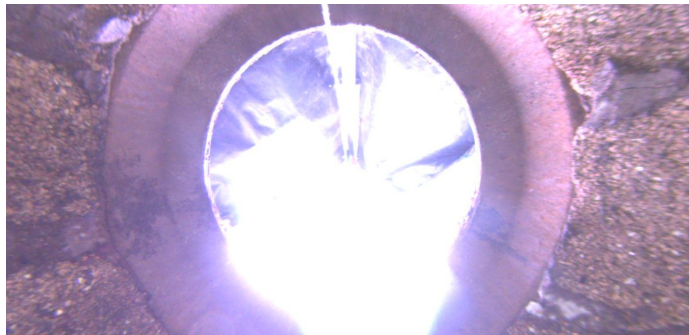
Code: **MGO**
Description: **General Observation**

Distance (ft): **2.2**
Structural Grade: **0**
O&M Grade: **0**
Clock Start/From:
Clock To:
1st Value:
2nd Value:
Value Percent:
Step: **NO**
Remarks: **UNDERSIDE OF FRAME**

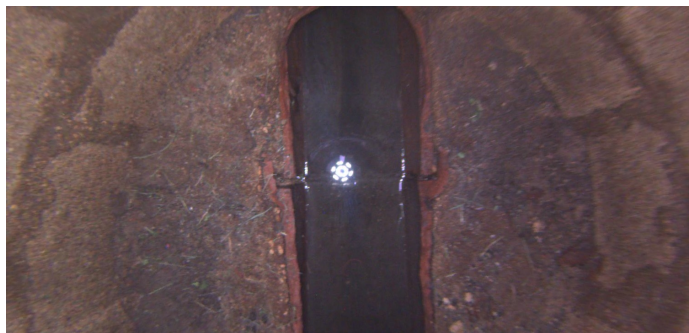
Code: **DSF**
Description: **Deposits Settled Fine**

Distance (ft): **9.4**
Structural Grade: **0**
O&M Grade: **2**
Clock Start/From: **12**
Clock To: **12**
1st Value:
2nd Value:
Value Percent: **5.000**
Step: **NO**
Remarks:

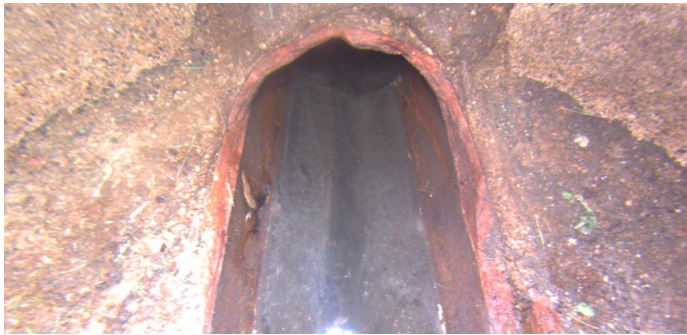
Code: **SRI**
Description: **Surface Roughness Increased**

Distance (ft): **10.5**
Structural Grade: **1**
O&M Grade: **0**
Clock Start/From: **12**
Clock To: **12**
1st Value:
2nd Value:
Value Percent:
Step: **NO**
Remarks:

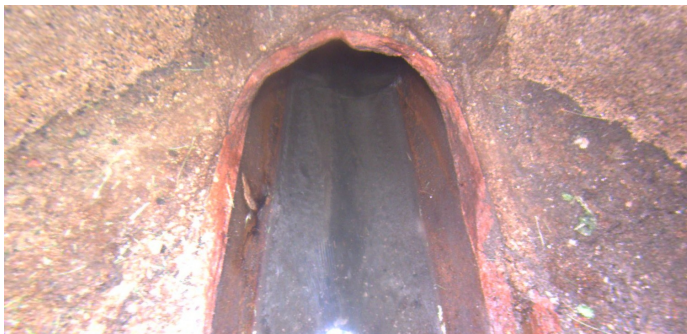
Code: **MGO**
Description: **General Observation**

Distance (ft): **10.5**
Structural Grade: **0**
O&M Grade: **0**
Clock Start/From:
Clock To:
1st Value:
2nd Value:
Value Percent:
Step: **NO**
Remarks: **END SURVEY**
