Manhole Inspection Report

Date:	05/15/2018	Weather:		Coding:	RZMACP
MH#:	M-504-123	Owner:	NA	Len. Surveyed:	10.0
P.O.#:		Surveyor:	Jen Costello	Rim to Invert:	10.2
Customer:		Cert. #:	U-907-5518	Wall Material:	Brick

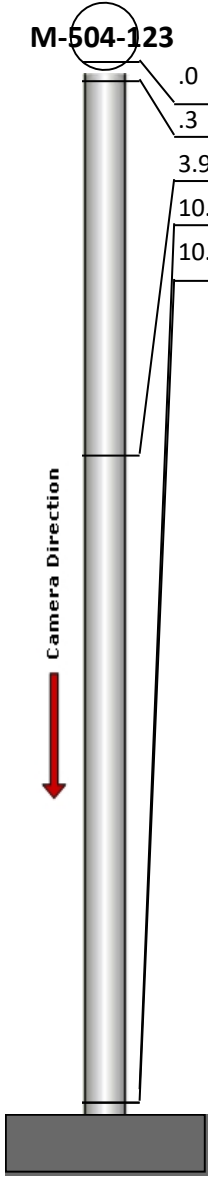
Position	Code	Observation	Video (sec)	Grade

.0	MGO	General Observation	10	NA
	.3	SAV	Surface Aggregate Visible	22	S 3
	3.9	MGO	General Observation	42	NA
	10.0	MGO	General Observation	68	NA
	10.0	SAV	Surface Aggregate Visible	78	S 3

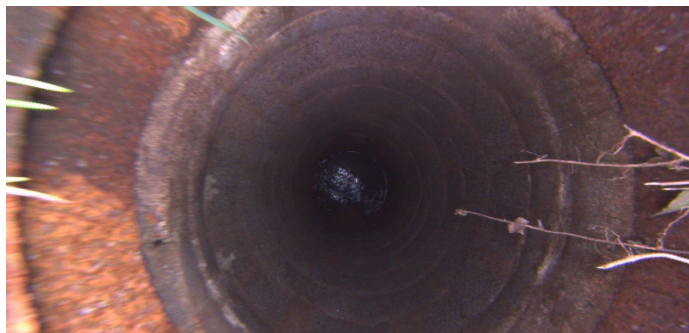
Code: **MGO**
Description: **General Observation**

Distance (ft): **.0**
Structural Grade: **0**
O&M Grade: **0**
Clock Start/From:
Clock To:
1st Value:
2nd Value:
Value Percent:
Step: **NO**
Remarks: **access MH**

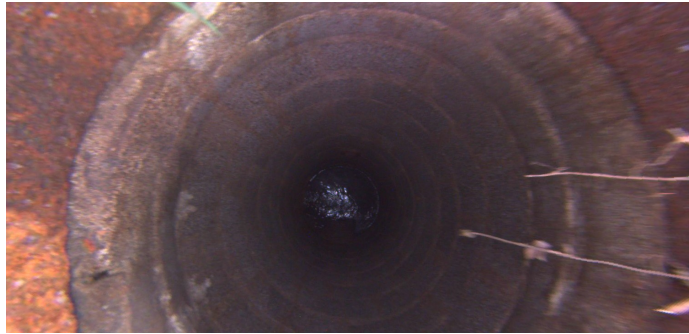
Code: **SAV**
Description: **Surface Aggregate Visible**

Distance (ft): **.3**
Structural Grade: **3**
O&M Grade: **0**
Clock Start/From: **12**
Clock To: **12**
1st Value:
2nd Value:
Value Percent:
Step: **NO**
Remarks:

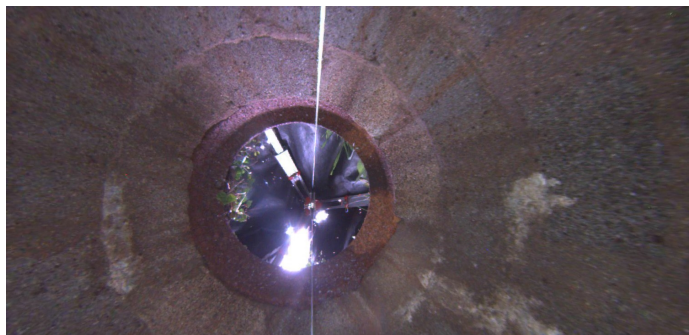
Code: **MGO**
Description: **General Observation**

Distance (ft): **3.9**
Structural Grade: **0**
O&M Grade: **0**
Clock Start/From:
Clock To:
1st Value:
2nd Value:
Value Percent:
Step: **NO**
Remarks: **UNDERSIDE OF FRAME**

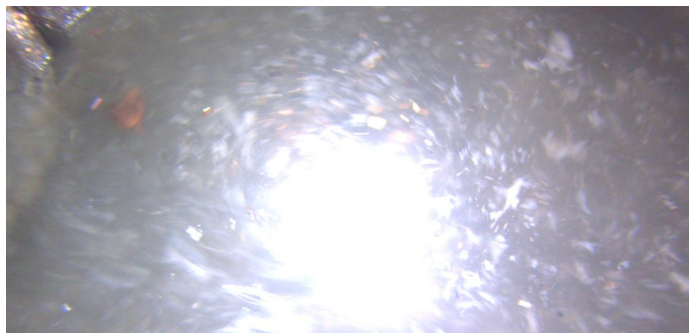
Code: **MGO**
Description: **General Observation**

Distance (ft): **10.0**
Structural Grade: **0**
O&M Grade: **0**
Clock Start/From:
Clock To:
1st Value:
2nd Value:
Value Percent:
Step: **NO**
Remarks: **END SURVEY BENCH IS SUBMERGED**

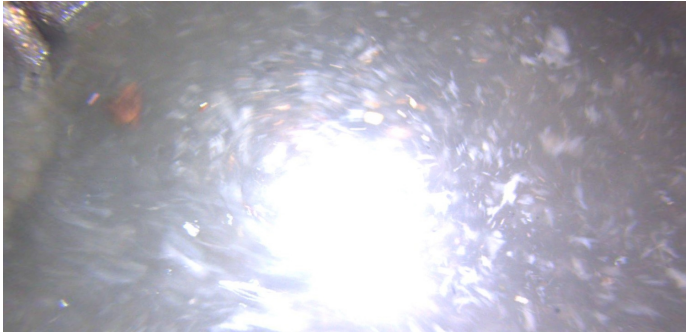
Code:	SAV
Description:	Surface Aggregate Visible
Distance (ft):	10.0
Structural Grade:	3
O&M Grade:	0
Clock Start/From:	12
Clock To:	12
1st Value:	
2nd Value:	
Value Percent:	
Step:	NO
Remarks:
