# Manhole Inspection Report

Date:	<b>05/15/2018</b>	Weather:		Coding:	<b>RZMACP</b>
MH#:	<b>M-504-126.1</b>	Owner:	<b>NA</b>	Len. Surveyed:	<b>6.8</b>
P.O.#:		Surveyor:	<b>Jen Costello</b>	Rim to Invert:	<b>7.4</b>
Customer:		Cert. #:	<b>U-907-5518</b>	Wall Material:	<b>Concrete (reinforced)</b>

Street:	<b>Ridge Road North. Between Guyer S</b>	Project:	<b>Hobart, IN</b>
City:	<b>Hobart, IN</b>	GPS Northing:	<b>41.54113388</b>
Location:		GPS Easting:	<b>-87.27771759</b>
Drain Area:	<b>Northwest</b>	GPS Accuracy:	<b>Nearest Meter</b>
Cover Shape:	<b>Circular</b>	Evidence of Surcharge:	<b>No</b>
Cover Size:	<b>22.5</b>	Potential for Runoff:	<b>None</b>
Comments:

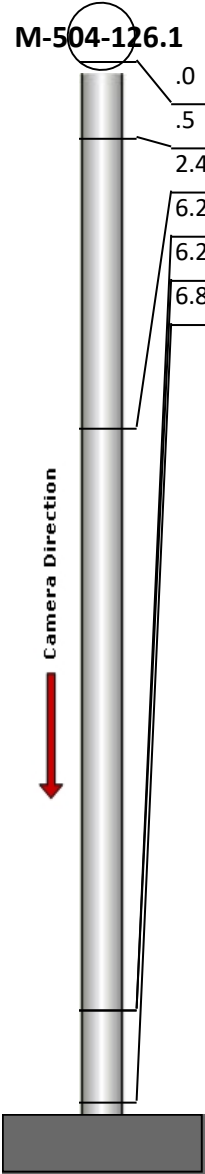
.0	MGO	General Observation	10	NA
	.5	DAE	Deposits Attached Encrustation	23	M 2
	2.4	MGO	General Observation	40	NA
	6.2	DSGV	Deposits Settled Gravel	61	M 2
	6.2	OBZ	Obstacle Other	73	M 2
	6.8	MGO	General Observation	86	NA

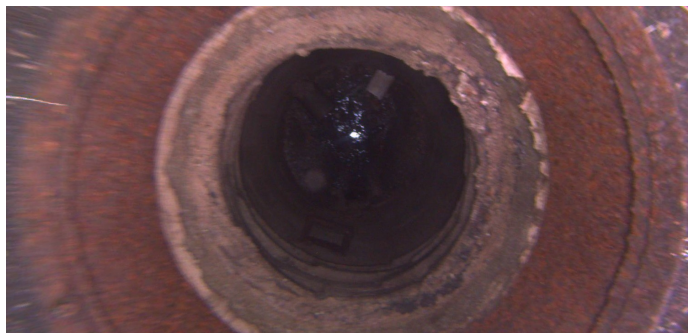
Code: **MGO**  
Description: **General Observation**

Distance (ft): **.0**  
Structural Grade: **0**  
O&M Grade: **0**  
Clock Start/From:  
Clock To:  
1st Value:  
2nd Value:  
Value Percent:  
Step: **NO**  
Remarks: **ACCESS MH**

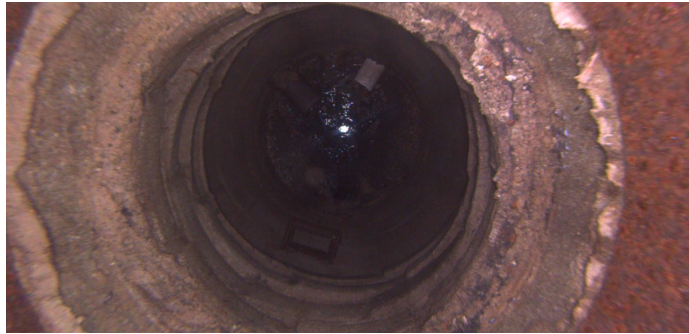
Code: **DAE**  
Description: **Deposits Attached Encrustation**

Distance (ft): **.5**  
Structural Grade: **0**  
O&M Grade: **2**  
Clock Start/From: **12**  
Clock To: **2**  
1st Value:  
2nd Value:  
Value Percent: **5.000**  
Step: **NO**  
Remarks:

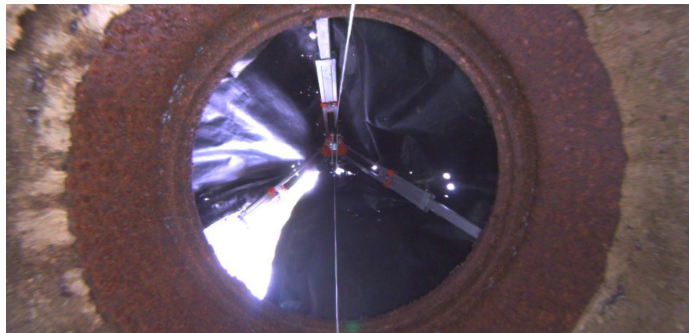
Code: **MGO**  
Description: **General Observation**

Distance (ft): **2.4**  
Structural Grade: **0**  
O&M Grade: **0**  
Clock Start/From:  
Clock To:  
1st Value:  
2nd Value:  
Value Percent:  
Step: **NO**  
Remarks: **END SURVEY**

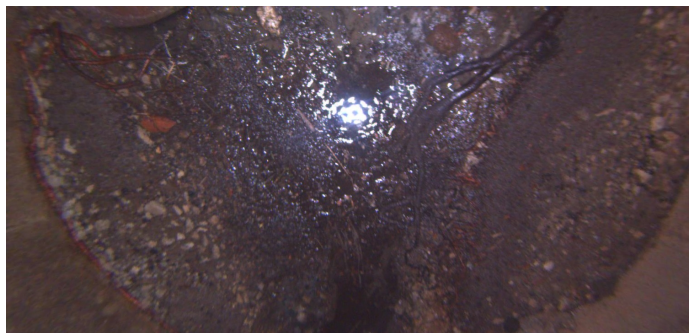
Code: **DSGV**  
Description: **Deposits Settled Gravel**

Distance (ft): **6.2**  
Structural Grade: **0**  
O&M Grade: **2**  
Clock Start/From: **12**  
Clock To: **12**  
1st Value:  
2nd Value:  
Value Percent: **5.000**  
Step: **NO**  
Remarks:

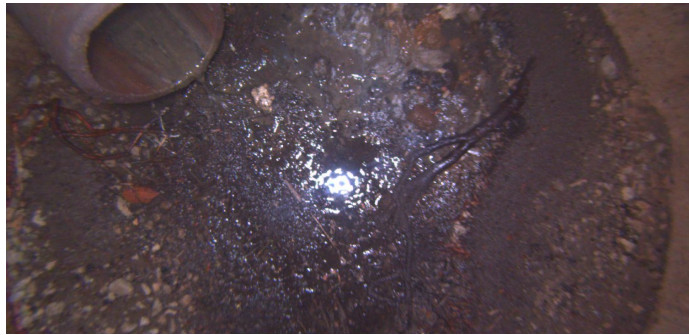
Code: **OBZ**  
Description: **Obstacle Other**

Distance (ft): **6.2**  
Structural Grade: **0**  
O&M Grade: **2**  
Clock Start/From: **1**  
Clock To: **6**  
1st Value:  
2nd Value:  
Value Percent: **5.000**  
Step: **NO**  
Remarks: **STICK**

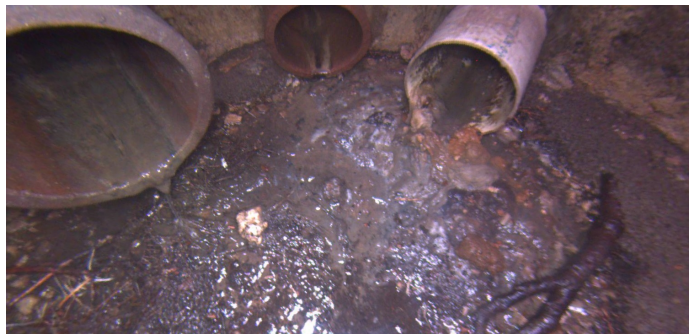
Code: **MGO**  
Description: **General Observation**

Distance (ft): **6.8**  
Structural Grade: **0**  
O&M Grade: **0**  
Clock Start/From:  
Clock To:  
1st Value:  
2nd Value:  
Value Percent:  
Step: **NO**  
Remarks: **END SURVEY**
