# Manhole Inspection Report

| MH#: | M-504-126 | Owner: | NA | Len. Surveyed: | 6.3 |

| Street: | 42nd Ave. Between Guyer St. and W | Project: | Hobart, IN |

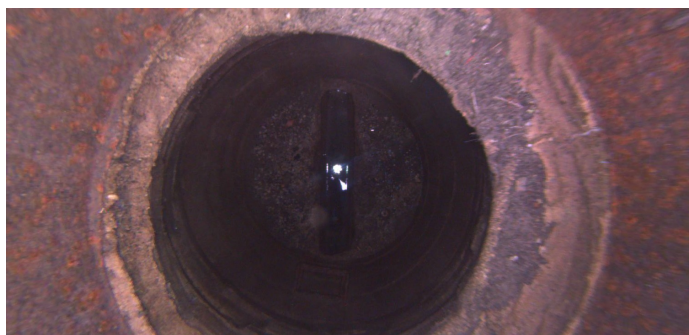
Code: **MGO**  
Description: **General Observation**

Distance (ft): **.0**  
Structural Grade: **0**  
O&M Grade: **0**  
Clock Start/From:  
Clock To:  
1st Value:  
2nd Value:  
Value Percent:  
Step: **NO**  
Remarks: **ACCESS MH**

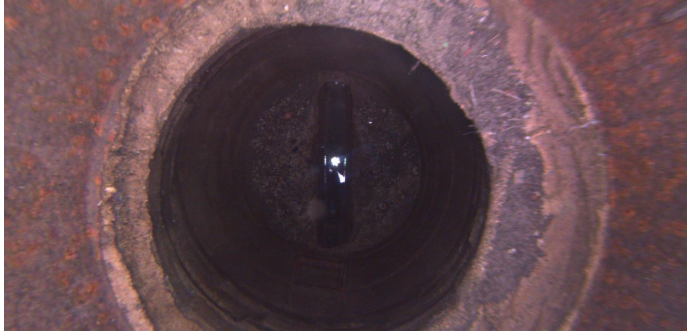
Code: **RFJ**  
Description: **Roots Fine Joint**

Distance (ft): **.0**  
Structural Grade: **0**  
O&M Grade: **1**  
Clock Start/From: **12**  
Clock To: **12**  
1st Value:  
2nd Value:  
Value Percent:  
Step: **NO**  
Remarks:

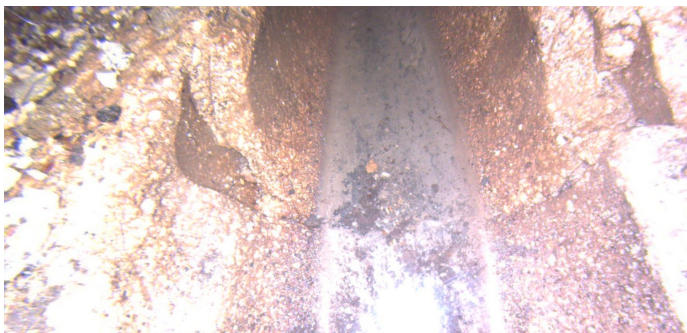
Code: **HSV**  
Description: **Hole Soil Visible**

Distance (ft): **6.3**  
Structural Grade: **5**  
O&M Grade: **0**  
Clock Start/From: **8**  
Clock To: **9**  
1st Value:  
2nd Value:  
Value Percent:  
Step: **NO**  
Remarks:

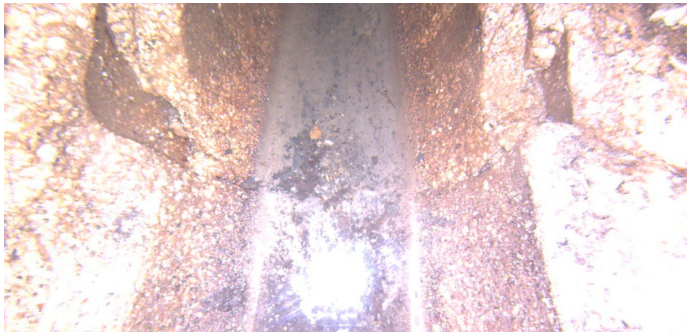
| Code: | <b>MGO</b> |
| Description: | <b>General Observation</b> |
| Distance (ft): | <b>6.3</b> |
| Remarks: | <b>END SURVEY</b> |
