Manhole Inspection Report

Date:	05/15/2018	Weather:		Coding:	RZMACP
MH#:	M-504-127	Owner:	NA	Len. Surveyed:	5.1
P.O.#:		Surveyor:	Jen Costello	Rim to Invert:	4.8
Customer:		Cert. #:	U-907-5518	Wall Material:	Concrete (reinforced)

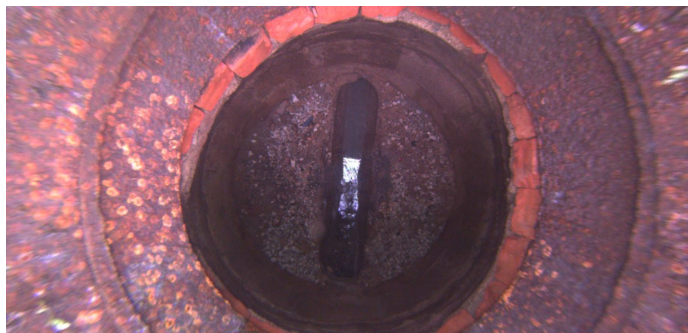
Code: **MGO**
Description: **General Observation**

Distance (ft): **.0**
Structural Grade: **0**
O&M Grade: **0**
Clock Start/From:
Clock To:
1st Value:
2nd Value:
Value Percent:
Step: **NO**
Remarks: **ACCESS MH**

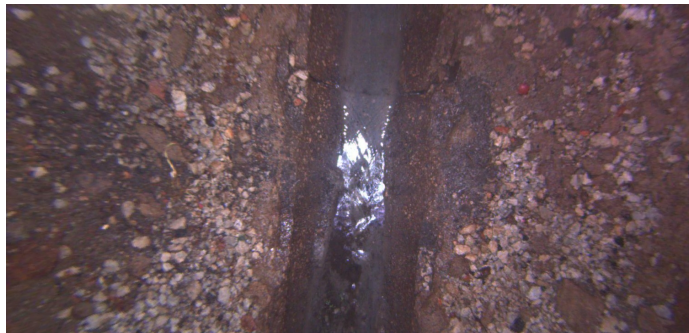
Code: **DSGV**
Description: **Deposits Settled Gravel**

Distance (ft): **3.3**
Structural Grade: **0**
O&M Grade: **2**
Clock Start/From: **12**
Clock To: **12**
1st Value:
2nd Value:
Value Percent: **5.000**
Step: **NO**
Remarks:

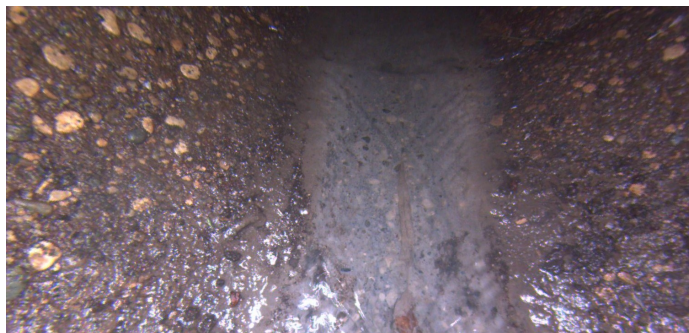
Code: **SAP**
Description: **Surface Aggregate Projecting**

Distance (ft): **5.1**
Structural Grade: **3**
O&M Grade: **0**
Clock Start/From: **3**
Clock To: **9**
1st Value:
2nd Value:
Value Percent:
Step: **NO**
Remarks:
