# Manhole Inspection Report

Date:	05/16/2018	Weather:		Coding:	RZMACP
MH#:	M-504-129	Owner:	NA	Len. Surveyed:	18.2
P.O.#:		Surveyor:	Jen Costello	Rim to Invert:	20.2
Customer:		Cert. #:	U-907-5518	Wall Material:	Concrete (reinforced)

Street:	Ridge Rd. 150' West of Virginia St.	Project:	Hobart, IN
City:	Hobart, IN	GPS Northing:	41.53992844
Location:		GPS Easting:	-87.27238464
Drain Area:	Northwest	GPS Accuracy:	Nearest Meter
Cover Shape:	Circular	Evidence of Surcharge:	No
Cover Size:	22.5	Potential for Runoff:	None
Comments:

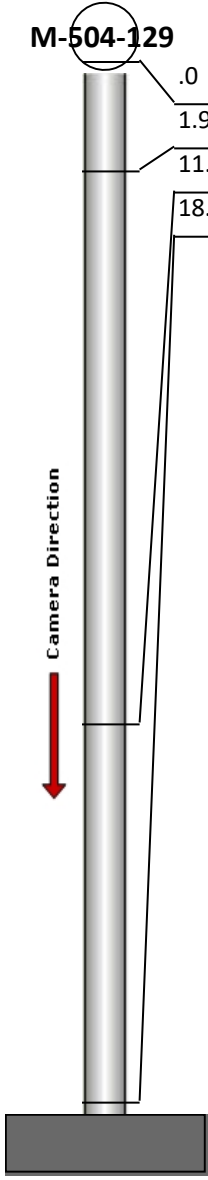
.0	MGO	General Observation	10	NA
	1.9	MGO	General Observation	27	NA
	11.6	RFB	Roots Fine Barrel	60	M 2
	18.2	MGO	General Observation	85	NA

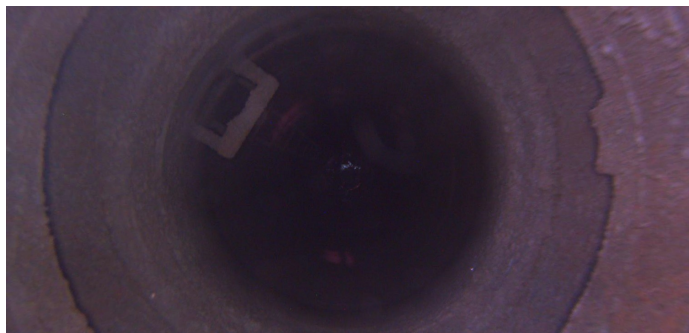
Code: **MGO**  
Description: **General Observation**

Distance (ft): **.0**  
Structural Grade: **0**  
O&M Grade: **0**  
Clock Start/From:  
Clock To:  
1st Value:  
2nd Value:  
Value Percent:  
Step: **NO**  
Remarks: **ACCESS MH**

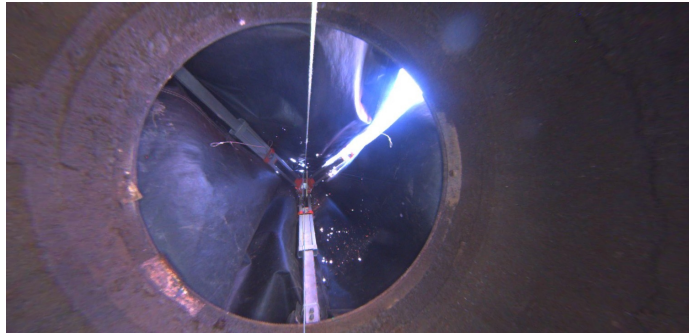
Code: **MGO**  
Description: **General Observation**

Distance (ft): **1.9**  
Structural Grade: **0**  
O&M Grade: **0**  
Clock Start/From:  
Clock To:  
1st Value:  
2nd Value:  
Value Percent:  
Step: **NO**  
Remarks: **UNDERSIDE OF FRAME**

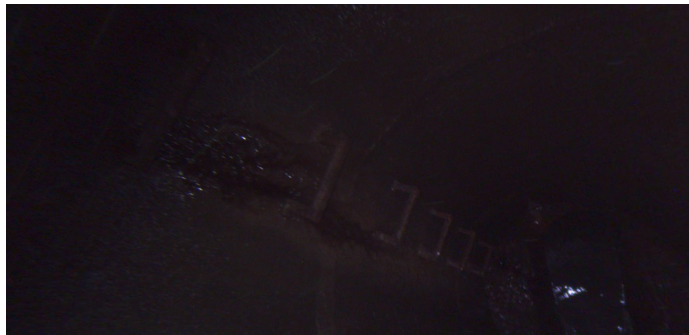
Code: **RFB**  
Description: **Roots Fine Barrel**

Distance (ft): **11.6**  
Structural Grade: **0**  
O&M Grade: **2**  
Clock Start/From: **9**  
Clock To:  
1st Value:  
2nd Value:  
Value Percent:  
Step: **YES**  
Remarks:

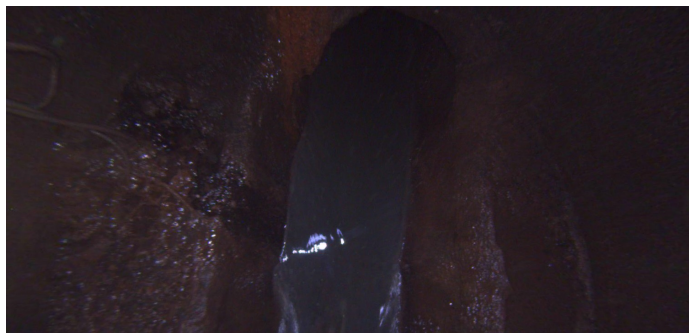
Code: **MGO**  
Description: **General Observation**

Distance (ft): **18.2**  
Structural Grade: **0**  
O&M Grade: **0**  
Clock Start/From:  
Clock To:  
1st Value:  
2nd Value:  
Value Percent:  
Step: **NO**  
Remarks: **END SURVEY**
