Manhole Inspection Report

Date:	05/15/2018	Weather:		Coding:	RZMACP
MH#:	M-504-130	Owner:	NA	Len. Surveyed:	8.6
P.O.#:		Surveyor:	Jen Costello	Rim to Invert:	9.5
Customer:		Cert. #:	U-907-5518	Wall Material:	Brick

Street:	42nd Ave. 165' West of California St.	Project:	Hobart, IN
City:	Hobart, IN	GPS Northing:	41.54183197
Location:		GPS Easting:	-87.27125549
Drain Area:	Northwest	GPS Accuracy:	Nearest Meter
Cover Shape:	Circular	Evidence of Surcharge:	No
Cover Size:	22.5	Potential for Runoff:	None
Comments:

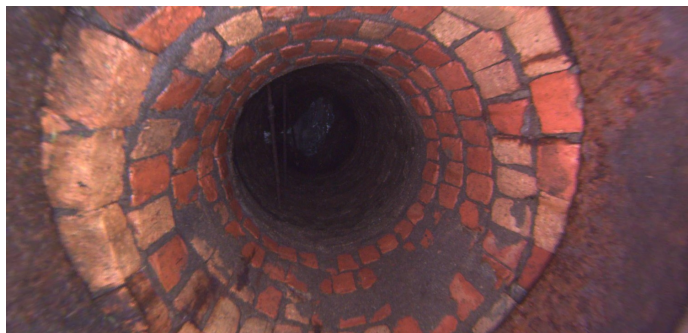
Code: **MGO**
Description: **General Observation**

Distance (ft): **.0**
Structural Grade: **0**
O&M Grade: **0**
Clock Start/From:
Clock To:
1st Value:
2nd Value:
Value Percent:
Step: **NO**
Remarks: **ACCESS MH**

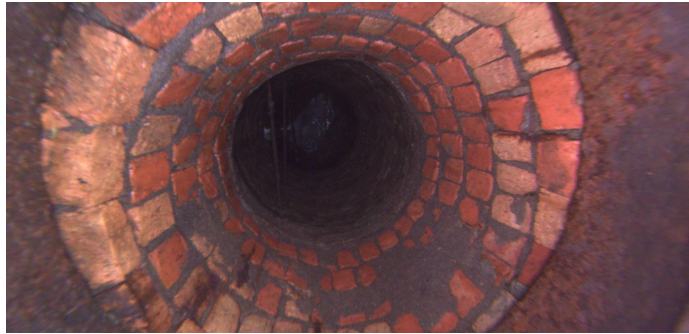
Code: **IW**
Description: **Infil Weeper**

Distance (ft): **.0**
Structural Grade: **0**
O&M Grade: **2**
Clock Start/From: **6**
Clock To: **8**
1st Value:
2nd Value:
Value Percent:
Step: **NO**
Remarks:

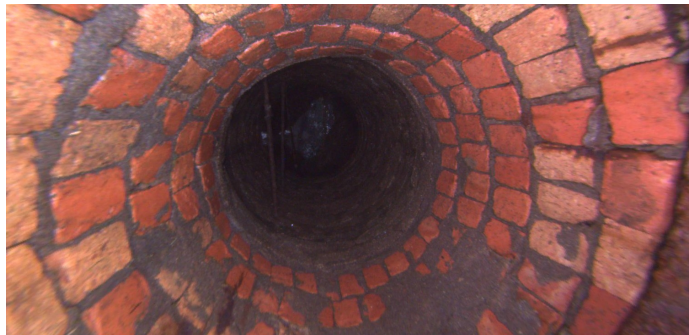
Code: **RFB**
Description: **Roots Fine Barrel**

Distance (ft): **.5**
Structural Grade: **0**
O&M Grade: **2**
Clock Start/From: **2**
Clock To: **3**
1st Value:
2nd Value:
Value Percent:
Step: **NO**
Remarks:

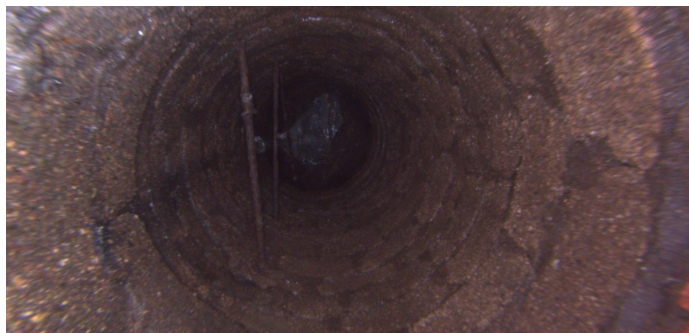
Code: **SAV**
Description: **Surface Aggregate Visible**

Distance (ft): **2.2**
Structural Grade: **3**
O&M Grade: **0**
Clock Start/From: **12**
Clock To: **12**
1st Value:
2nd Value:
Value Percent:
Step: **NO**
Remarks:

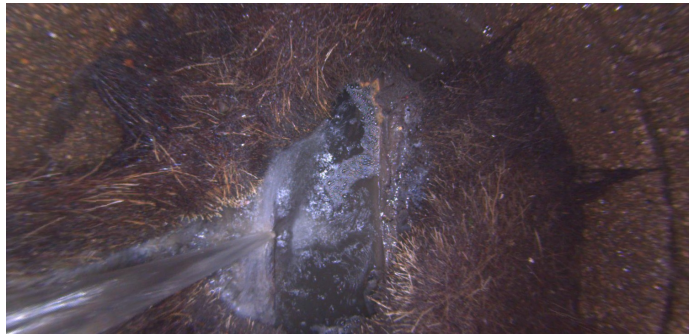
Code: **RBB**
Description: **Roots Ball Barrel**

Distance (ft): **8.1**
Structural Grade: **0**
O&M Grade: **5**
Clock Start/From: **12**
Clock To: **12**
1st Value:
2nd Value:
Value Percent: **60.000**
Step: **NO**
Remarks:

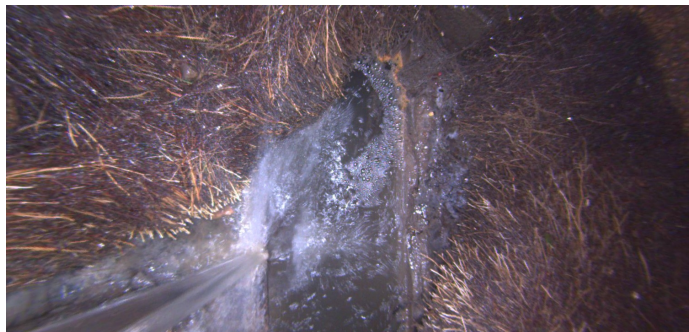
Code: **MGO**
Description: **General Observation**

Distance (ft): **8.6**
Structural Grade: **0**
O&M Grade: **0**
Clock Start/From:
Clock To:
1st Value:
2nd Value:
Value Percent:
Step: **NO**
Remarks: **END SURVEY**

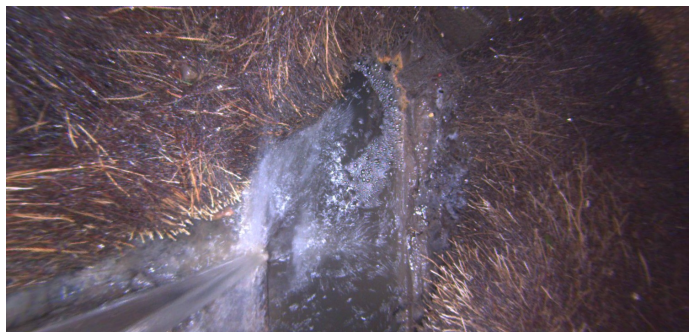
Code: **SAV**
Description: **Surface Aggregate Visible**

Distance (ft): **8.6**
Structural Grade: **3**
O&M Grade: **0**
Clock Start/From: **12**
Clock To: **12**
1st Value:
2nd Value:
Value Percent:
Step: **NO**
Remarks:
